File number: Inspection date: August 27, 2022

# PRE-PURCHASE INSPECTION REPORT

The condominium was built in 2009 and it has:

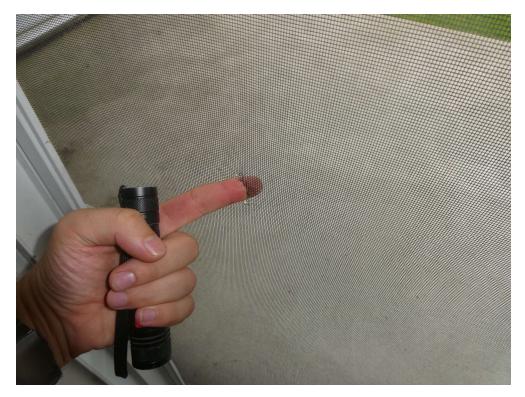
Rear patio door

# DOOR REQUIRING ADJUSTMENT

We noted that one or more doors require adjustements.

We recommend that you contact a licensed contractor to bring corrective measures to the door.

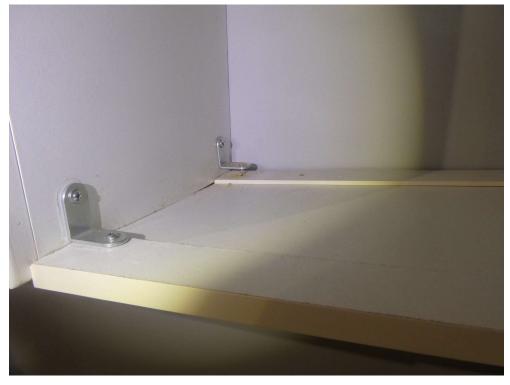
Washroom

We noted one or more damaged countertops or cabinets.

We recommend that you contact a licensed contractor to bring corrective measures to the affected elements.

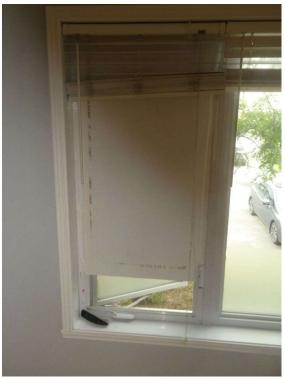
Living room

We noted that one or more windows and/or doors were covered which limited our inspection.
