File number: [REDACTED]
Inspection date: August 1, 2022

PRE-PURCHASE INSPECTION REPORT

Kevin Mercurio
Les Inspections Mercurio Inc.
1066 rue du Souvenir
Saint-Eustache, Québec
J7R 0M5
August 2, 2022

The property is a 1957 construction duplex. The foundation walls are made poured concrete and the siding is made of brick, stucco and wood. The windows are made of aluminum and the property has a multilayer asphalt and gravel roof covering. This building also has:

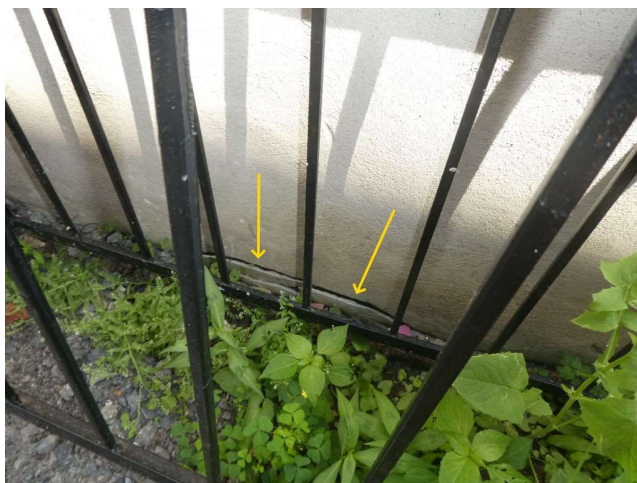
left facade

PARGING CRACK

We noticed one or more parging cracks.

We recommend applying a parging or a 100% acrylic paint to protect the concrete.

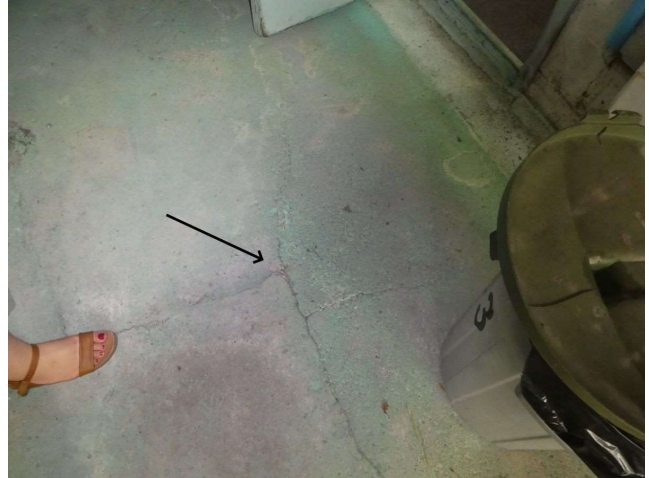
Front garage

CRACK

We noted one or more concrete slab cracks.

Concrete slabs often crack due to the concrete's curing process or due to slight settling during construction. Cracks can also occur if there are no control joints in place when pouring the slab. However, these cracks are common in most buildings and are usually not a major problem.

The concrete slab serves as a floor covering and protects the interior of the building against moisture and gases from the ground. As is, this situation can cause water infiltration which could cause frost heaving therein which can make the ground unstable and cause a tripping hazard. The pressure from swelling can also cause cracks in the foundation walls around the slab and cause structural damage to the building.

We recommend that you contact a firm specializing in crack repair to determine the necessary corrective measures to be taken and their costs, before concluding the inspection condition of your promise to purchase.

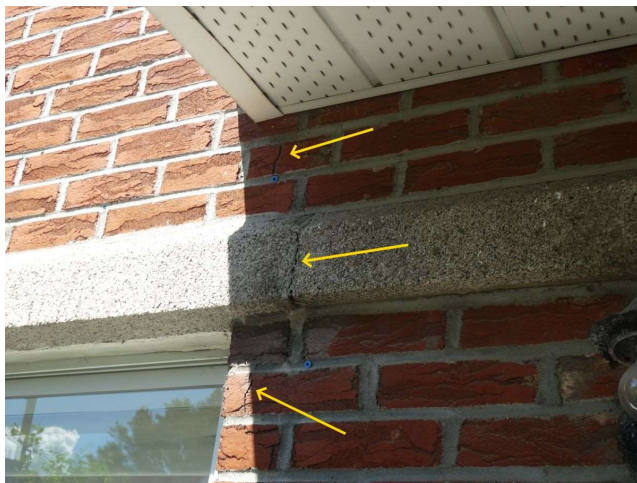
Front facade (living room window)

MASONRY WORK REQUIRED

We noted one or more areas that require repair work.

Masonry buildings will inevitably require conservation work to extend their life cycle. Repointing mortar joints is an intervention that is generally part of a regular maintenance program in order to restore the resistance to water infiltration of the masonry and to preserve its integrity.

We recommend that you consult a master mason in order to assess the costs and correct this situation.

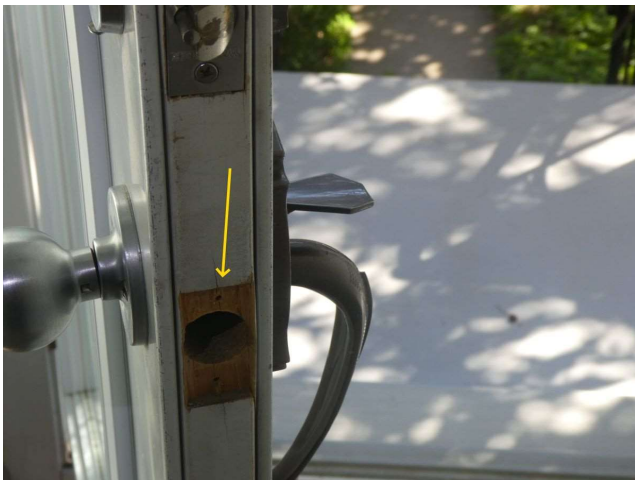
Front door leading to second floor

MISSING DOOR LATCH

We noted one or more doors that were a latch.

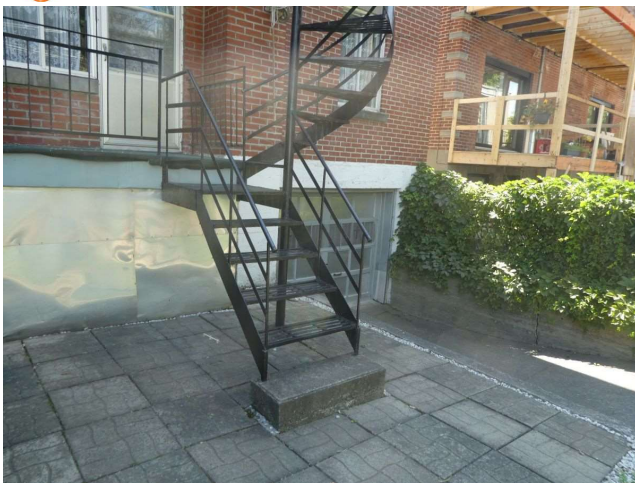
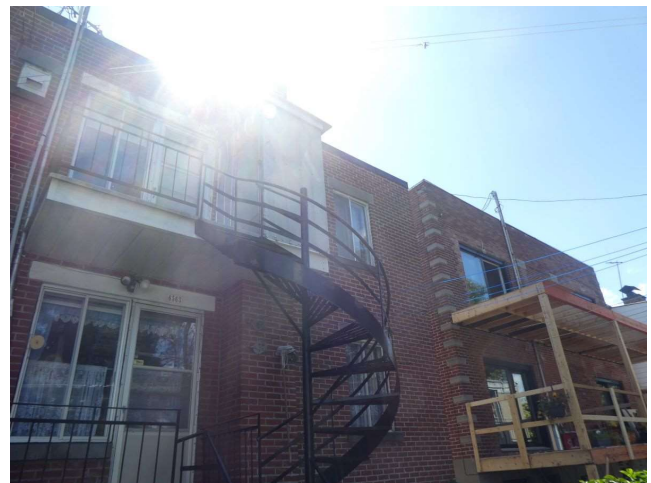
Rear

SPIRAL (OR UNSAFE) STAIRCASE

We noted a spiral staircase or a staircase that was unsafe.

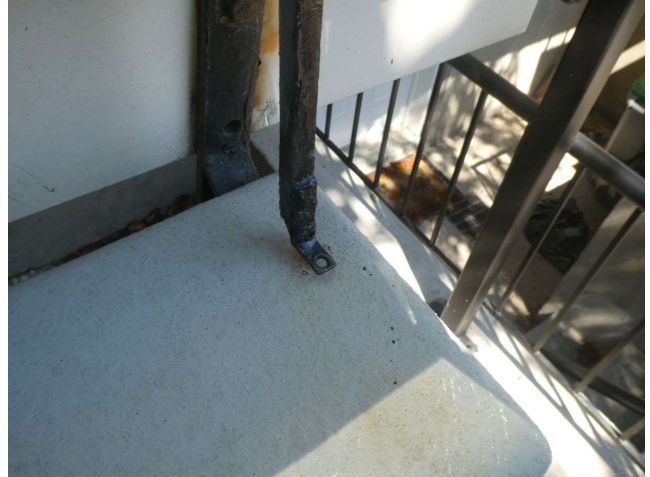
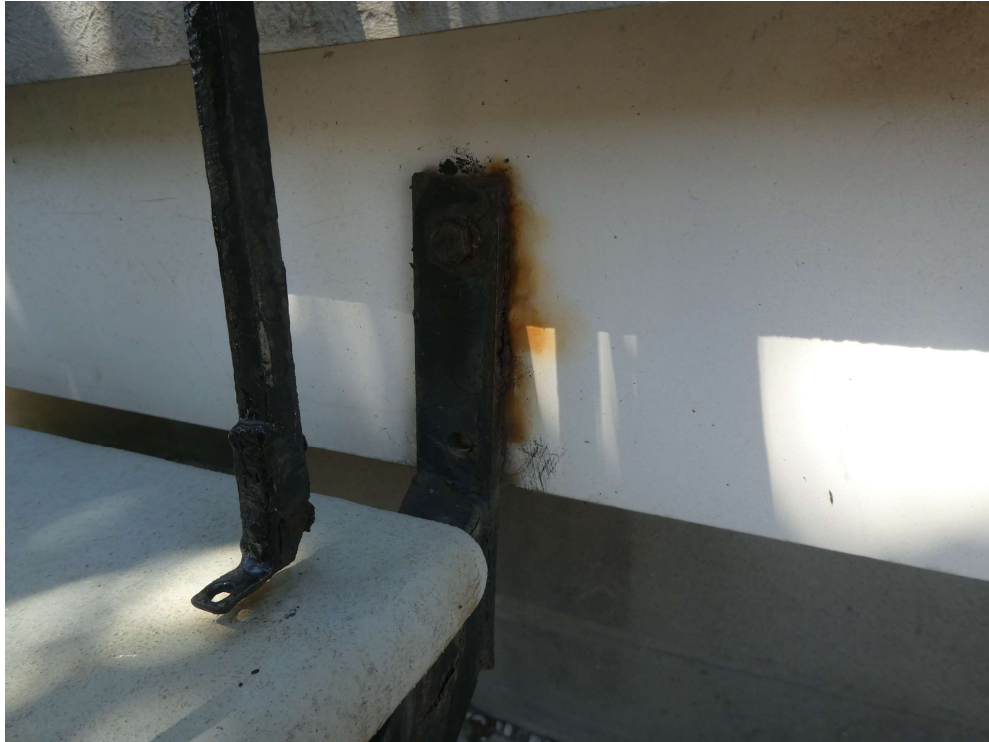
Front balcony

We observed damage to one or more balconies.

We recommend having the balcony structure evaluated further by a qualified contractor.

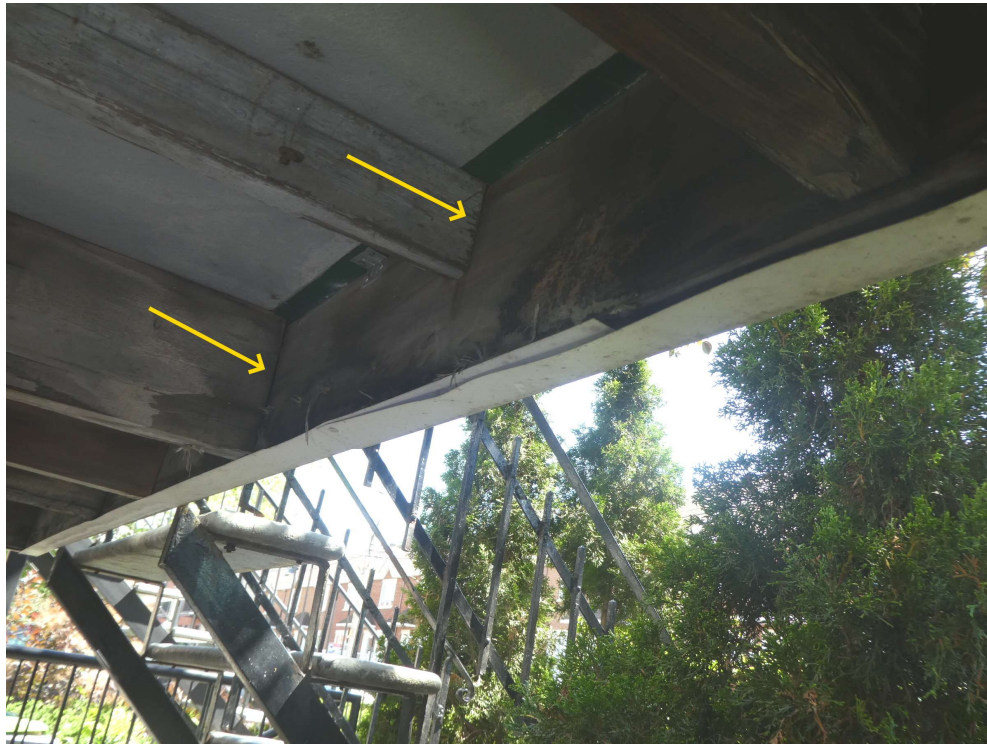
Below front balcony

We noted that deck's floor joists were attached to the ledger board without joist hangers.

We recommend that you have the situation corrected by a qualified contractor.

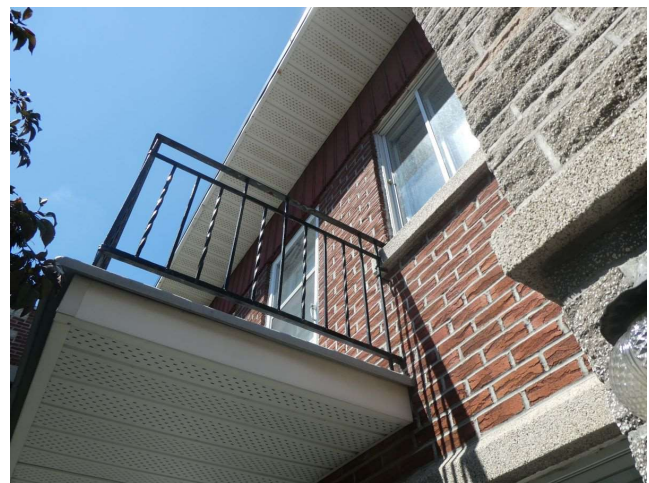
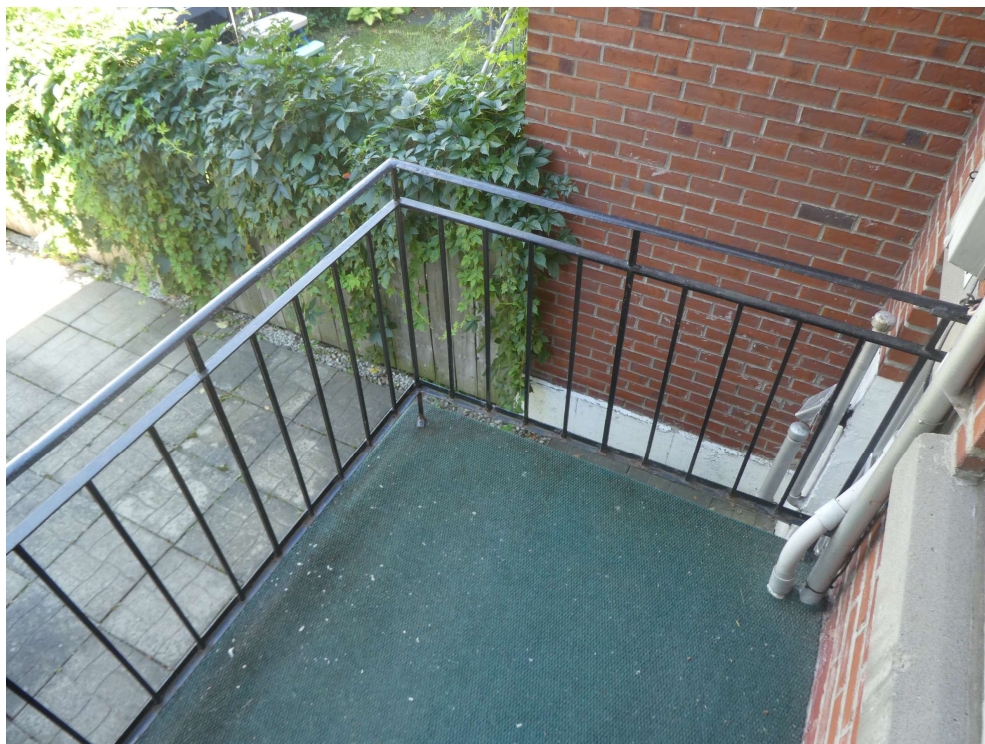
Front balcony (second floor)

We noted that the height of one or more balusters was unsafe

This situation constitutes a risk of accident and injury to the occupants.

We recommend Immediately mandating a licensed contractor to implement the necessary repairs.

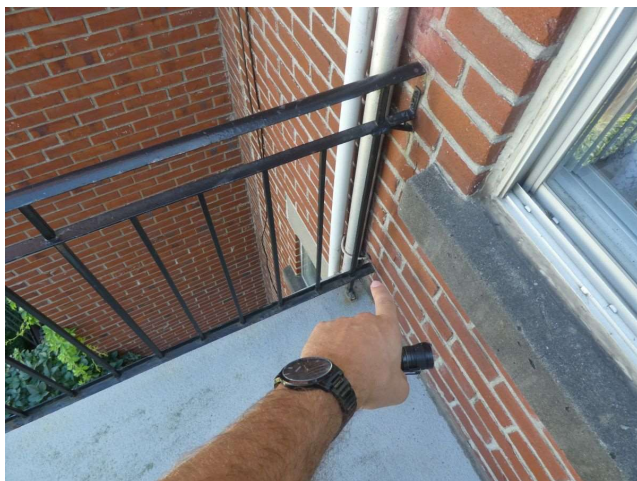
Rear balcony (second floor)

UNSECURED GUARDRAIL

We noted that the resistance for one or more guardrails was unsafe.

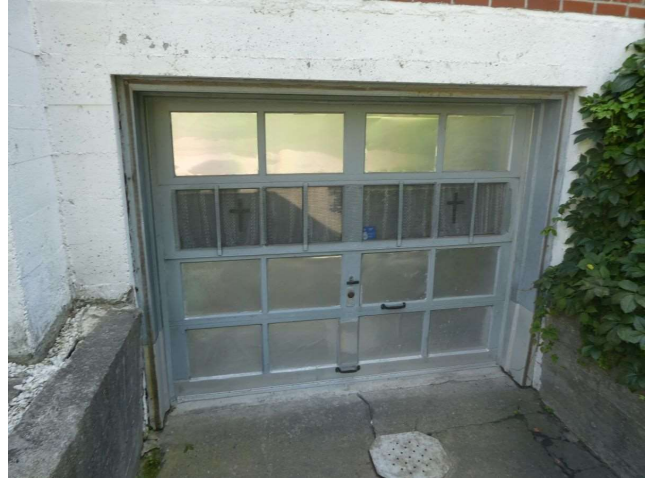
Rear

We noted one or more wooden garage doors.

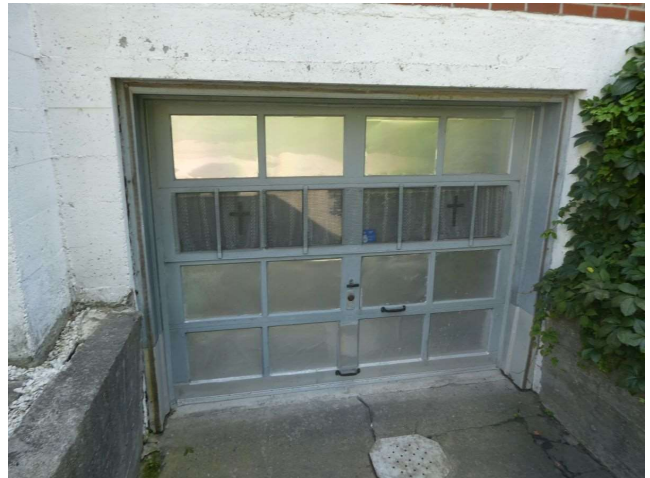
Rear driveway

We noted that one or more garage door openings were low in relation to the ground (low opening or steep driveway).

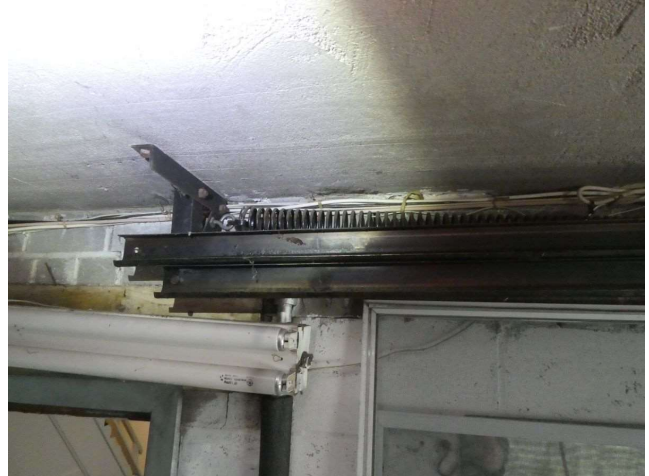
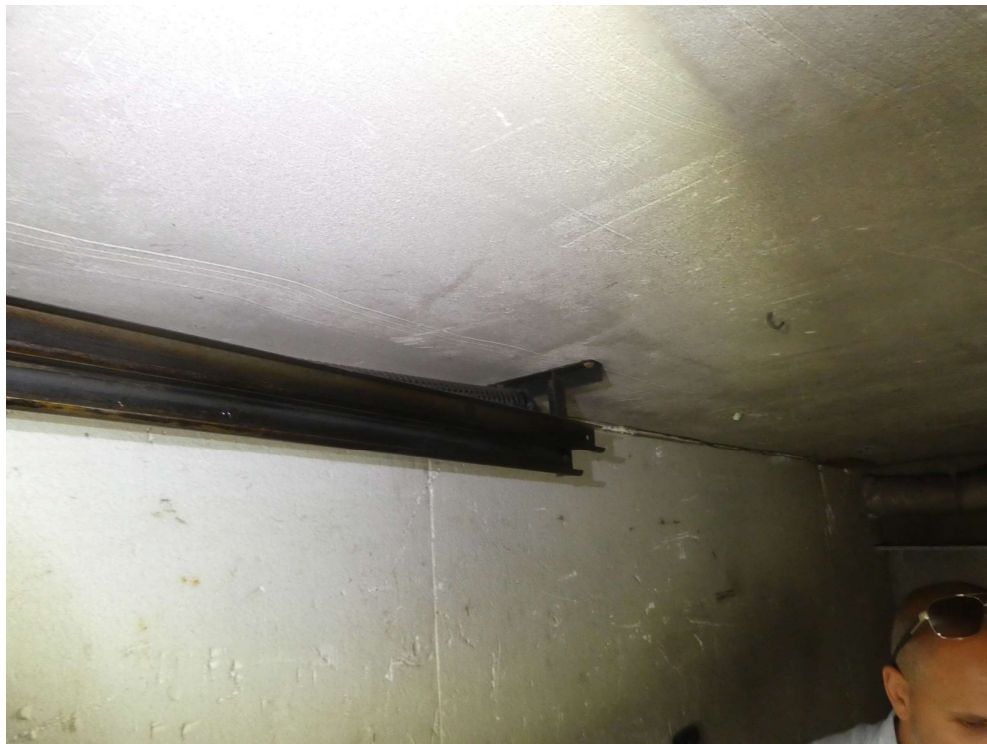
Front and rear garage door

We noted one or more garage doors that were not equipped with safety cables.

We recommend that safety cables be installed as a back-up if ever the spring coils on the garage door are defective. This will prevent injury and further damage to the door.

We recommend contacting a qualified contractor to verify and correct the issue.

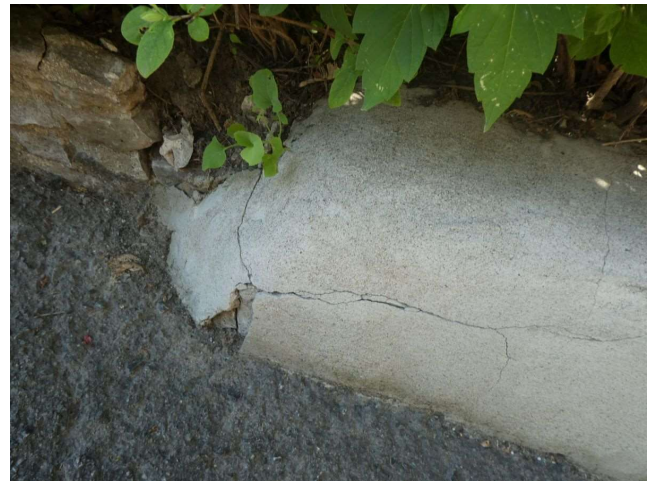
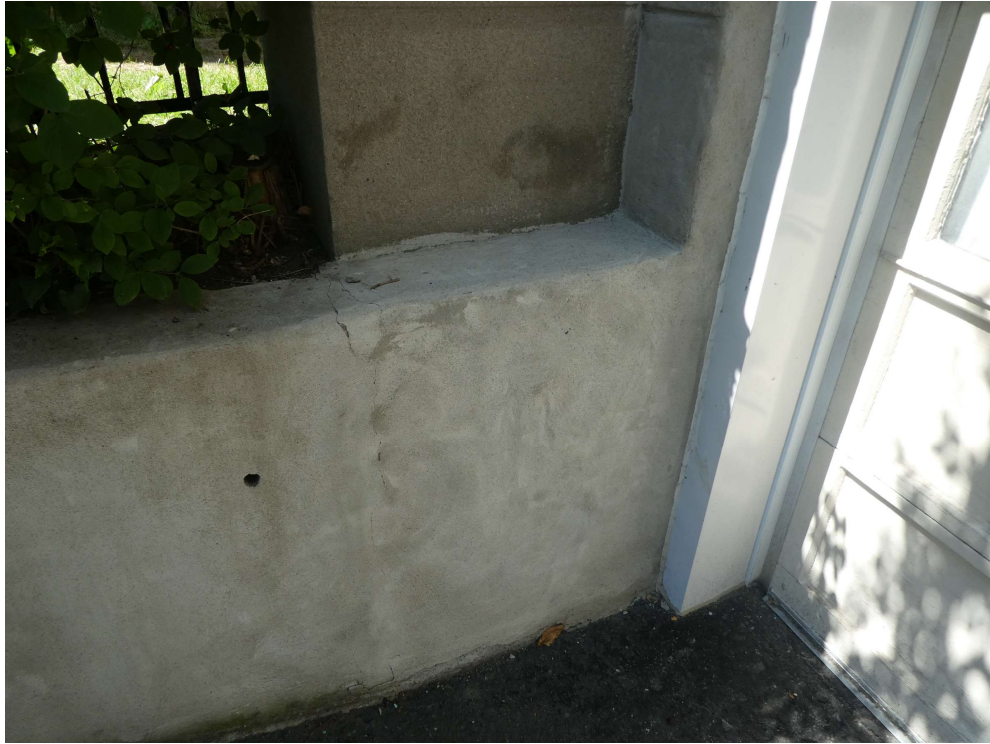
Front driveway

We noted that one or more retaining walls were leaning.

We recommend contacting a qualified contractor to determine a suitable plan of action for repairing or replacing the affected walls.

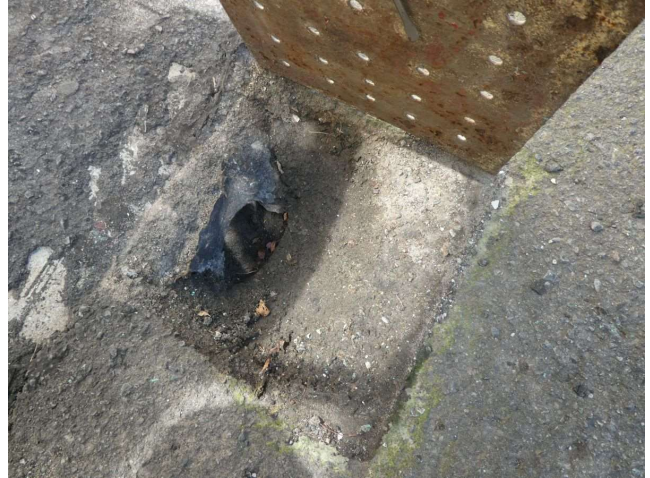
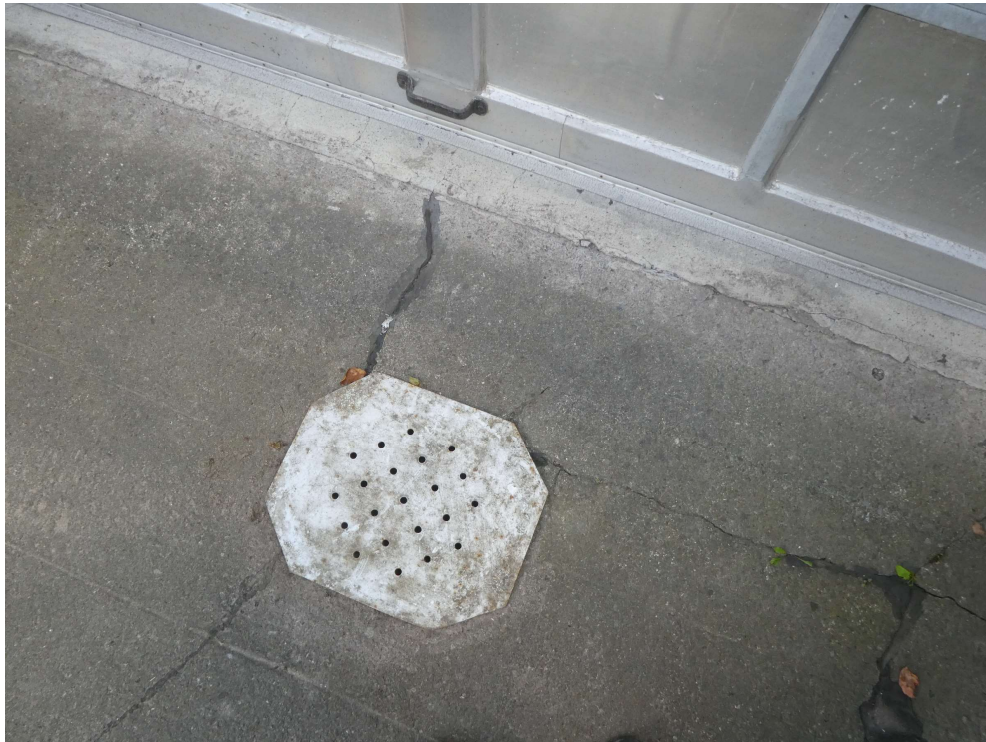
Front driveway

We noted a floor drain without a basin.

This type of drain can be easily obstructed with sand, dirt, and other debris. Only a plumber equipped with a cable-mounted camera can verify if there is an obstruction in the drain pipe.

We recommend having a plumber verify the situation and install an appropriate catch basin.

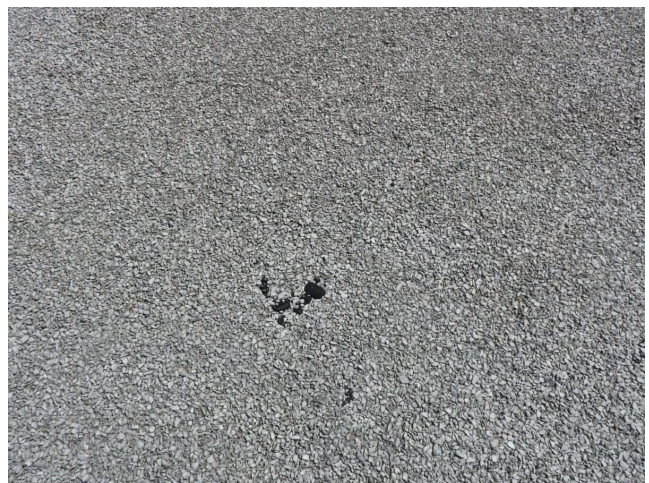
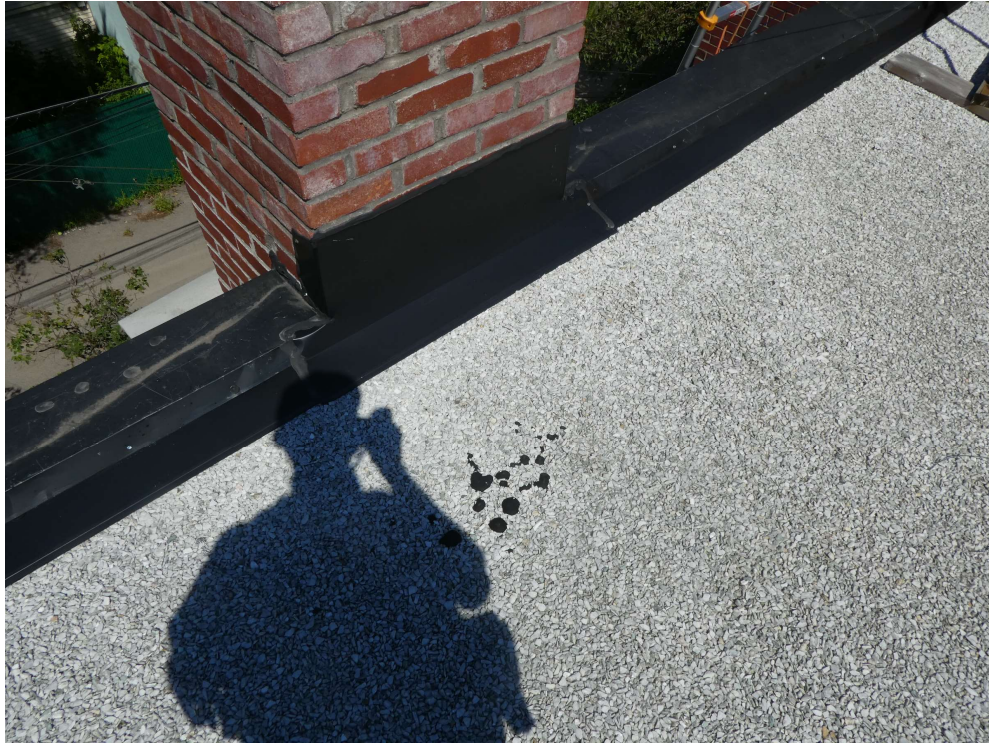
roof

We noted that the asphalt membrane was visible in some areas.

In order to prevent more serious deterioration, which can lead to infiltration, we recommend covering these areas with the appropriate roofing gravel, in order to protect it from external weather elements.

Consult a roofing specialist to obtain a more detailed evaluation of the repairs needed.

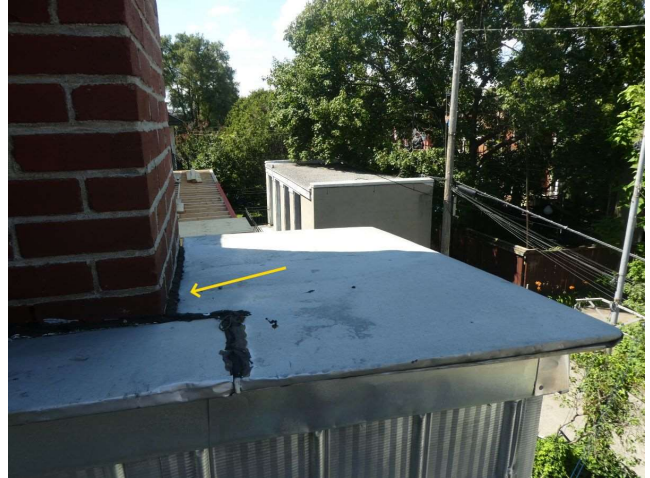
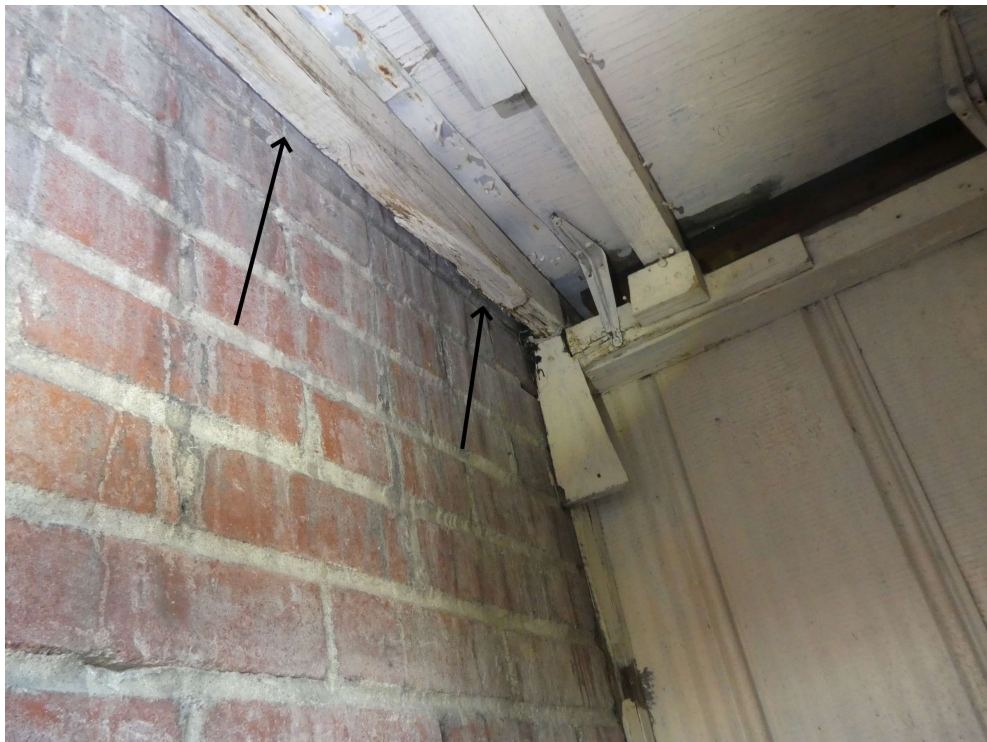
Rear balcony (second floor)

We noted one or more roof flashings that were poorly installed.

We recommend contacting a licensed roofer for further evaluation and correction.

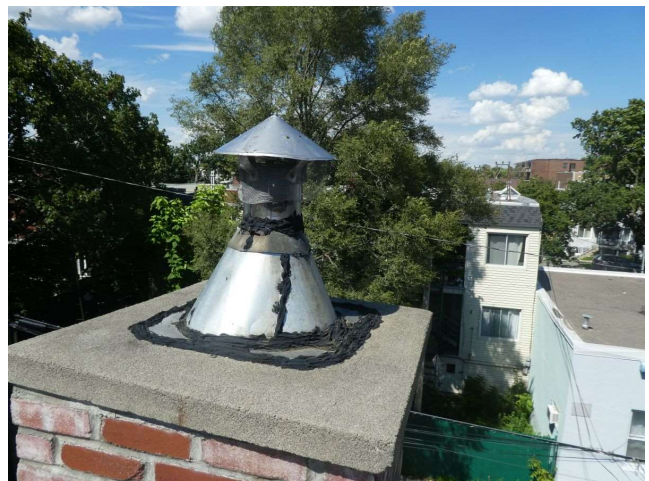
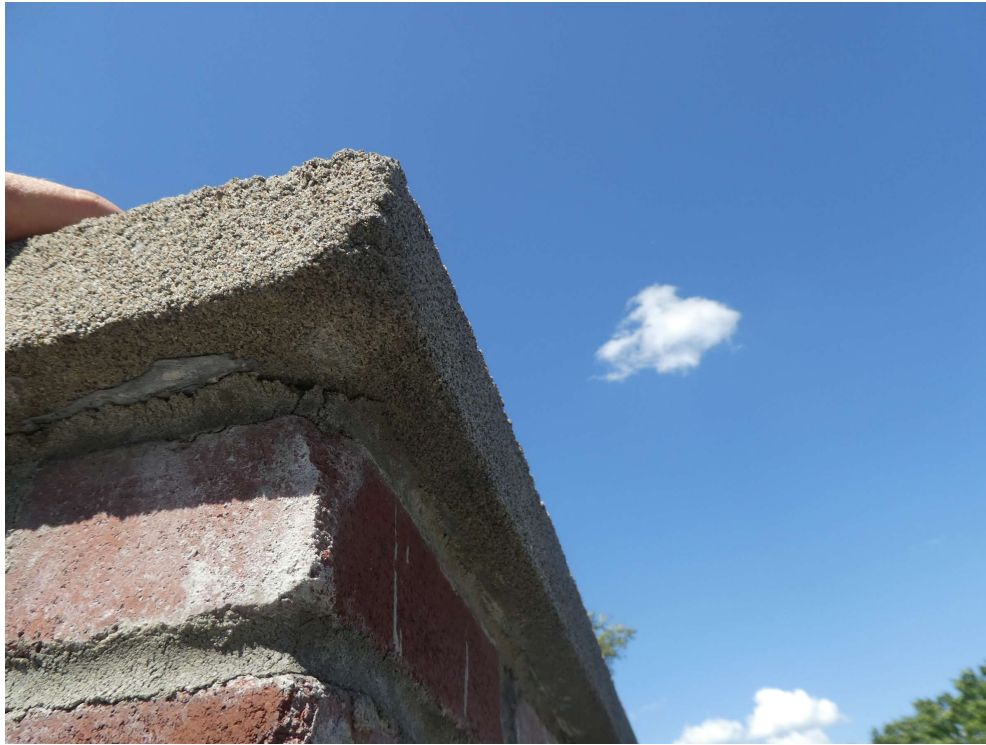
Chimney

We noted one or more chimney caps that were not equipped with a drip edge.

Debris can accumulate in the bottom of the chimney and may block off the appliance vent if not cleared. Many chimneys have a clean-out door to allow removal of accumulated debris.

We recommend contacting a mason for further evaluation and correction.

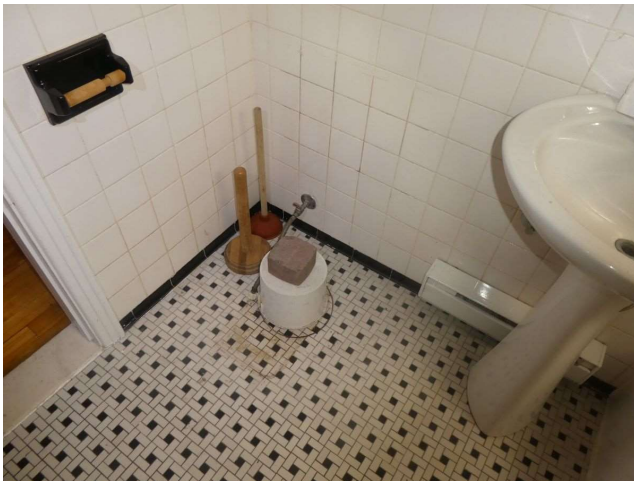
Second floor washroom

MISSING TOILET

We noted that the upstairs washroom was missing a toilet.

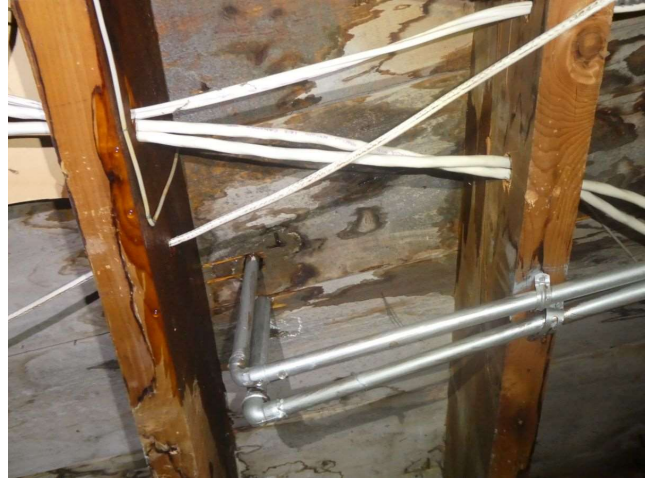
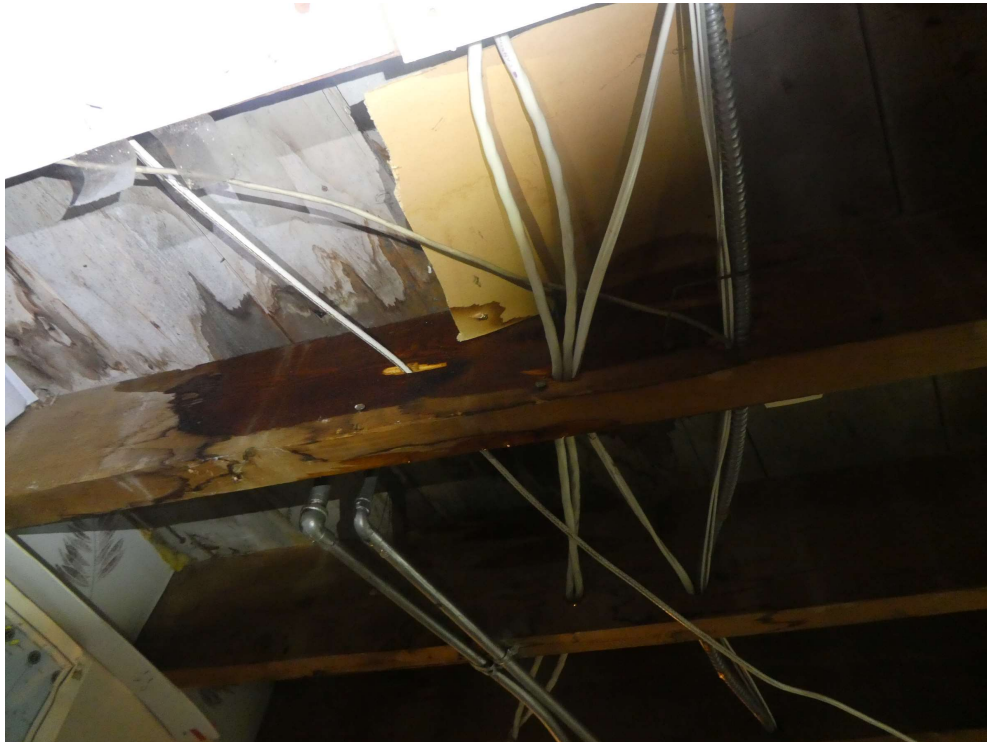
Basement (mechanical room)

We noted several leaking appliances or faucets.

In their current state, there is currently a risk of water damage to other components, such as flooring and structural elements of the floor.

We recommend that you have the necessary corrections carried out by a licensed plumber.

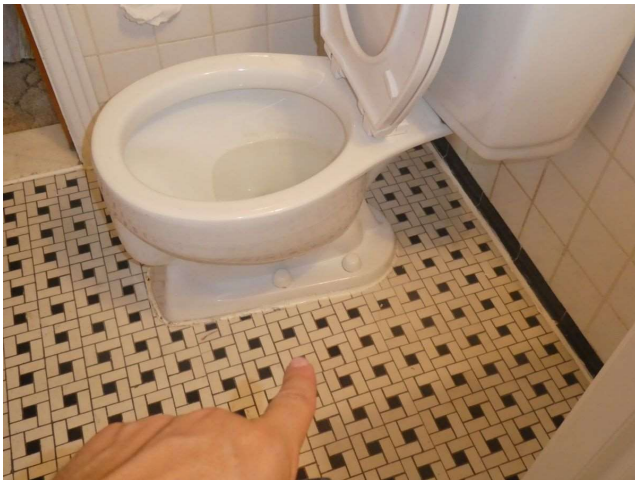
ground floor washroom

CAULKED TOILET BASE

We noted that one or more toilet bases were sealed with caulked.

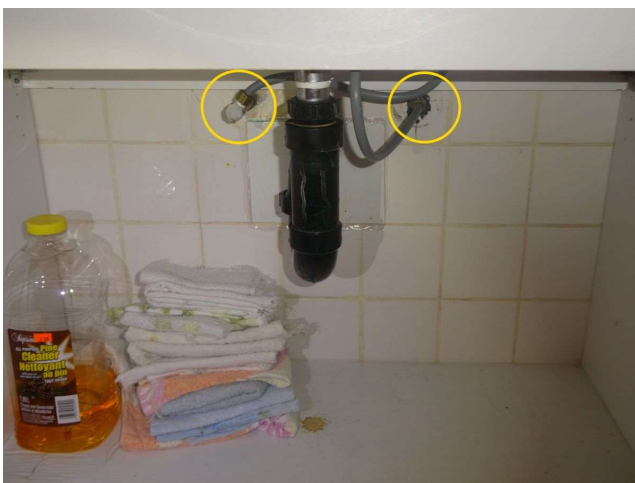
ground floor washroom

NO INDEPENDENT SHUTOFF VALVE

We noted one or more fixtures without independent shut-off valves on each supply pipe.

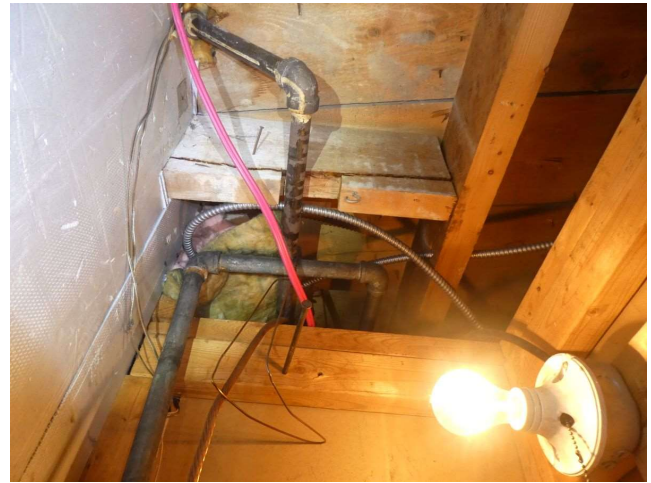
Basis

We note that some sections of the water supply system are made of steel piping, which will corrode and develop leaks.

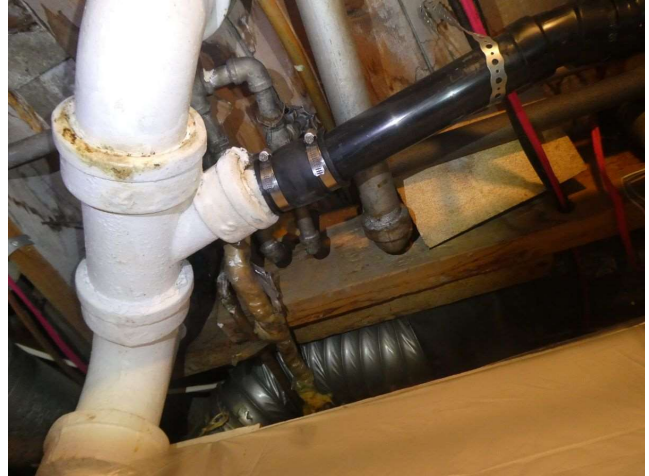
Basement (air exchanger room)

We noted that some of the drainage piping was made of cast iron.

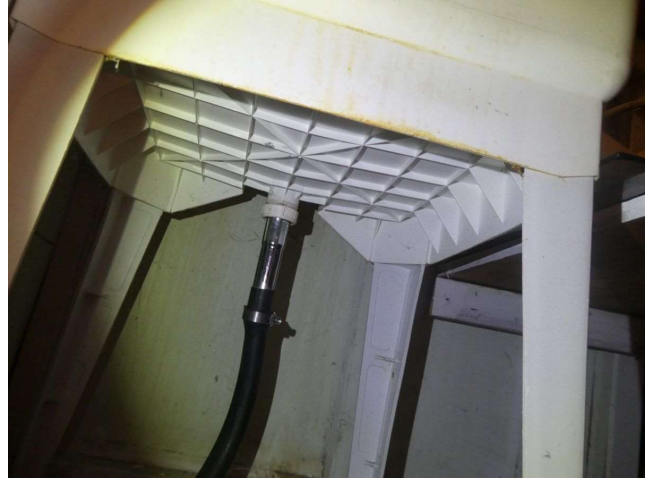
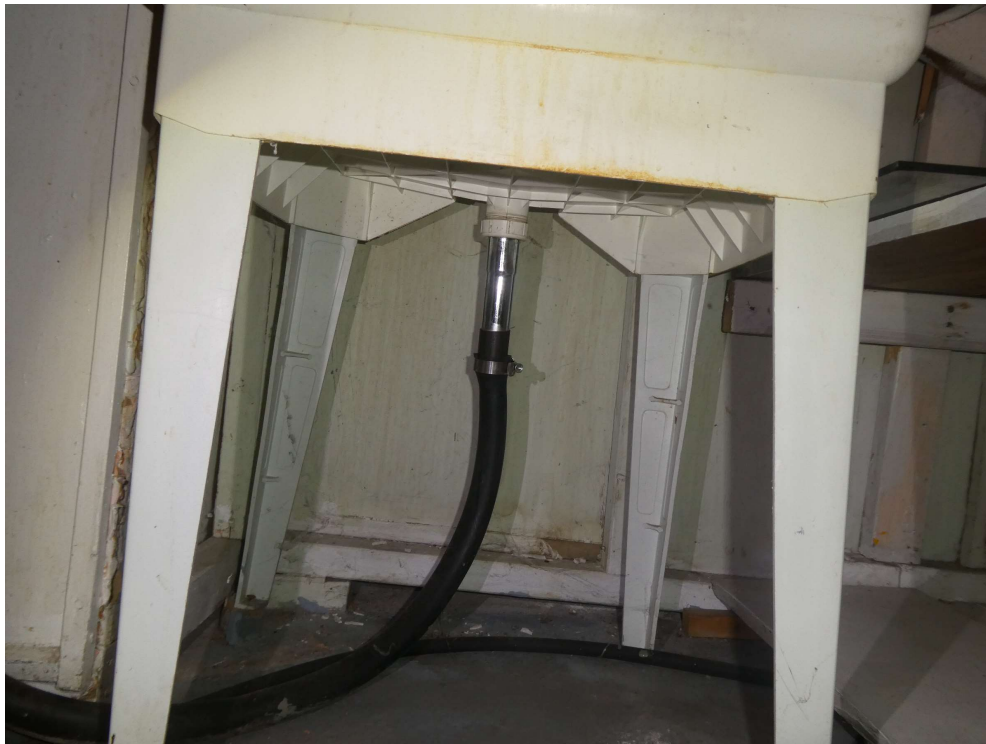
Basement (air exchanger room)

We noted that the floor drain in the basement was not installed properly.

Furthermore, it was connected to the laundry sink without a P-trap.

We recommend contacting a licensed plumber to have the floor drain and lavatory drain corrected.

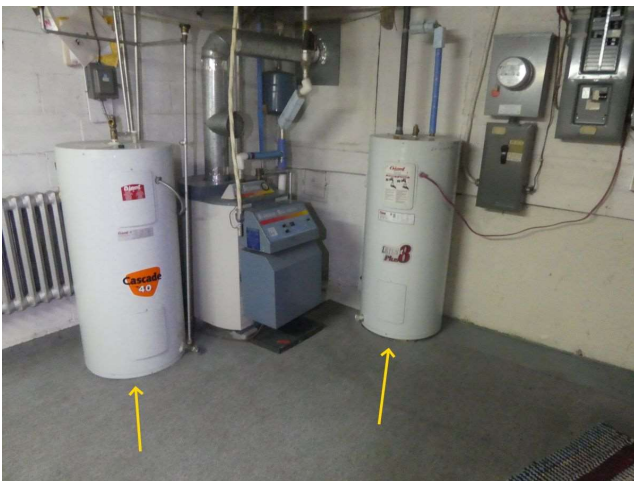
Basement (mechanical room)

MISSING DRAIN PAN

We noted one or more water heaters installed without a drain pan.

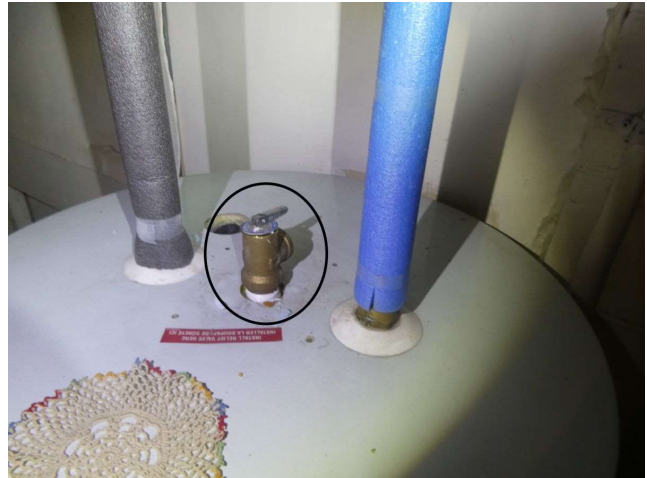
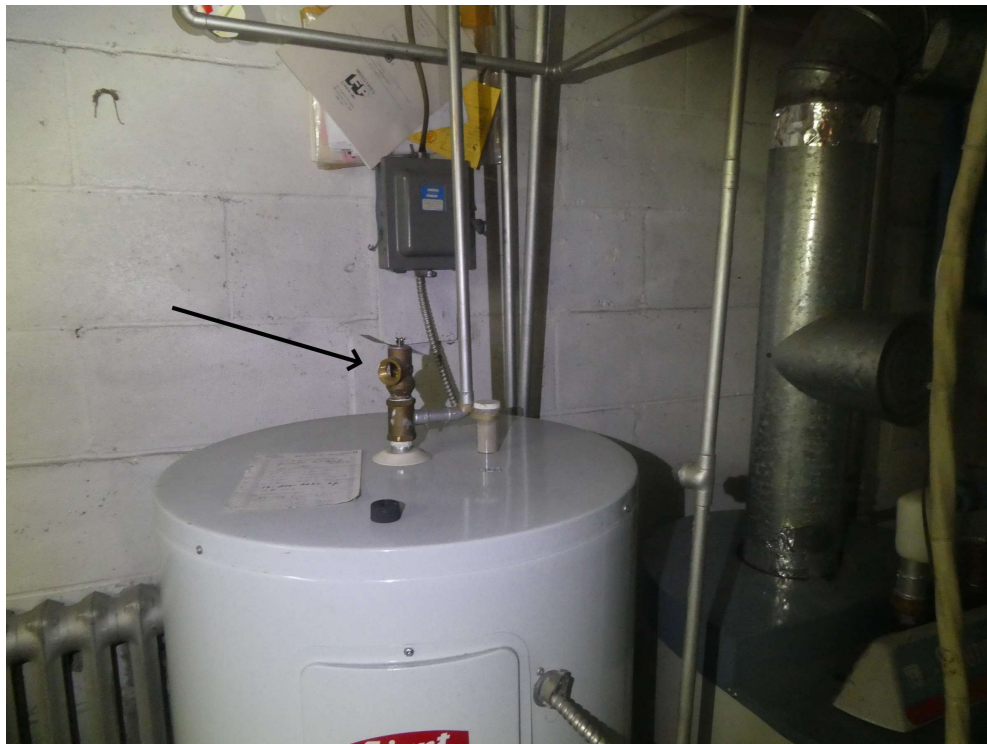
Basement (mechanical room)

We noted that one or more water heaters did not have a discharge pipe attached to their temperature/pressure relief valves.

The temperature/pressure relief (TP or TPR) valve lets water escape if the temperature or pressure is too high. This valve should be connected to a tube that discharges no more than six inches above floor level so hot water is not sprayed on to anyone nearby. Some areas require that the tube discharge outside the building. The tube should be as large as the tank fitting and the tube end should never be threaded, capped or plugged. The tube diameter should be at least as large as the TPR valve fitting. The tube should be able to withstand 250°F temperatures, should have no shut-off valve, and should be as short and as straight as possible.

We recommend that you contact a licensed plumber to make the necessary corrections.

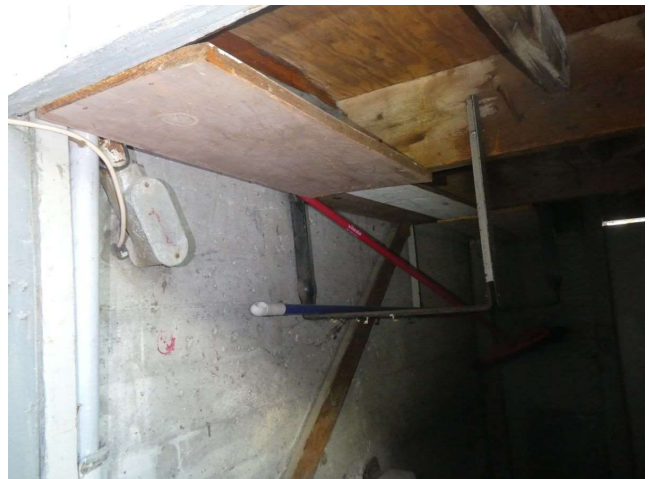
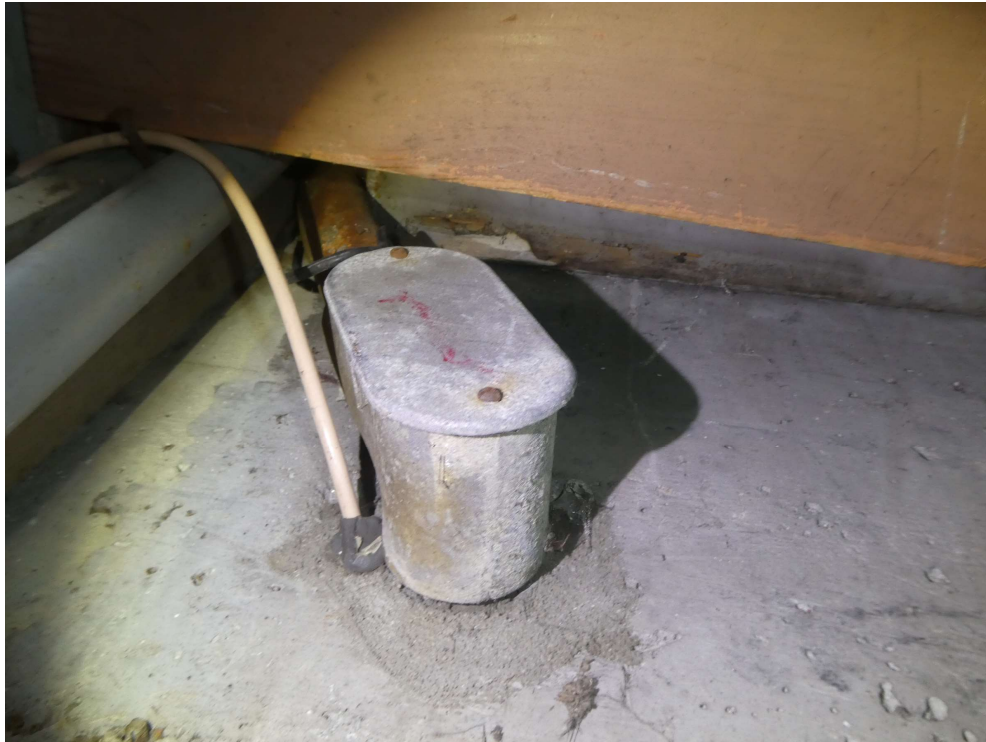
Below rear balcony

The lower seal of the electric mast (LB trim) has no opening on its underside for drainage. An opening should be present to allow the evacuation of rainwater. The absence of such an opening can cause water infiltration in electrical installations with the risk of electrical danger connected to it.

We recommend that you consult an electrician for the safe execution of the work.

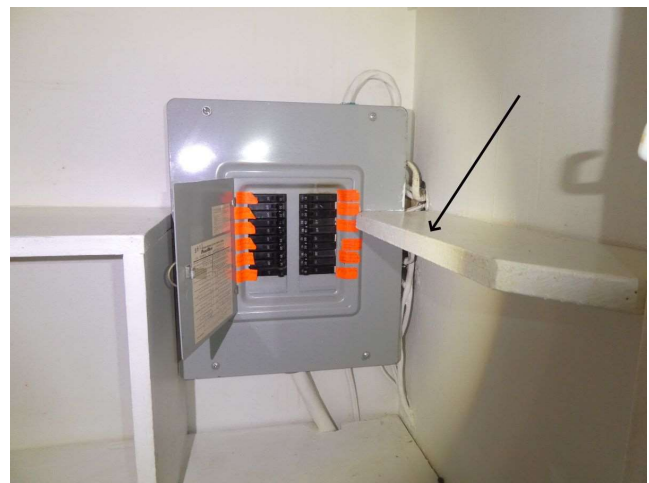
Second floor kitchen (pantry)

We noted one or more electrical panels that were not safely and easily accessible.

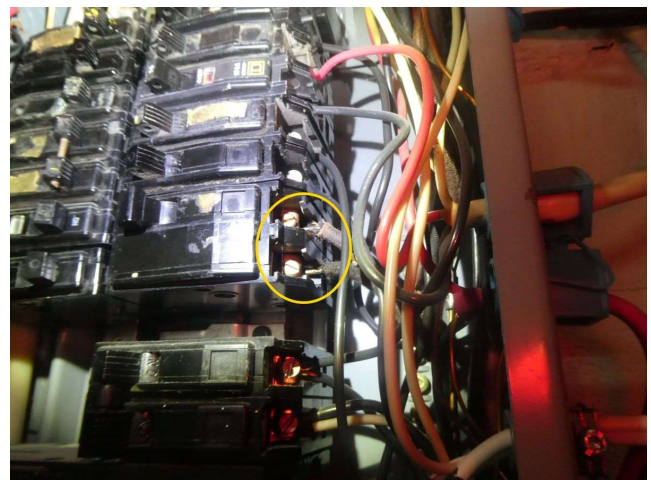
Base electrical panel

We noted the presence of aluminum wiring.

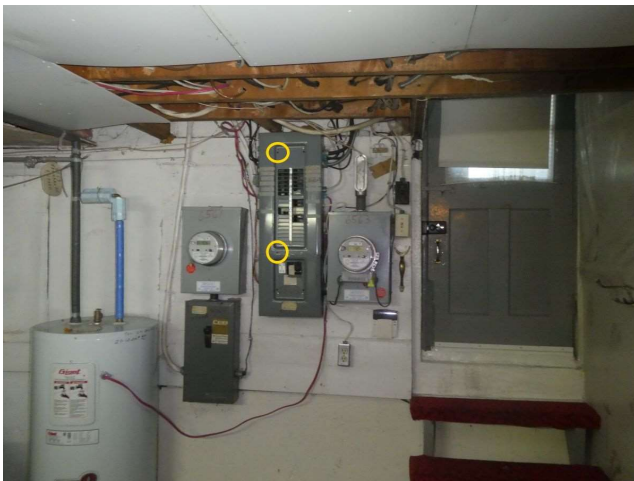
Basement (mechanical room)

PANEL COVER MISSING SCREW

We noted that one or more electrical panel screws were missing.

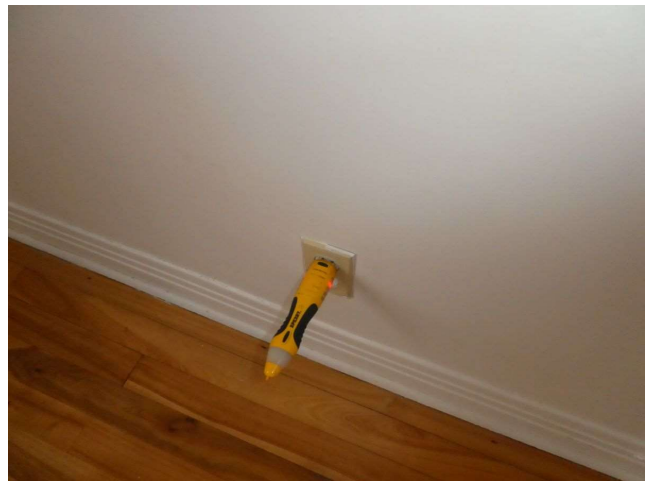
Second floor (rear bedroom)

We found one or more electrical outlets without grounding.

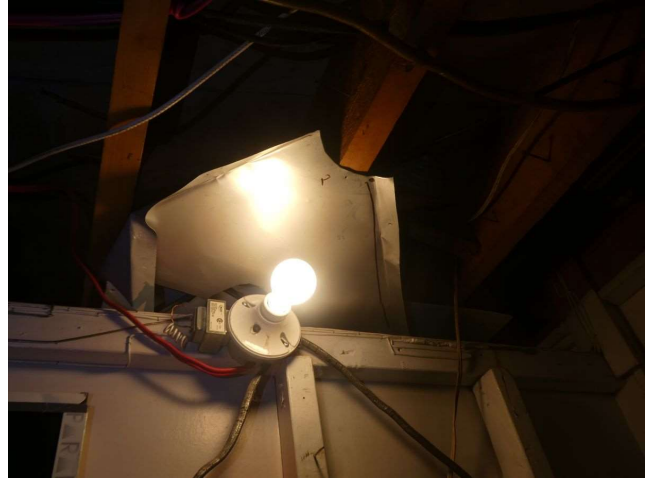
Basement (air exchanger room)

We noted one or more unprotected light bulb in an enclosed space.

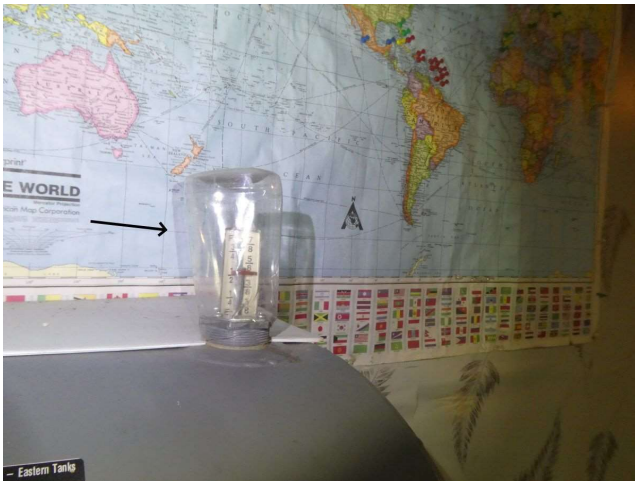
Basement (mechanical room)

DAMAGED FUEL GAUGE COVER

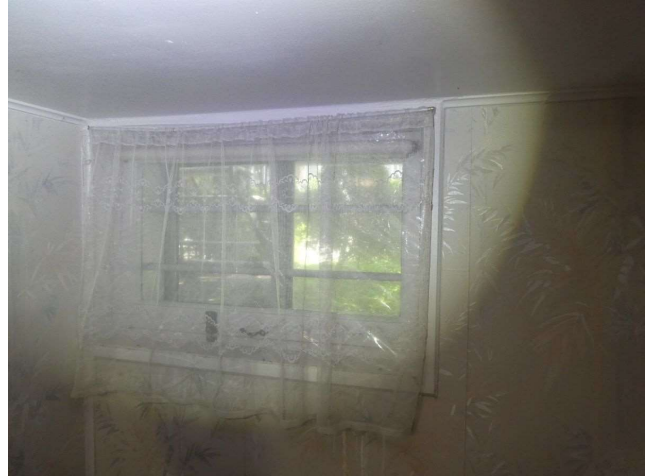
Basement (front room)

We noted one or more windows that have exceeded their life cycle.
