File number: [REDACTED]
Inspection date: August 1, 2022

PRE-PURCHASE INSPECTION REPORT

Kevin Mercurio
Les Inspections Mercurio Inc.
1066 rue du Souvenir
Saint-Eustache, Québec
J7R 0M5
August 2, 2022

The property is a 1957 construction duplex. The foundation walls are made poured concrete and the siding is made of brick, stucco and wood. The windows are made of aluminum and the property has a multilayer asphalt and gravel roof covering. This building also has:

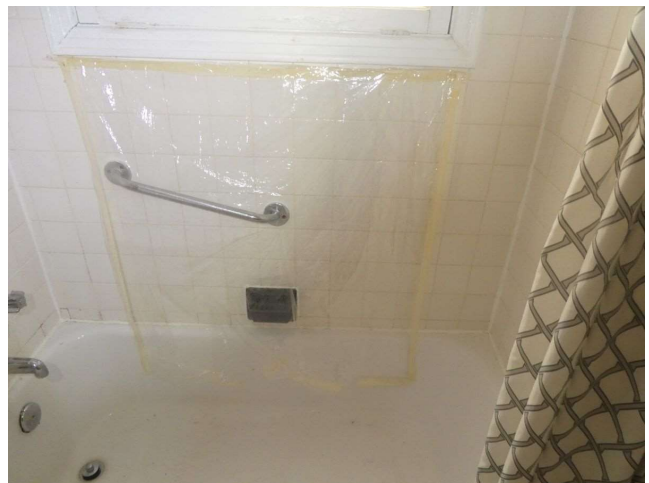
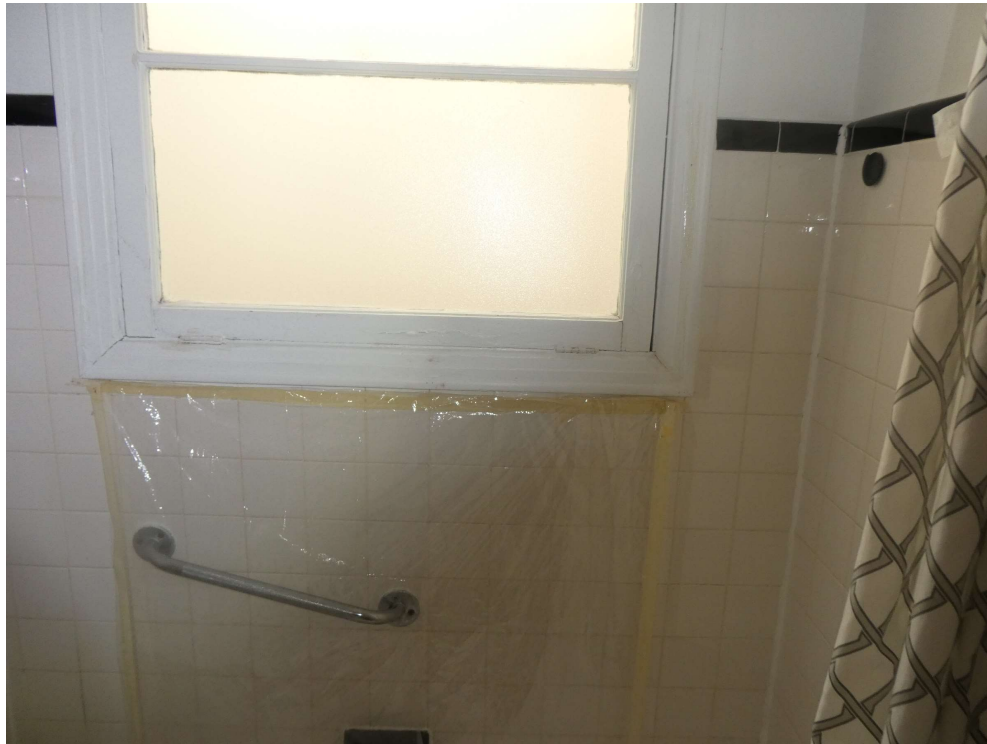
Second floor washroom

We noted one or more windows in a shower or bathtub.

We recommend contacting a licensed contractor to further evaluation and correction.

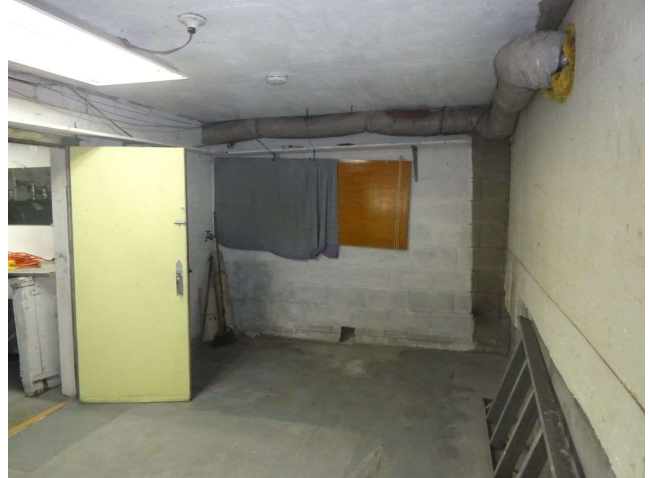
rear garage

We noted one or more openings in the walls and/or ceiling of the garage that may allow exhaust fumes into the home's living quarters, which can be harmful to the health of anyone who occupies the property.

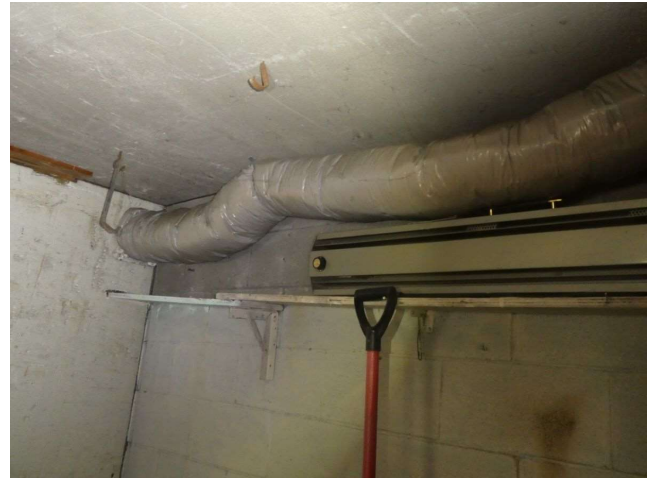
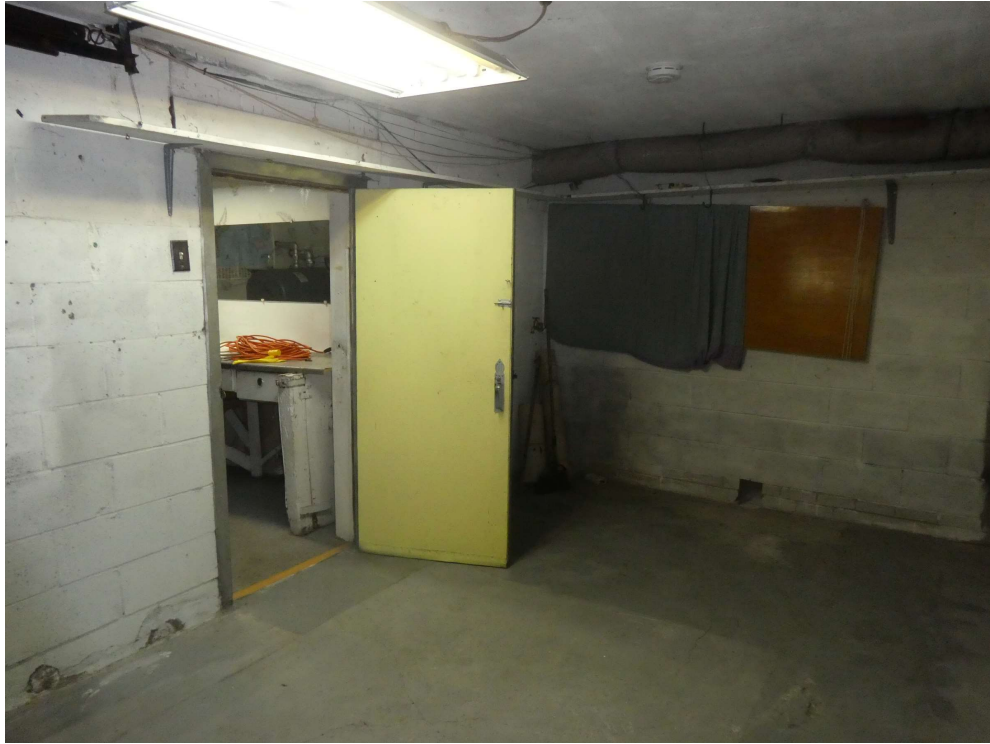
Front garage

We noted one or more air ducts passing through the garage.

We recommend contacting a licensed contractor to have this resolved..

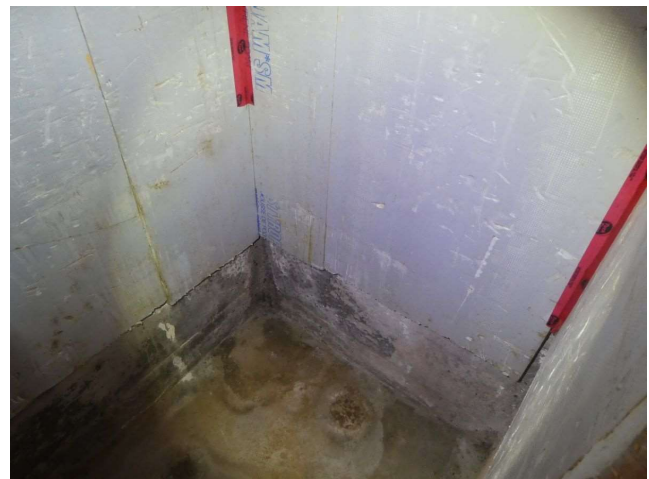
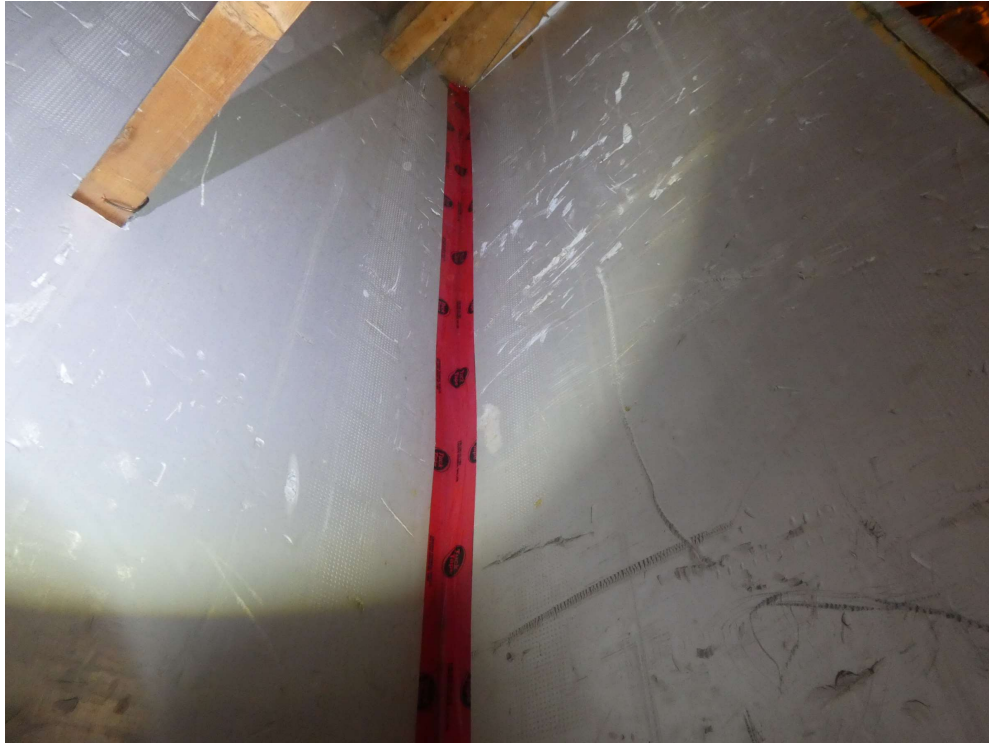
Basement (main valve closet)

We noted one or more areas in which there was exposed combustible insulation.

We recommend contacting a licensed contractor to have the situation evaluated further.

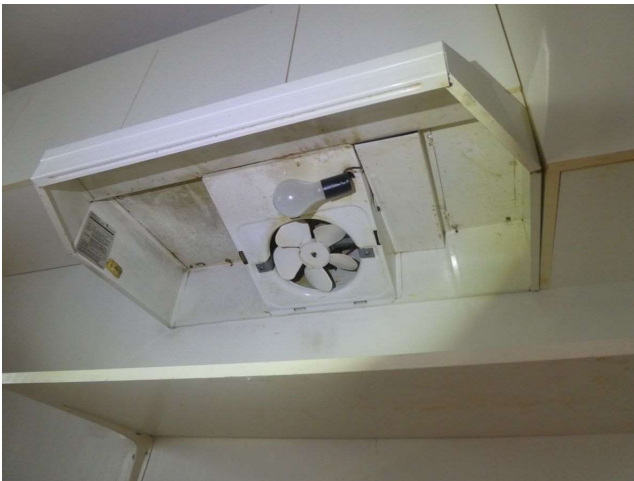
Second floor kitchen

INOPERATIVE

We noted that one or more rangehood were inoperative.

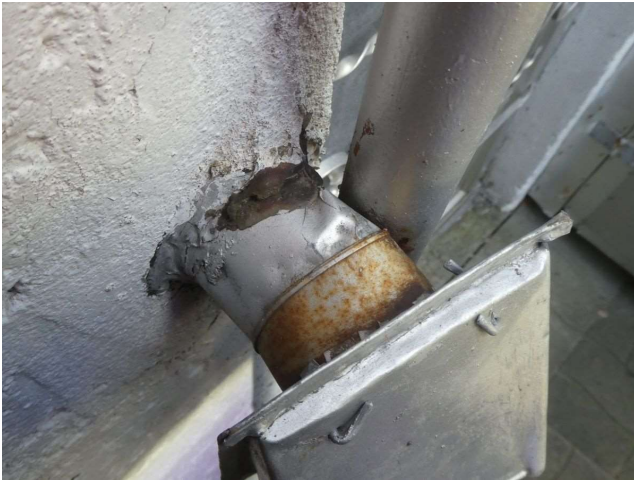
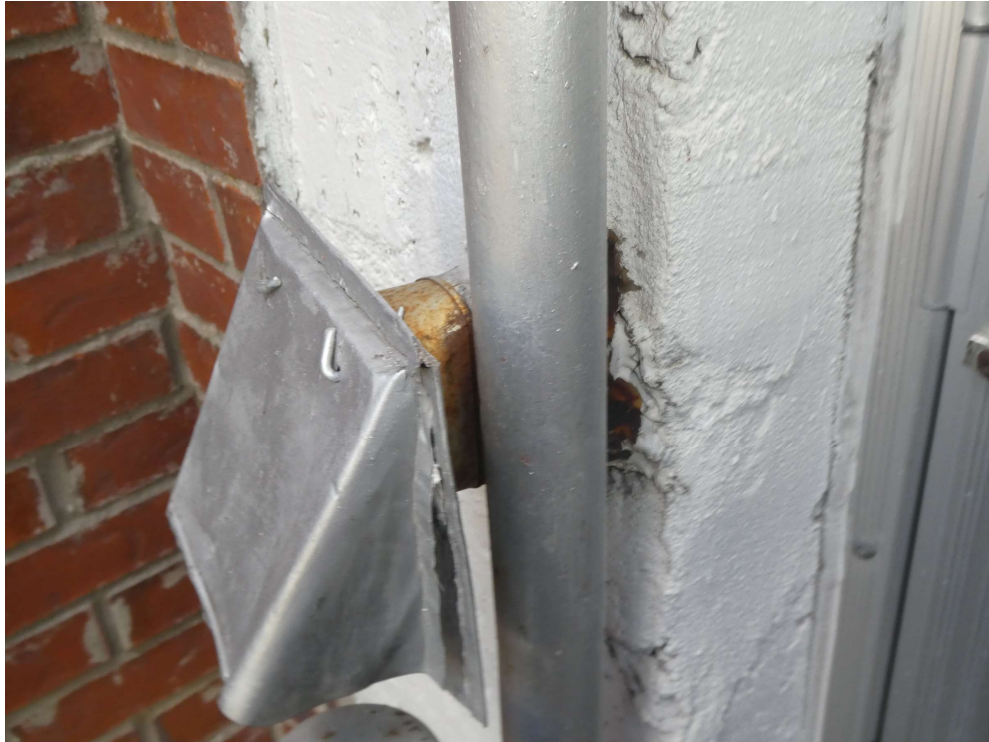
Rear facade

DAMAGED REGISTER

We recommend that this situation be corrected by a qualified contractor and that the register be kept clear at all times.

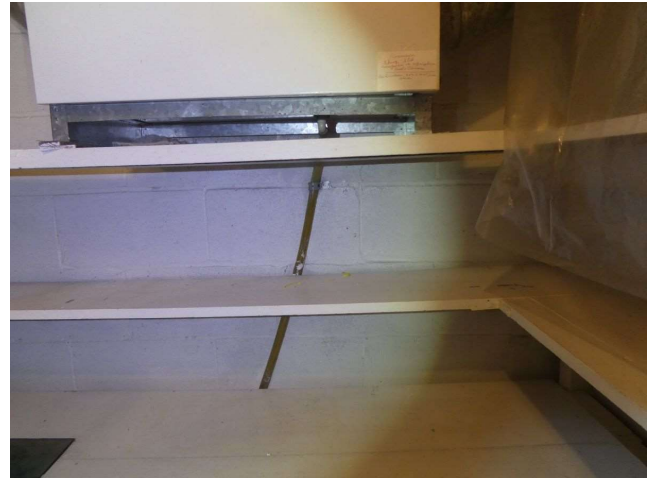
air-exchanger

We noted that the air exchanger's condensate line is not equipped with a trap (also called a drip loop) to limit the rise of liquid or vapors to protect the device.

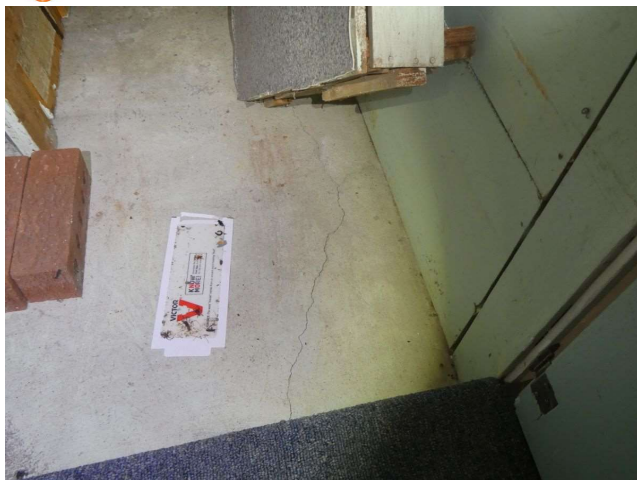
Below basement staircase

MOUSE TRAP

We noted one or more mouse traps inside the property.
