PRE-PURCHASE INSPECTION REPORT

Kevin Mercurio

Les Inspections Mercurio Inc.

July 24, 2022

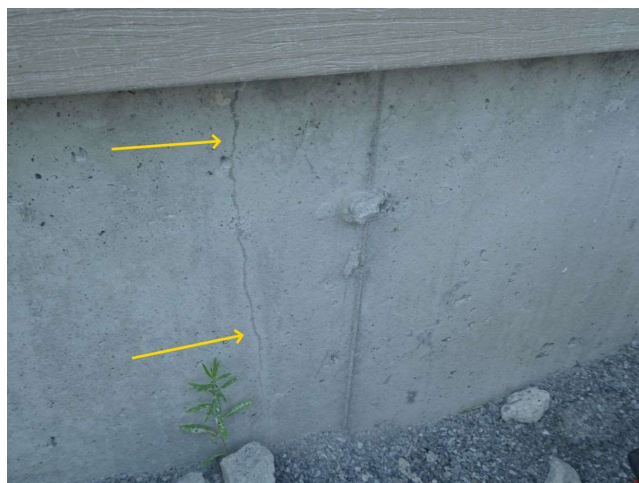
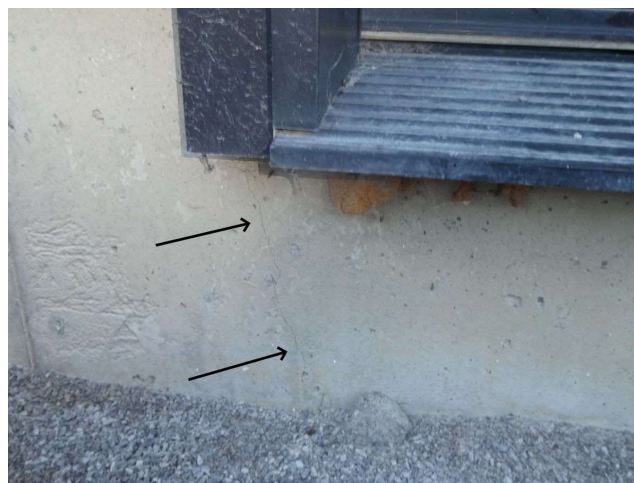
Right facade

We noted the presence of two hairline foundation cracks.

We recommend monitoring the cracks. If a crack continues to widen, we recommend consulting a foundation expert.

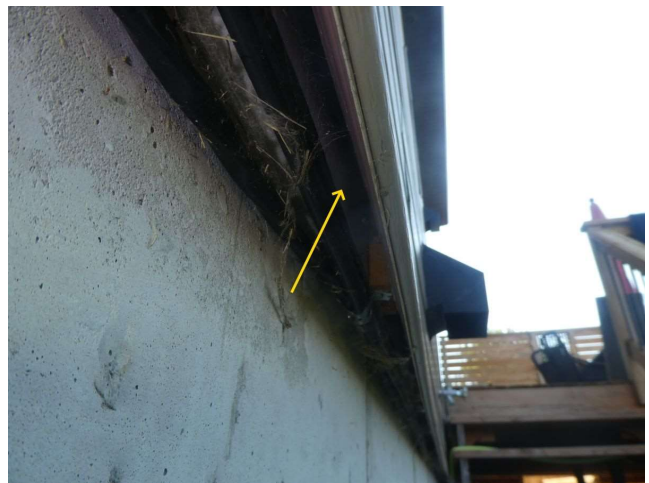
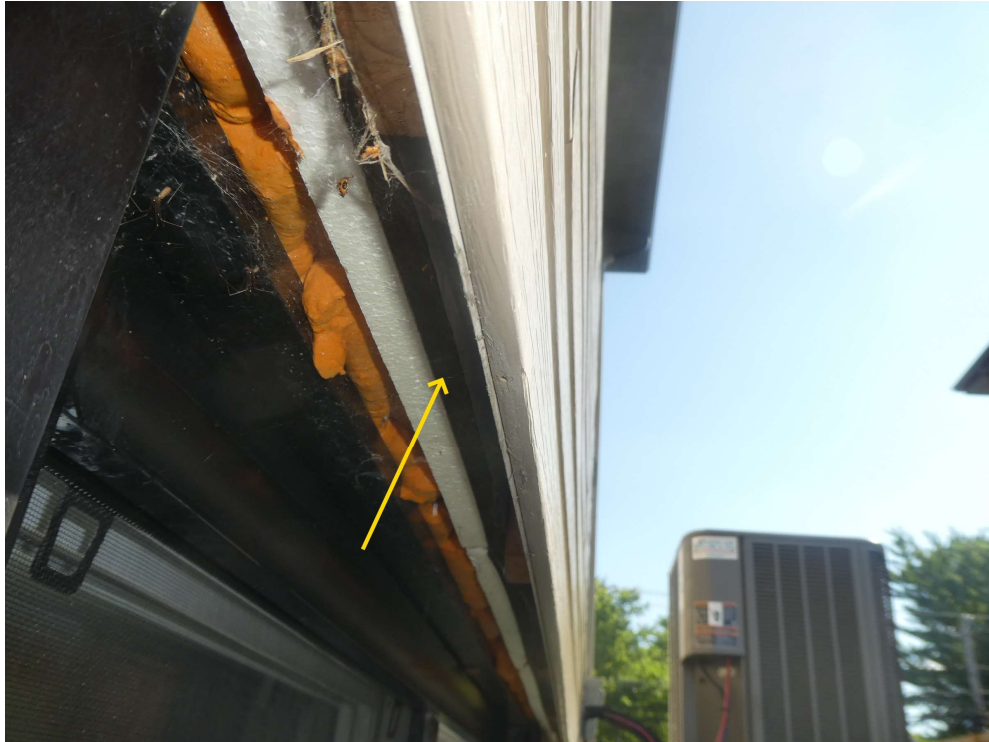
Exterior siding (view from below)

We noted there was no screen behind the siding to prevent insects from nesting behind it.

The air space behind the exterior siding is designed to allow water to exit from behind the siding and for ventilation. However, to prevent access to insects, it is recommended to install a bug screen at the opening, as seen in the illustration.

We recommend contacting a licensed contractor to have this corrected.

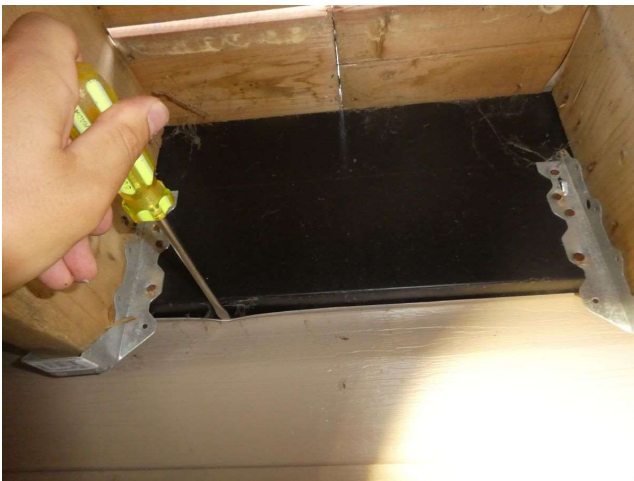
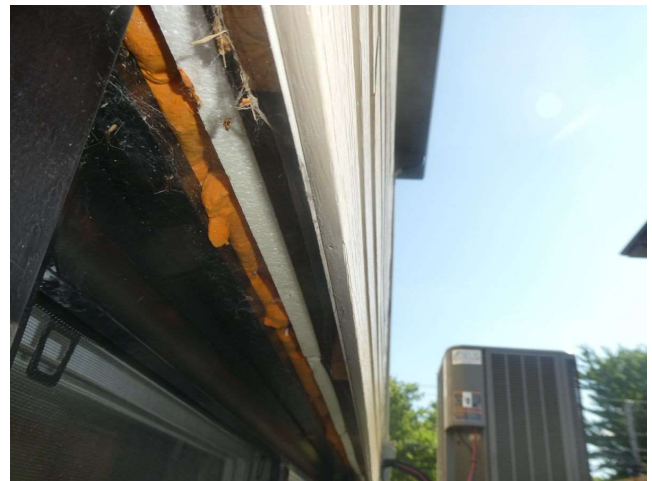
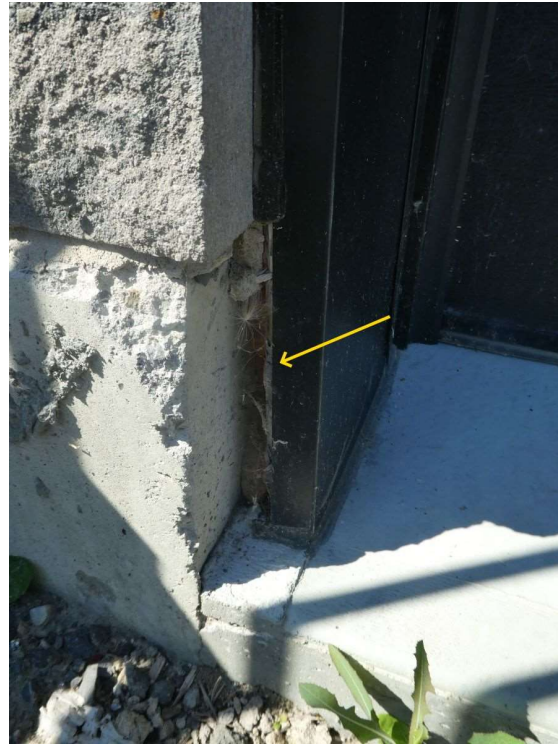
IMPROPERLY INSTALLED EXTERIOR SIDING

We noted that the exterior siding was not properly installed and the finishing was incomplete in some areas.

Unsecured panels can give way to wind and tear and even hurt people. Openings, if not sealed, may allow water to infiltrate or rodents or other unwanted animals to enter the building. Subsequent damage could then be caused by the deterioration of the internal structure of the walls or the appearance of mold which can be harmful to the health of the occupants.

We recommend that you have the openings sealed and the exterior siding repaired to adequately protect the

walls from accelerated deterioration. We also recommend that repairs be made before the wind makes the problem worse by tearing off the loose piece or by promoting water infiltration into the building envelope.

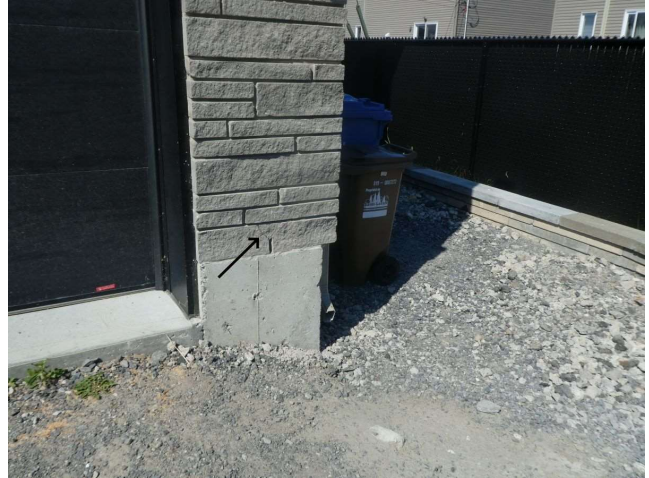
Front facade

We noted one or more areas that require repair work.

Masonry buildings will inevitably require conservation work to extend their life cycle. Repointing mortar joints is an intervention that is generally part of a regular maintenance program in order to restore the resistance to water infiltration of the masonry and to preserve its integrity.

We recommend that you consult a master mason in order to assess the costs and correct this situation.

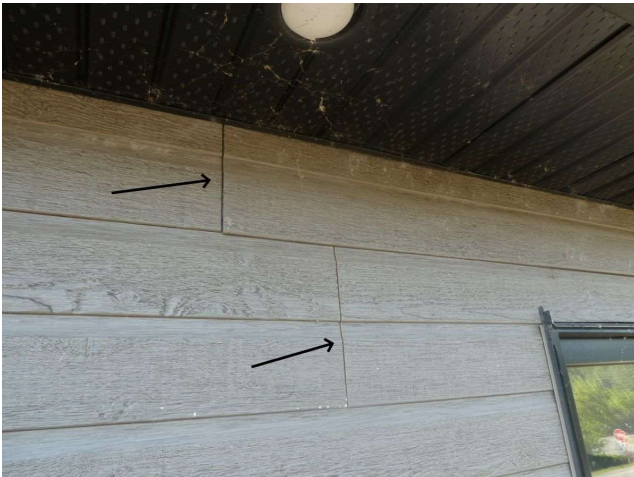
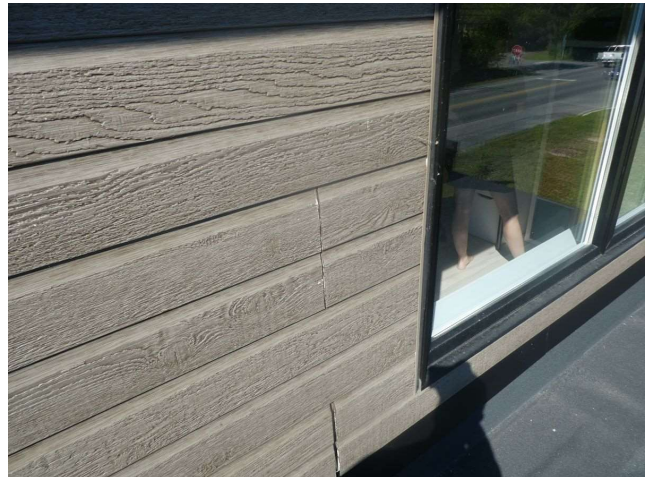
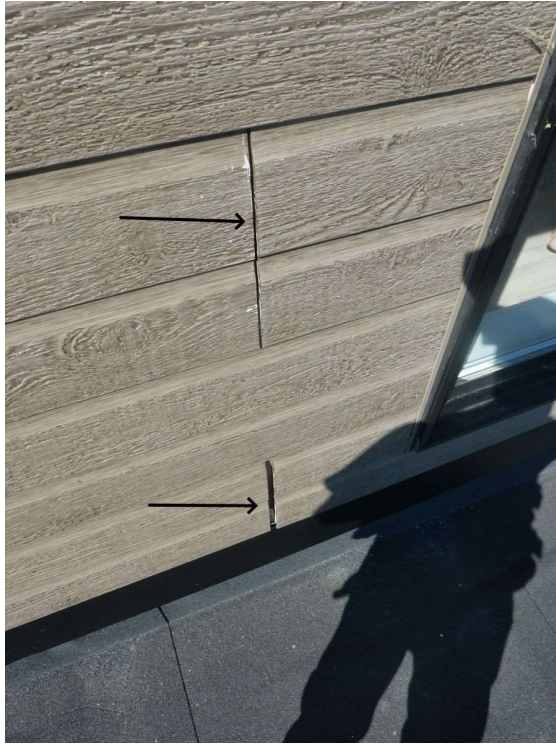
Front facade (above garage)

We noted that the engineered siding was improperly installed in certain areas.

The vertical joint between adjacent engineered siding pieces (also referred to as CanExel) should be located over the middle of a stud or furring strip that is also located over a stud. Furthermore, the gap should be sealed with caulking or molding, as illustrated in the included photos; the installation observed has neither of the two.

We recommend contacting a licensed contractor to have the siding correctly installed.

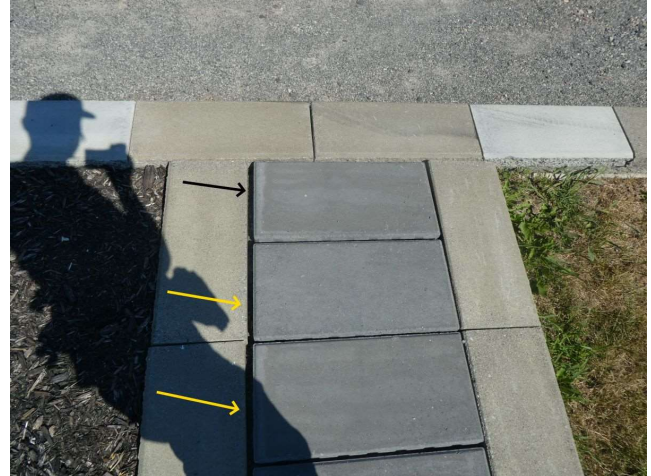
front walkway

We noted that the paving stones have shifted or settled in some areas and the polymeric sand that is used to fill paver joints is missing.

When paving stones settle, there is an increased trip hazard. Furthermore, depending on the angle that the stones have settled, the resulting layout may promote a negative slope towards the building.

To avoid the risk of water infiltration and a trip hazard, we recommend that you contact a qualified contractor to check the grading and make any corrections if needed. If necessary, we recommend that you consult a landscaping specialist to brainstorm landscaping strategies that will divert water away from the building.

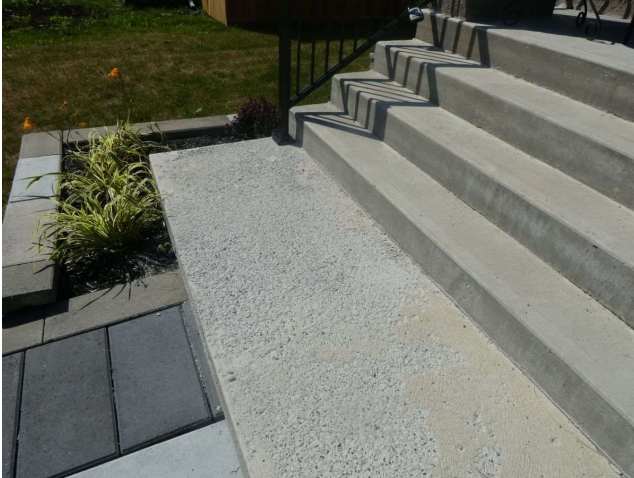
Front balcony

We noted flaking on the front walkway.

Spalling, crumbling or flaking concrete is usually indicative of either poor concrete or freeze damage.

We recommend contacting a concrete specialist to evaluate the slab further.

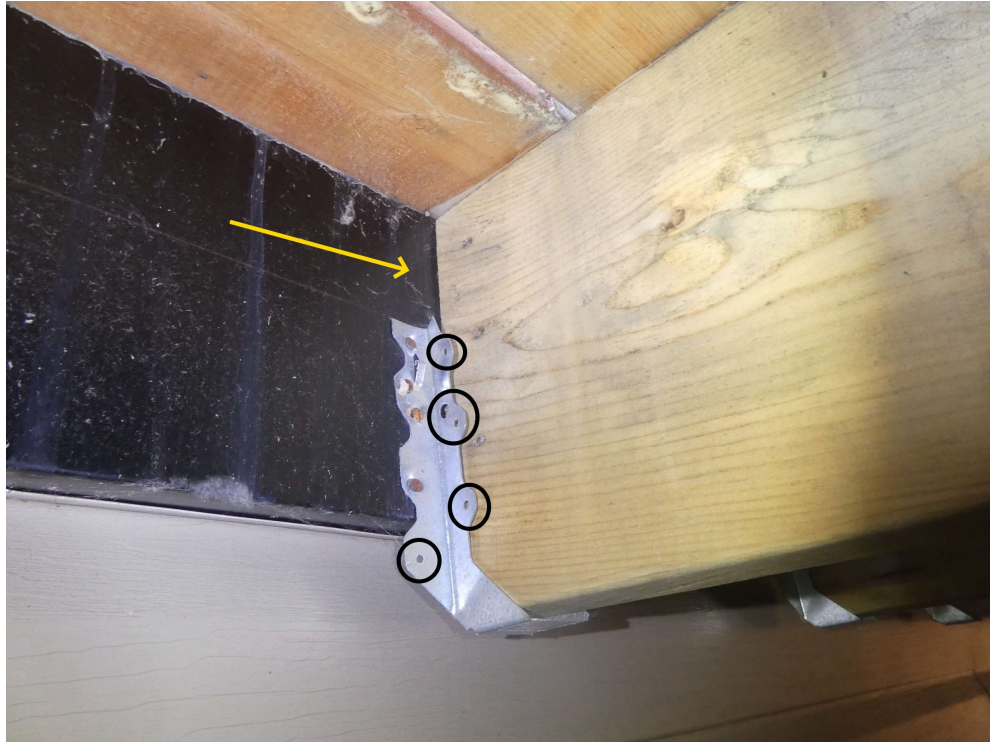
Below rear balcony

We noted that the rear deck's joists were not fully seated on the ledger board. Furthermore, they were installed using undersized joist hangers, many of which were missing screws or nails.

We recommend contacting a licensed contractor to evaluate the deck structure further.

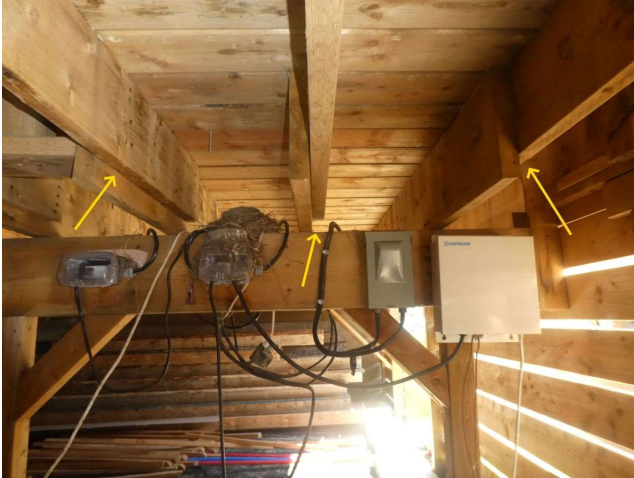
Below rear deck

We noted that the deck was improperly extended

When additional joist are added to a deck structure to extend it's length, the additional joists should also be supported by the beam. We noted that the additional joist were not resting on the beam, they were merely supported by the fasteners that were used to attach them to the existing joists.

We recommend that you have the situation corrected by a qualified contractor.

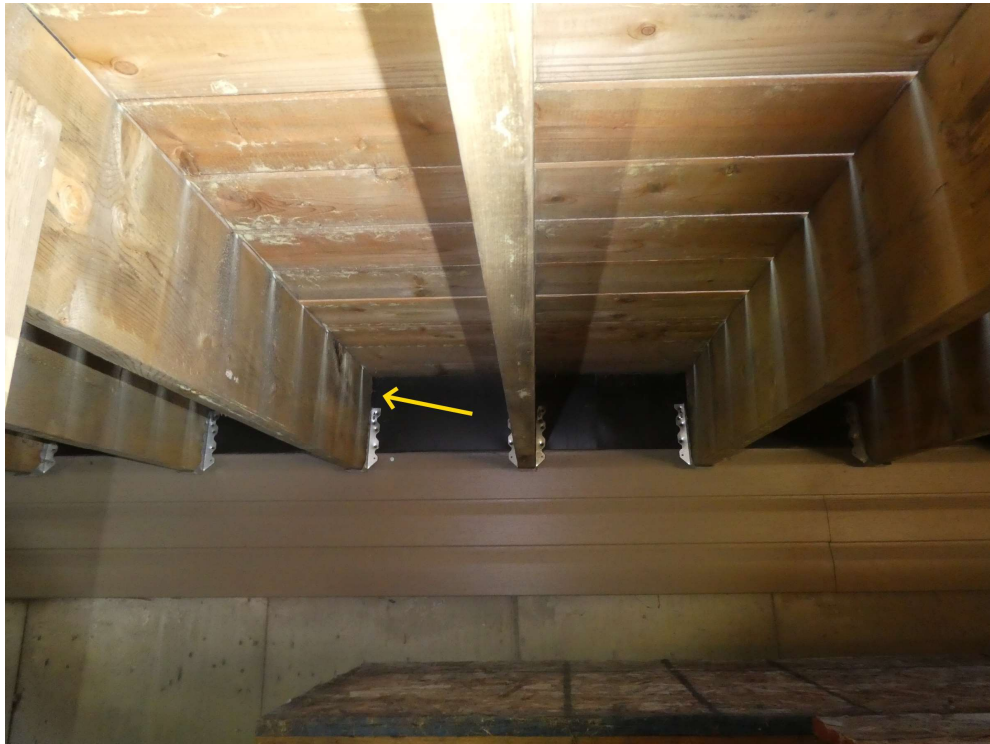
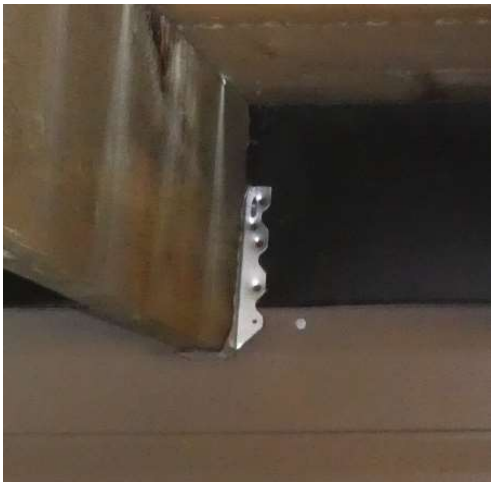
Below rear deck

We noted that deck's floor joists were attached to the ledger board with undersized joist hangers.

We recommend that you have the situation corrected by a qualified contractor.

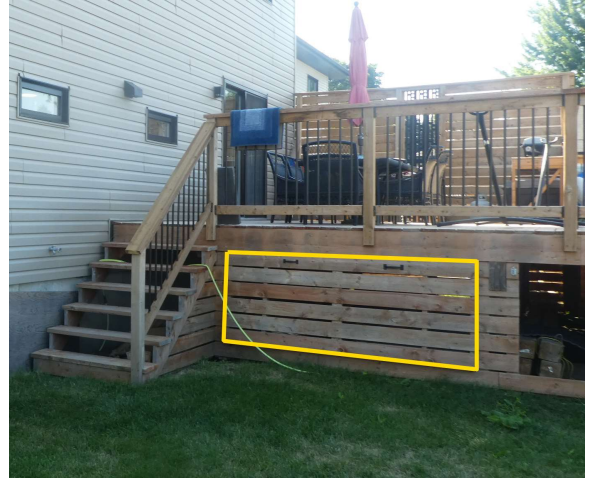
rear balcony

We noted that certain doors and drawers providing access to the rear balcony's structure did not operate properly.

We recommend having them adjusted by a licensed contractor.

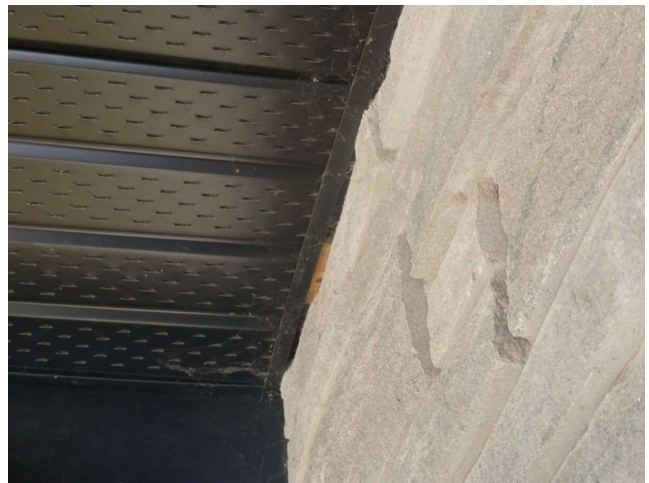
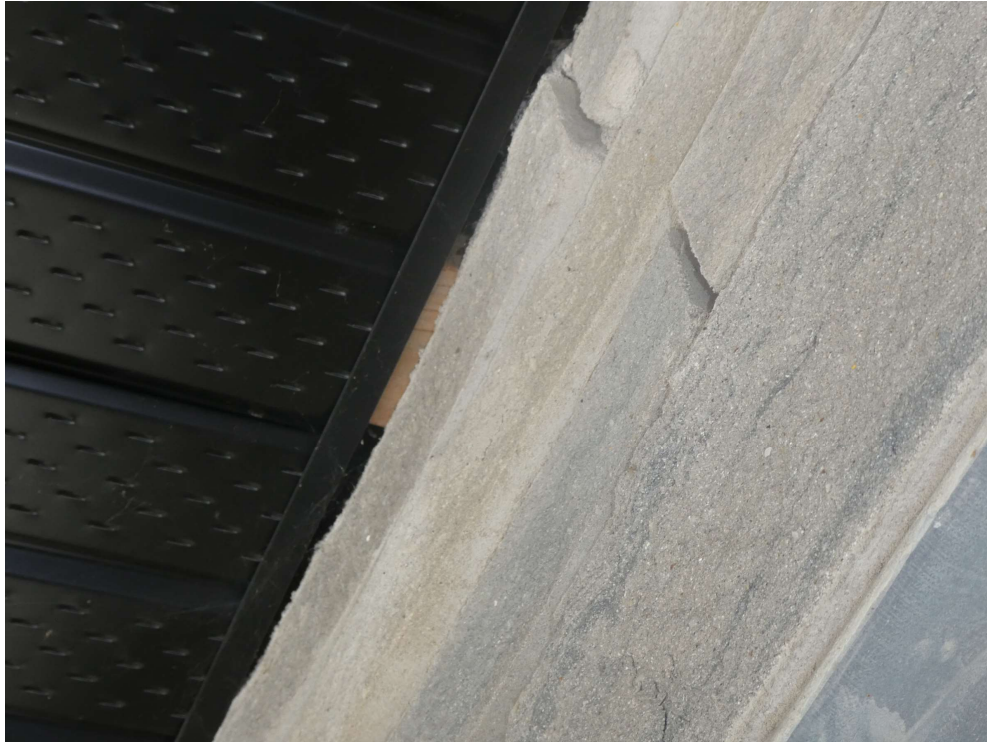
Front balcony

We noted one or more openings in the soffits.

We recommend that the openings be sealed by a skilled and competent person.

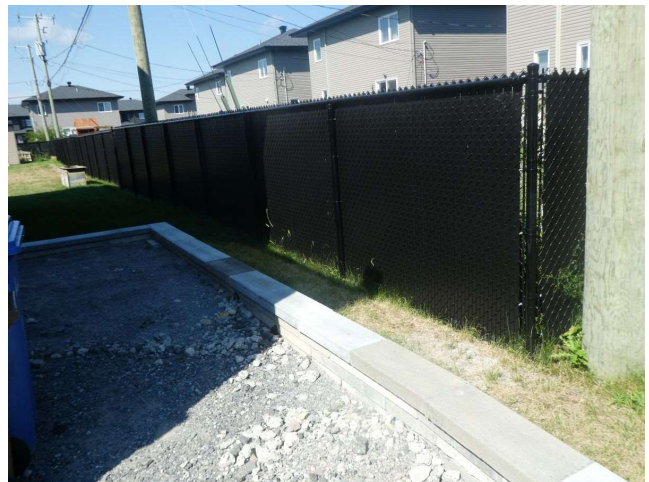
We noted that the concrete blocks or pavers that make up the retaining wall in the driveway were not fastened.

We recommend contacting a qualified contractor to have the retaining wall secured so there is not risk of it toppling over.

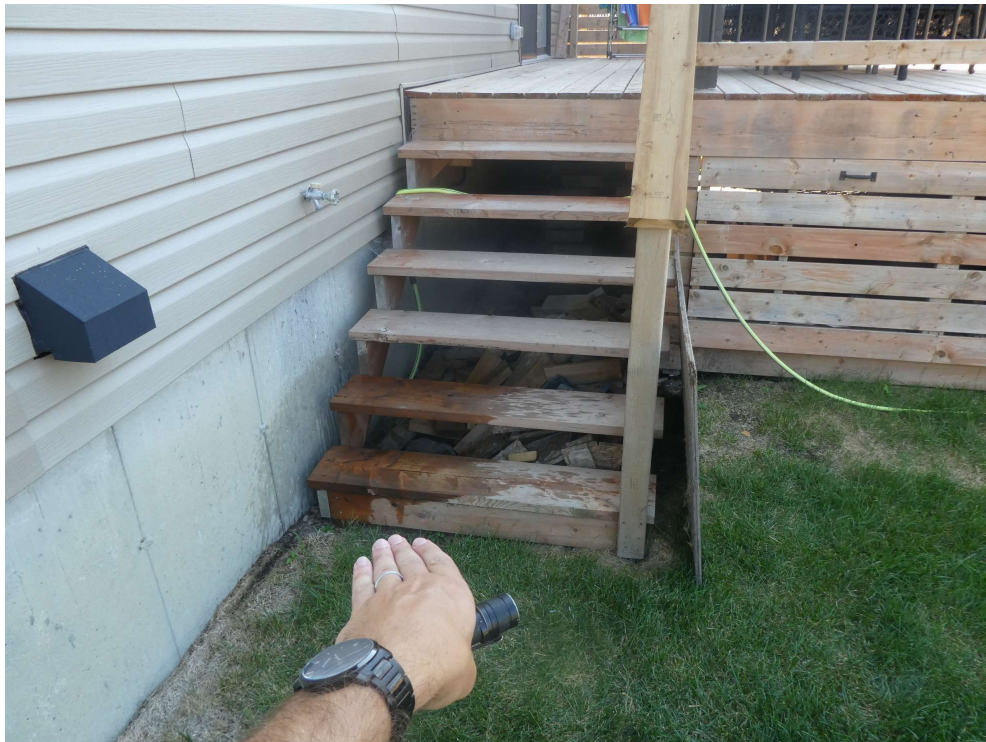
Rear facade

We noted that in some places, the soil was directing water towards the building.

Counter-slopes which direct water towards the foundation increase the risk of infiltration.

We recommend consulting a landscaper to have the situation verified and corrected.

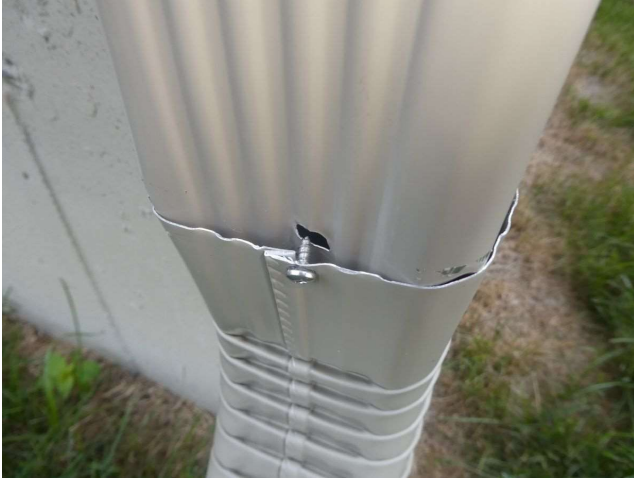
Rear facade

We noted that one or more sections of the property's gutter system was damaged.

In its current condition, the gutter may evacuate water uncontrollably.

We recommend having the gutters replaced or repaired by a qualified contractor.

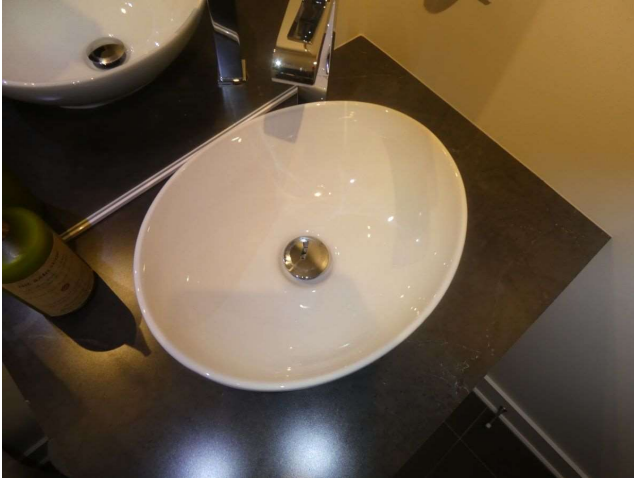
powder room

We noted one or more sink with no overflow drain.

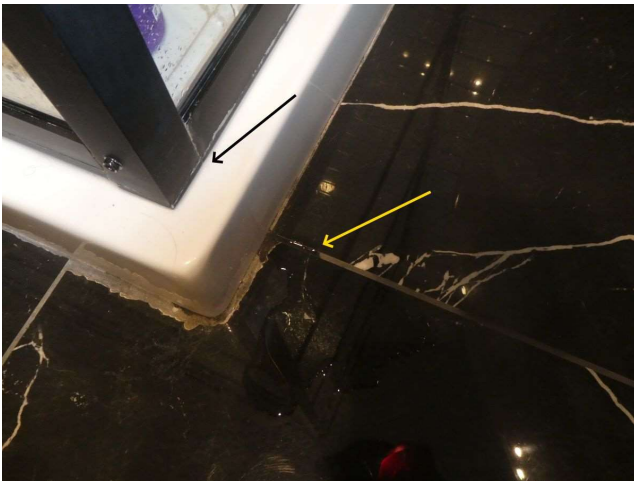
washroom

We noted one or more appliances or faucets are leaking.

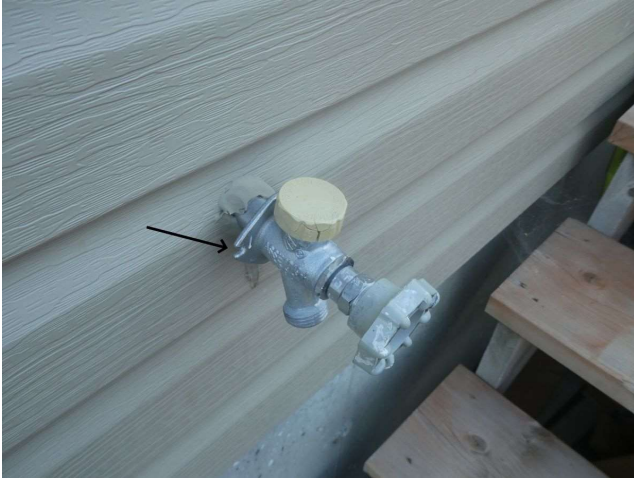
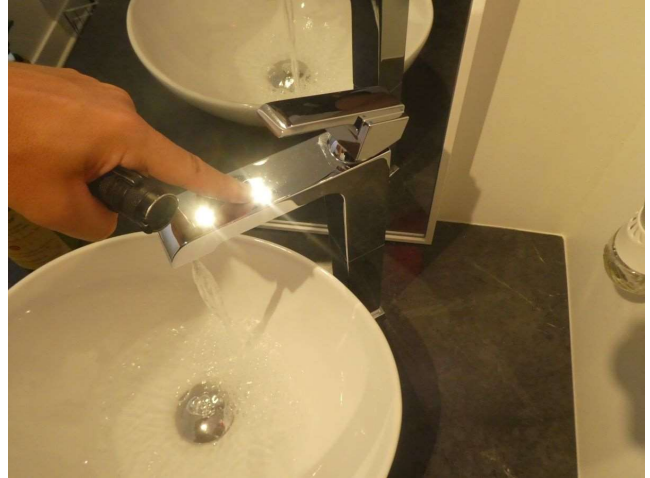
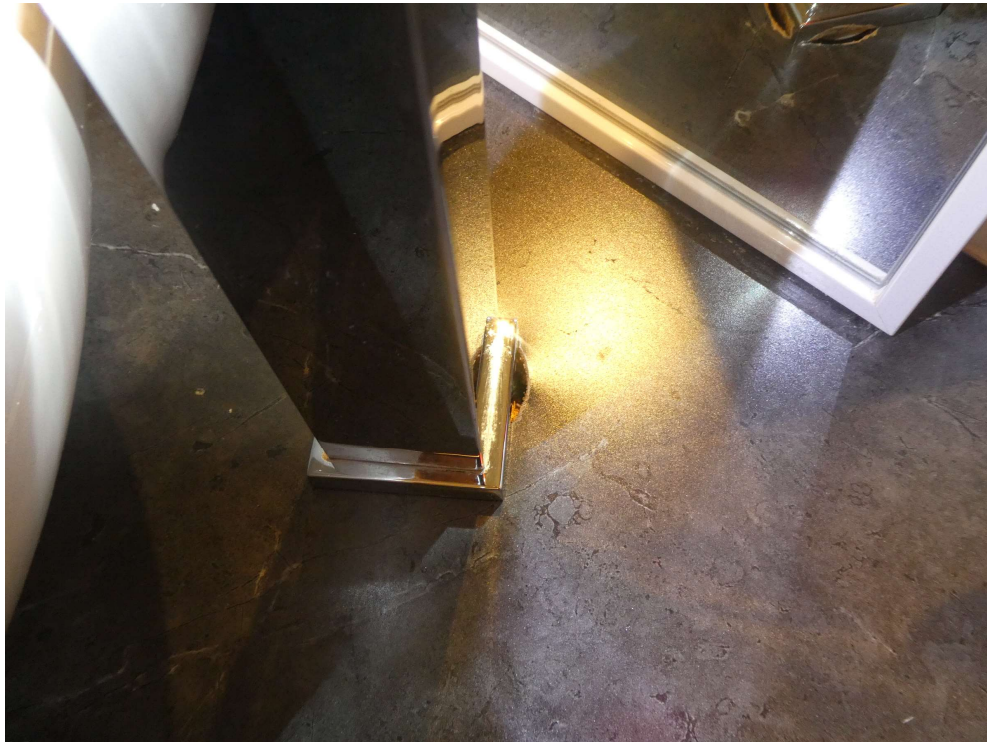
powder room

We noted one or more damaged or loose faucets.

When faucets are not securely fastened, this can eventually create leaks in cabinets and on the floor.

We recommend replacing or repairing the faucet(s) in question to ensure proper function, as well as to prevent possible water damages.

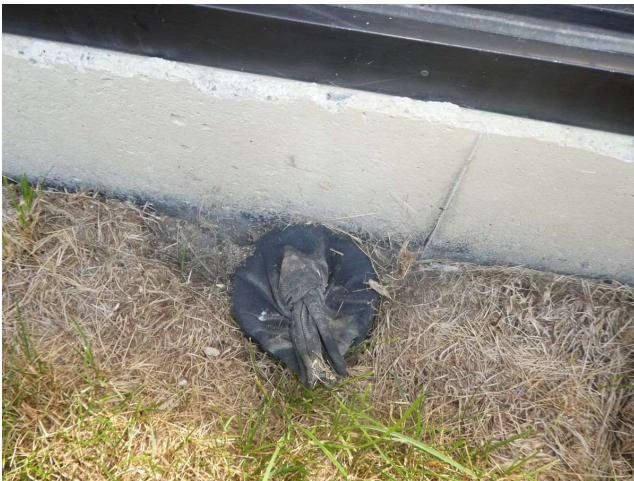
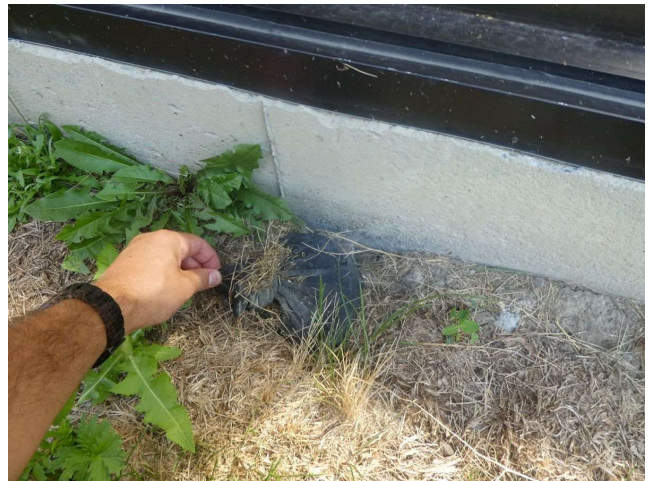
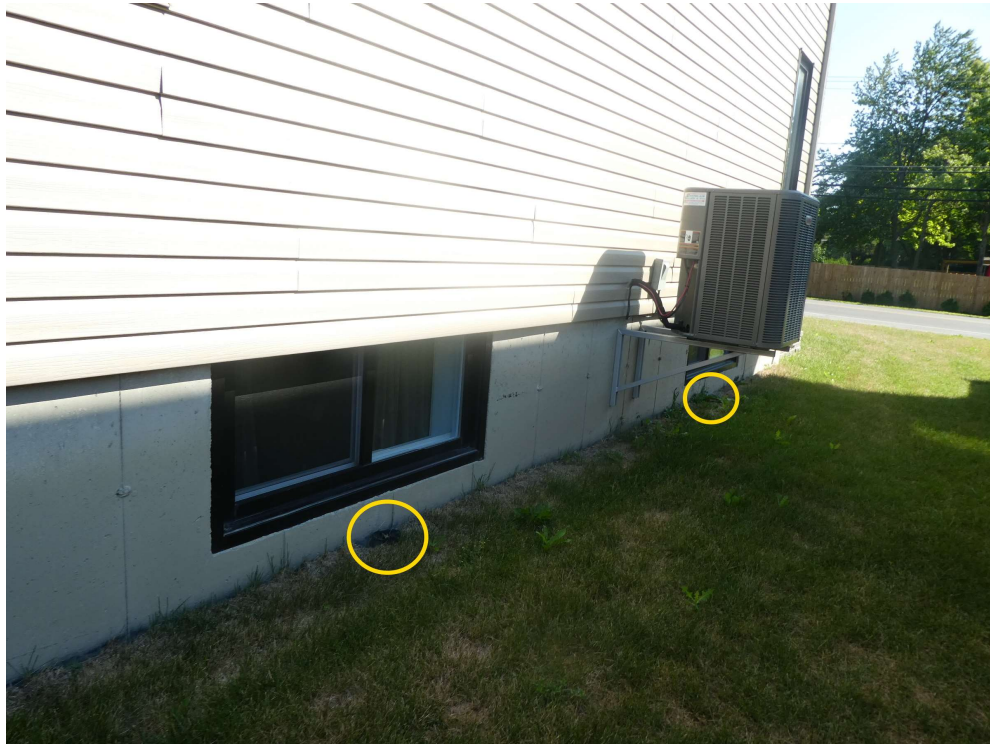
left facade

We noted that the cleanouts providing access to the property's foundation drain were covered with a geotextile membrane.

Over time, the geotextile membrane may wear or be torn, creating an opening that risks blocking the drain.

It is recommended that rigid cap be installed to cover the access points.

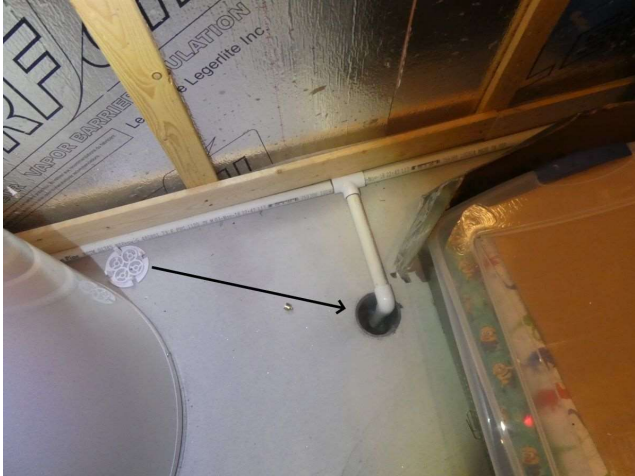
mechanical room

We noted that one or more floor drains were not equipped with a strainer.

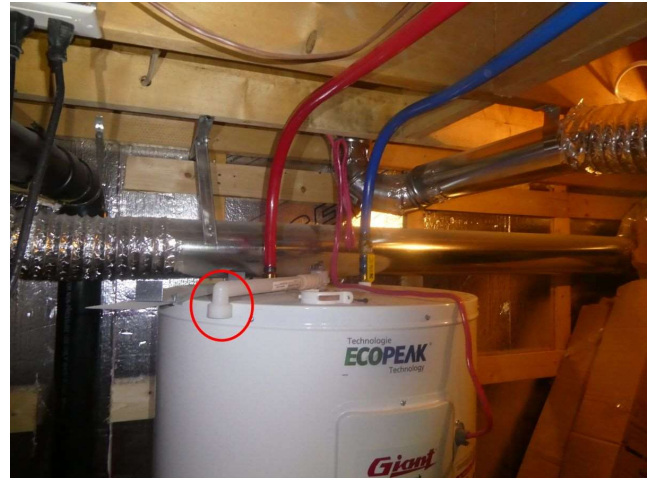
mechanical room

We noted that one or more water heaters did not have a discharge pipe attached to their temperature/pressure relief valves.

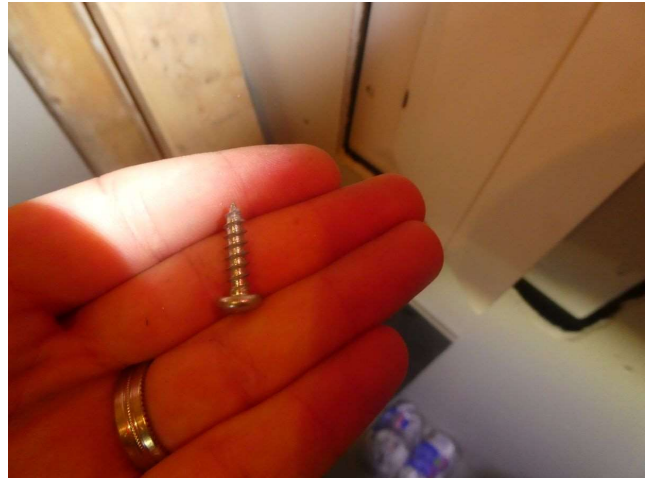
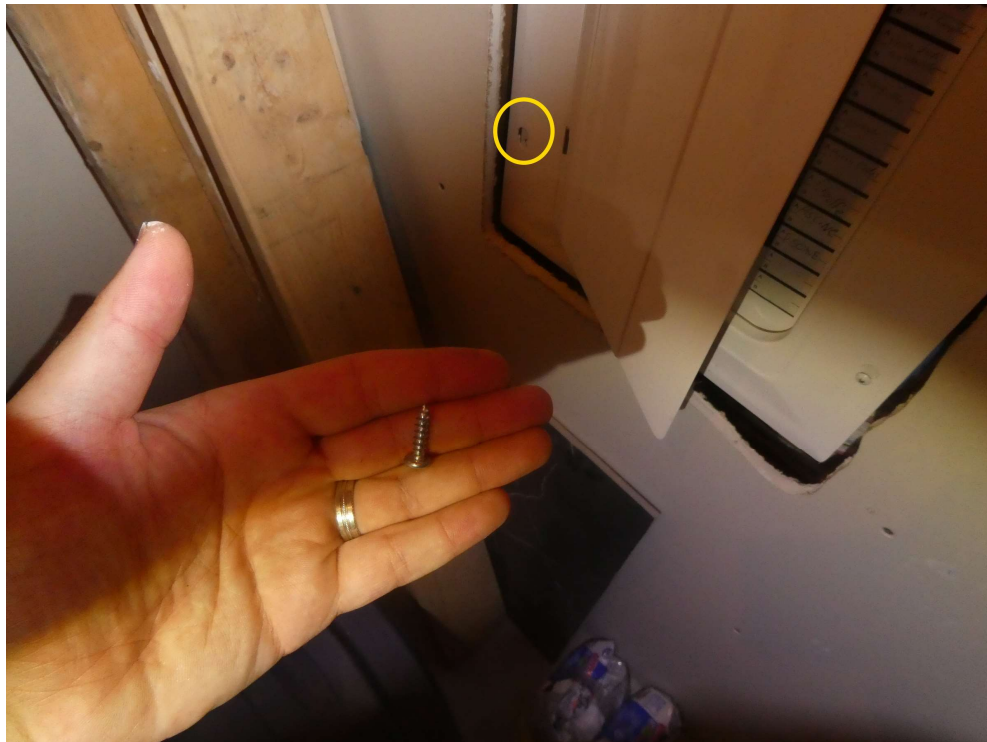
Electrical panel

We noted that the cover of the electrical panel was fastened with pointy screws.

This situation poses a risk of electrocution and electrification for the occupants.

We recommend contacting a master electrician to replace the screws.

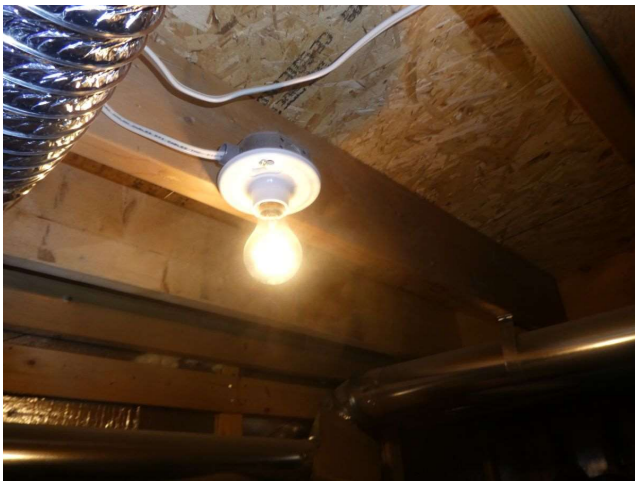
mechanical room

We noted one or more unprotected light bulb in an enclosed space.

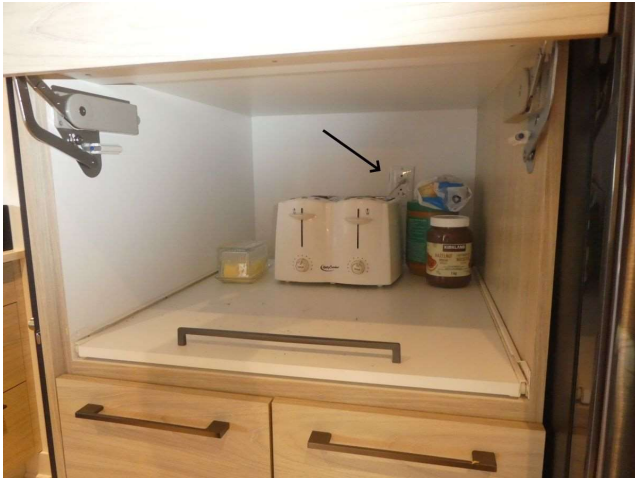
Kitchen

We found one or more power outlets installed in a poor location.

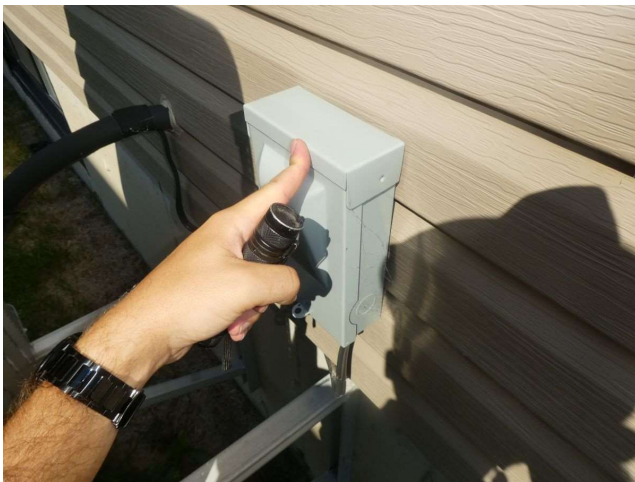
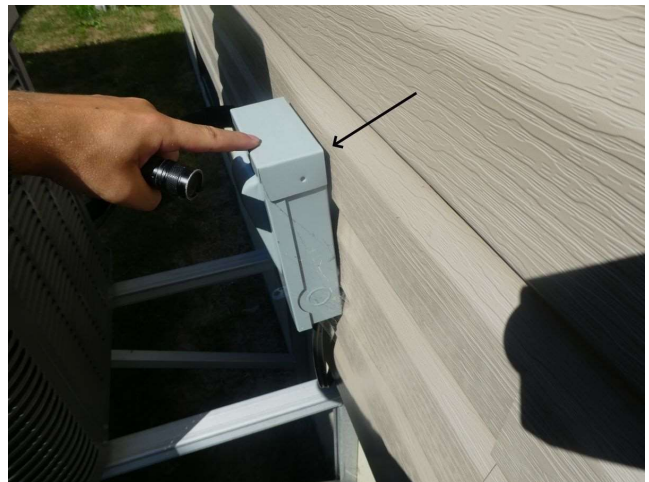
left facade

We noted that the safety disconnect switch for the air conditioner exterior condensing unit was not properly fastened to the building.

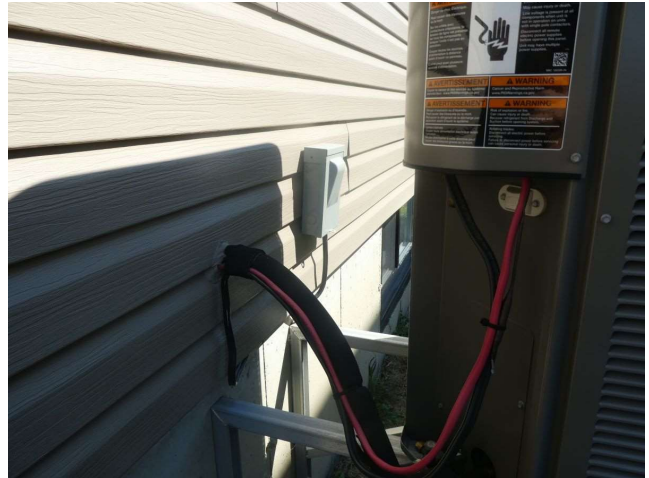
left facade

We noted that the safety disconnect for one or more air conditioners (or heat pumps) was not locked.

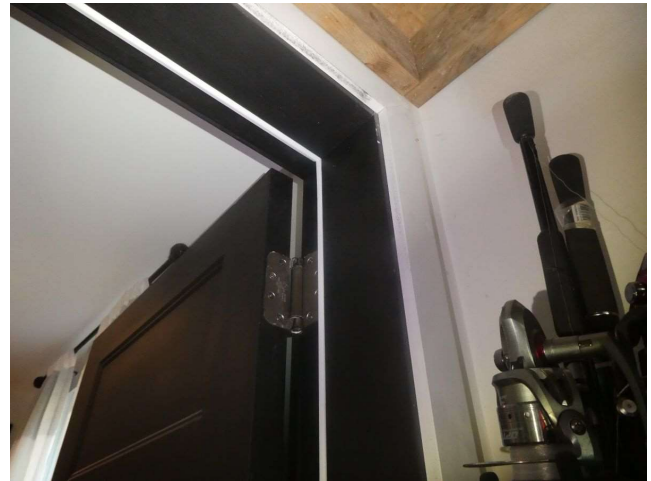
Garage door (man's door)

We noted that the interior door providing access to the living area from the garage did not close itself automatically.

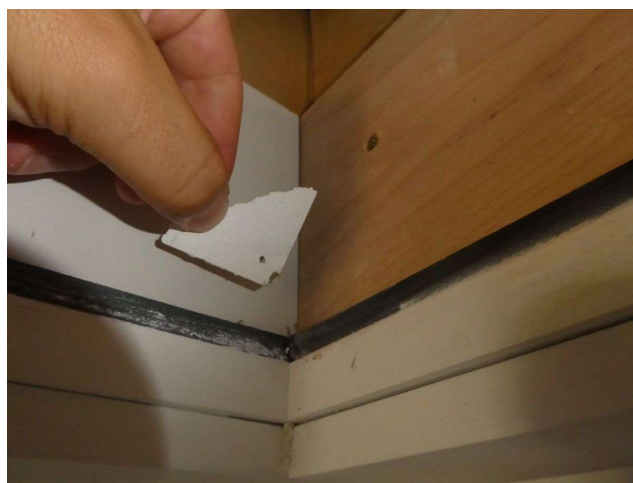
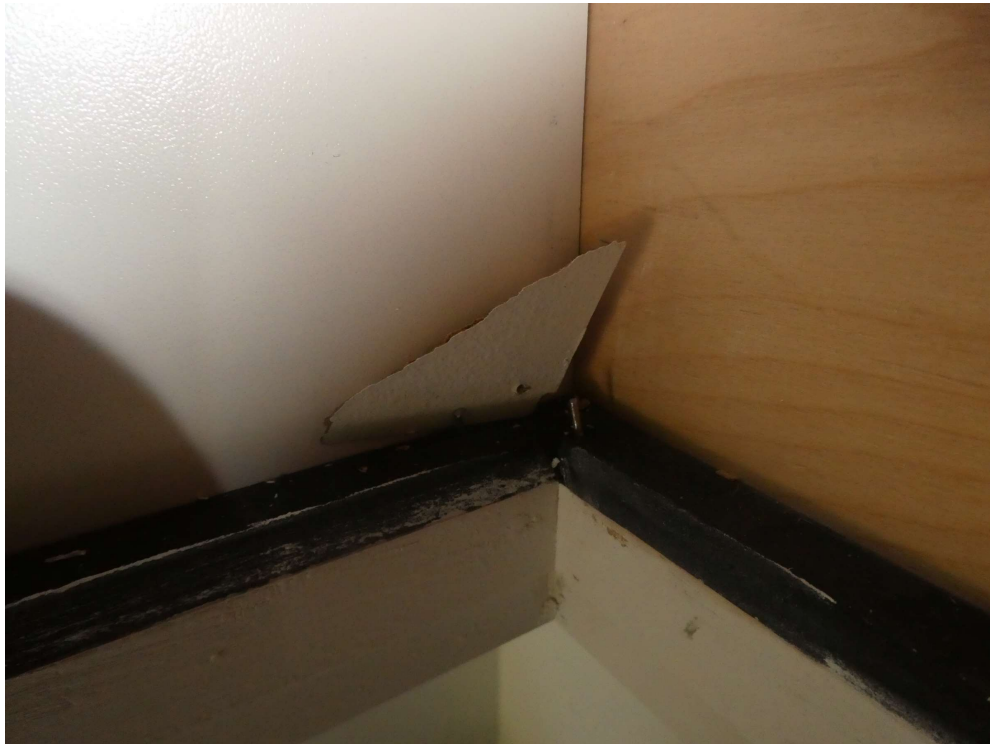
attic hatch

We noted that, at the attic hatch, the finishing nails for the trim work were too long and driven into the access door.

We recommend contacting a qualified contractor to carry out the necessary corrections to the attic access hatch.

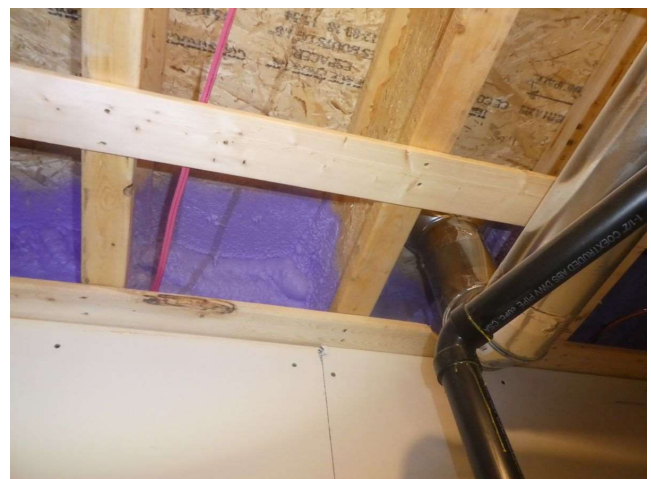
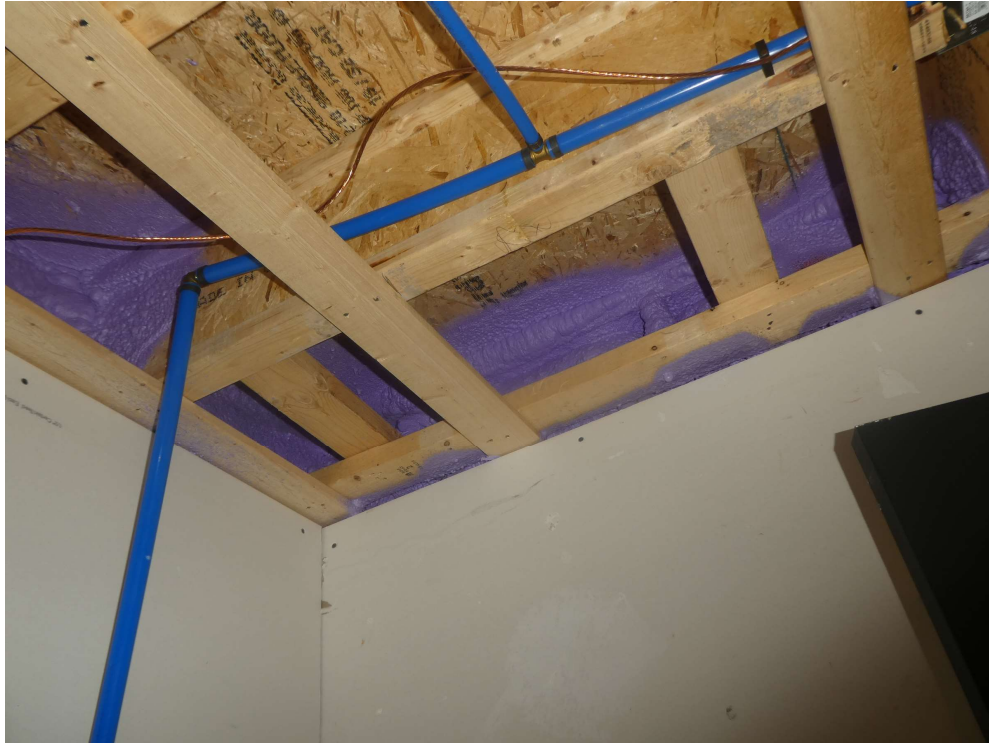
mechanical room

We noted one or more areas in which there was exposed combustible insulation.

We recommend contacting a licensed contractor to have the situation evaluated further.

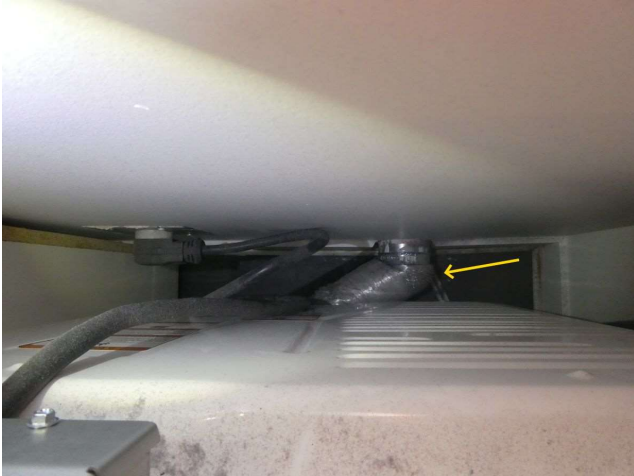
Laundry closet (behind dryer)

We noted that one or more dryer exhaust ducts appeared to be crushed.

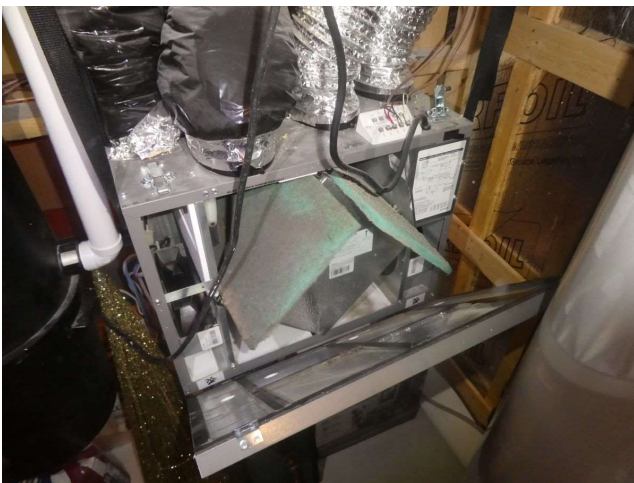
mechanical room

We found that one or more of the air exchanger filters were dirty and should be cleaned (or replaced).
