File number: [REDACTED]
Inspection date: August 1, 2022

PRE-PURCHASE INSPECTION REPORT

Kevin Mercurio
Les Inspections Mercurio Inc.
1066 rue du Souvenir
Saint-Eustache, Québec
J7R 0M5
August 2, 2022

The property is a 1957 construction duplex. The foundation walls are made poured concrete and the siding is made of brick, stucco and wood. The windows are made of aluminum and the property has a multilayer asphalt and gravel roof covering. This building also has:

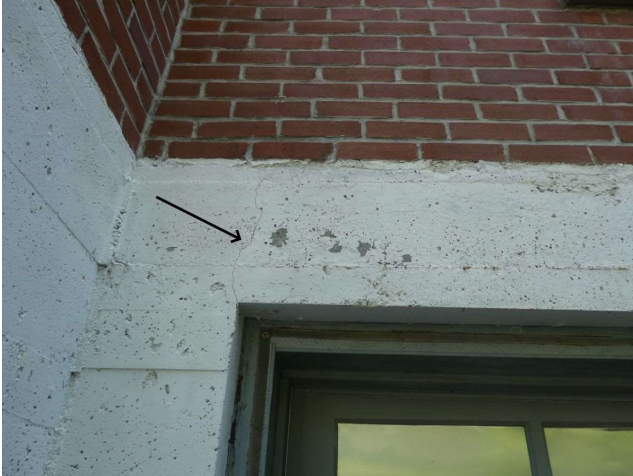
Rear facade (above garage door opening)

CRACK

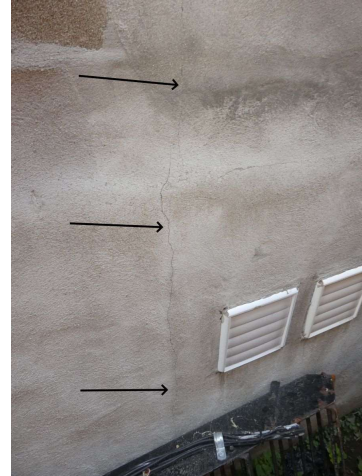
left facade

We noted one or more foundation cracks.

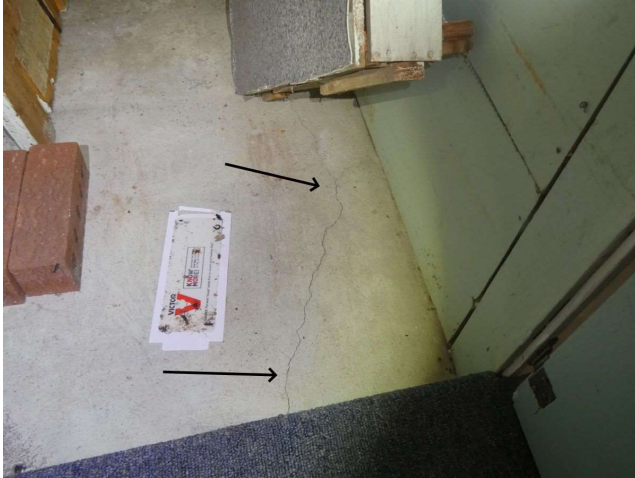
Below basement staircase

CRACK

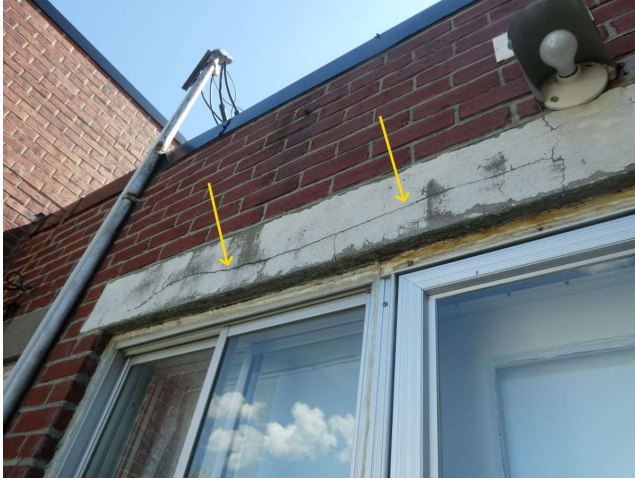
Rear facade (second floor balcony)

DAMAGED LINTEL

We noticed that one or more damaged lintels.

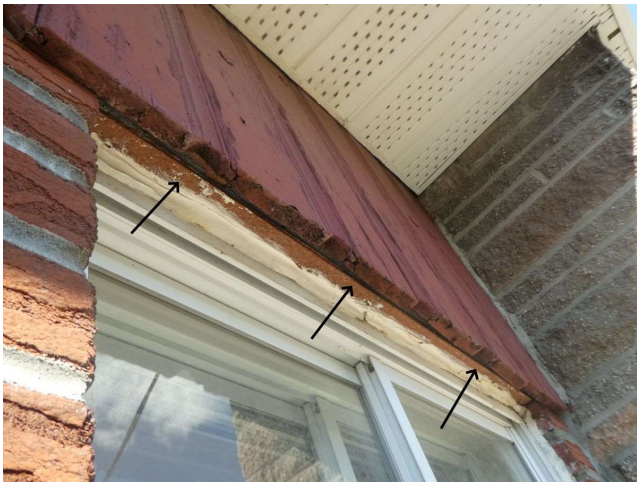
Front facade (bedroom window)

We noticed one or more rusting lintels.

The lintel is a structural element that supports the load of the materials above it (brick, stone, masonry, etc.), redistributing it to each side. Make sure to protect them against rust by maintaining them regularly.

We recommend contacting a mason to carry out the necessary corrections.

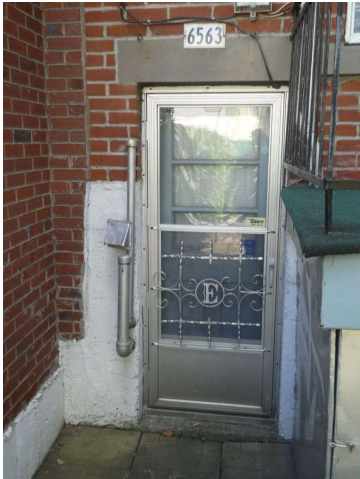
Rear base exit

WOOD

We noted one or more exterior wood doors.

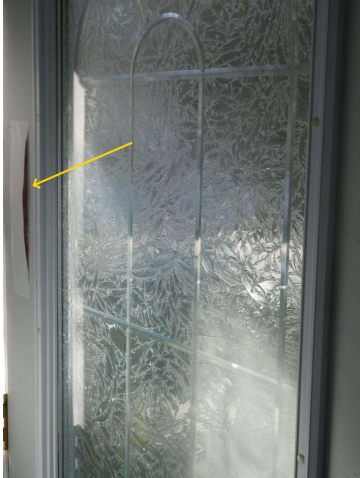
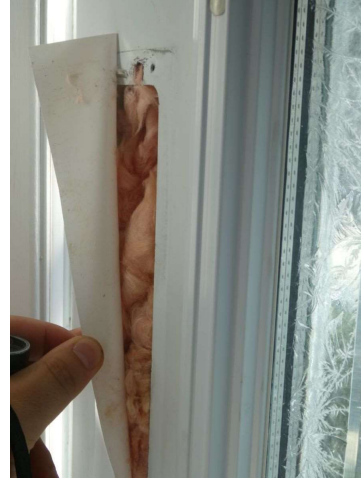
Front door leading to second floor

MAIL SLOT

We noted one or more mail slots on an exterior door.

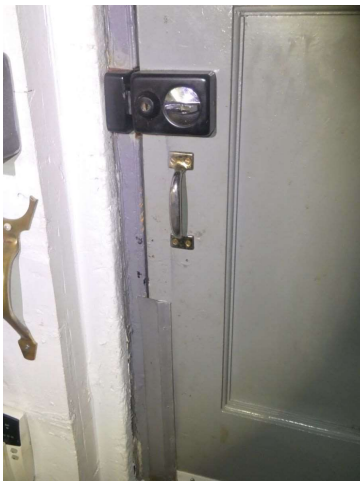
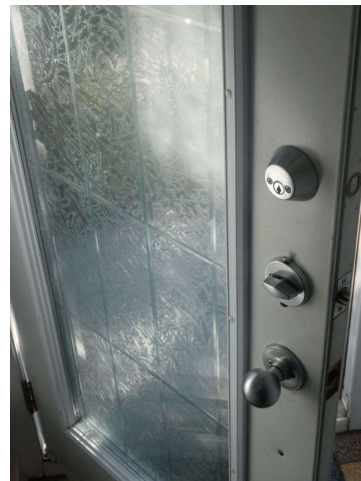
Rear base exit

KEYED DOOR HANDLE

We noted one or more door handles for which the latch required a key to operate.

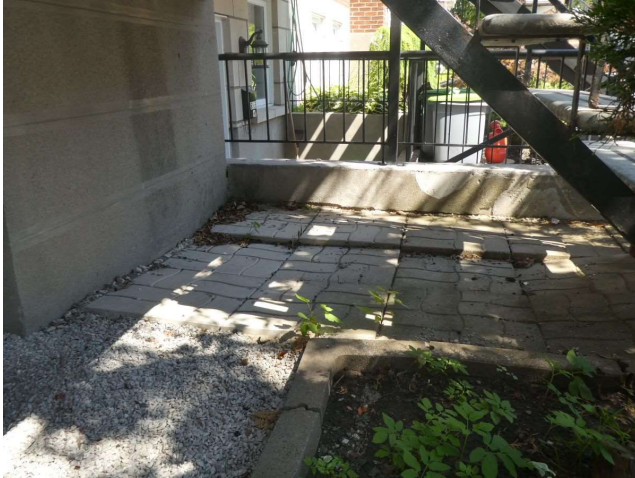
Below front balcony

SHIFTING OF PAVING STONES

We noted that the paving stones have shifted in some areas.

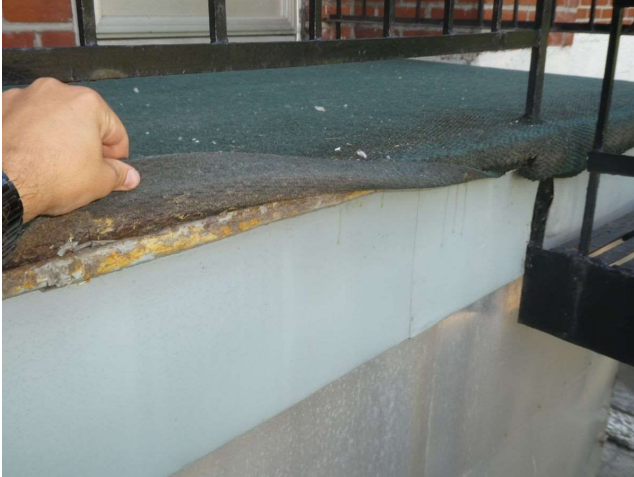
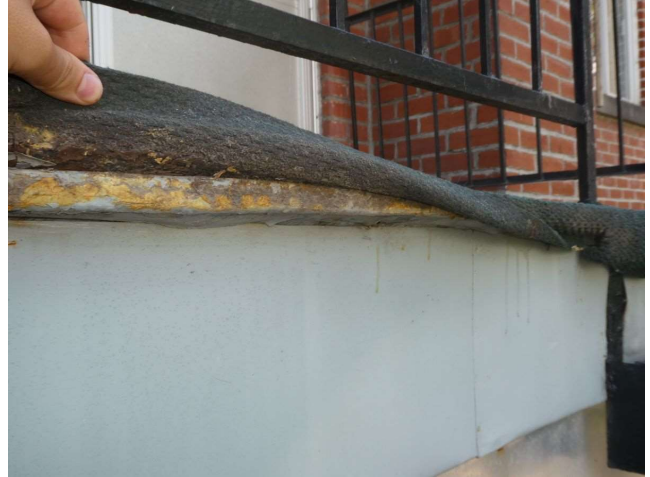
rear balcony

BALCONY COVERED WITH CARPET

We noticed sections of balconies covered with carpet.

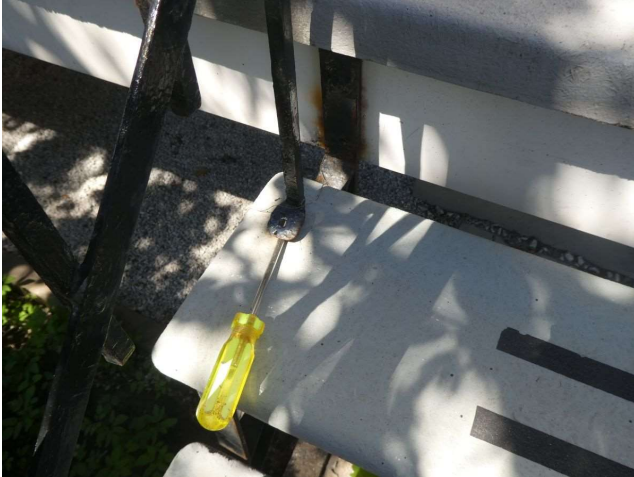
Front balcony

DAMAGED BALCONY

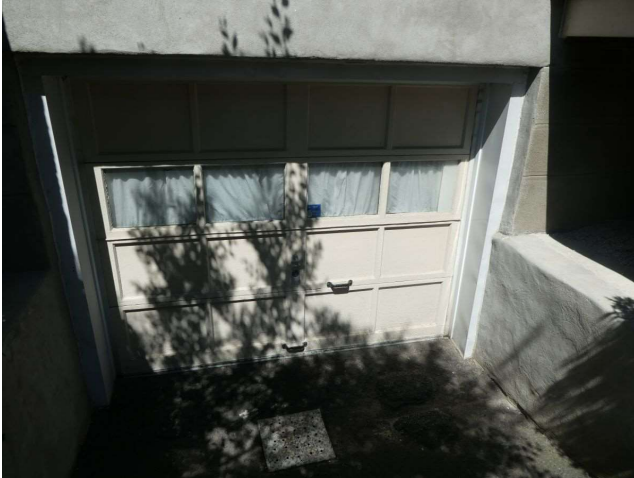
Forehead

WOOD GARAGE DOOR

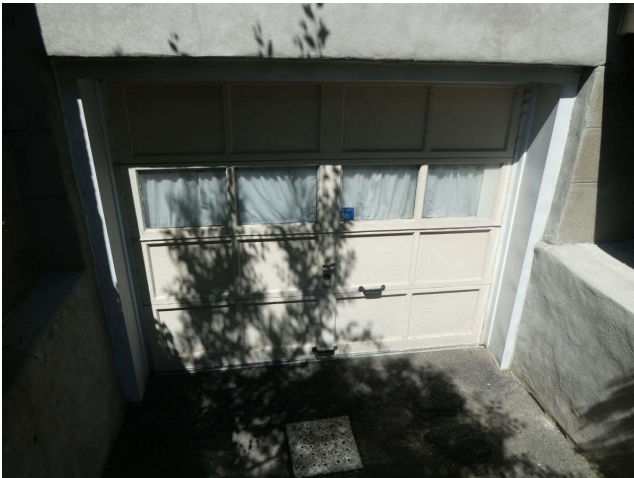
Front driveway

LOW GARAGE DOOR OPENING

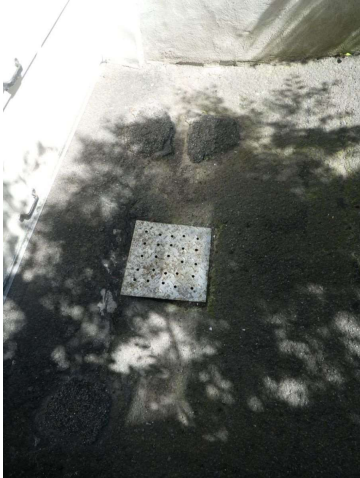
Front driveway

DRAIN WITHOUT CATCH BASIN

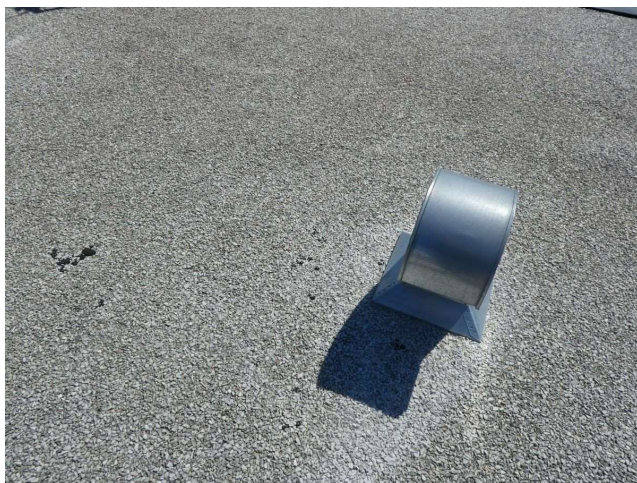
roof

VISIBLE ASPHALT MEMBRANE

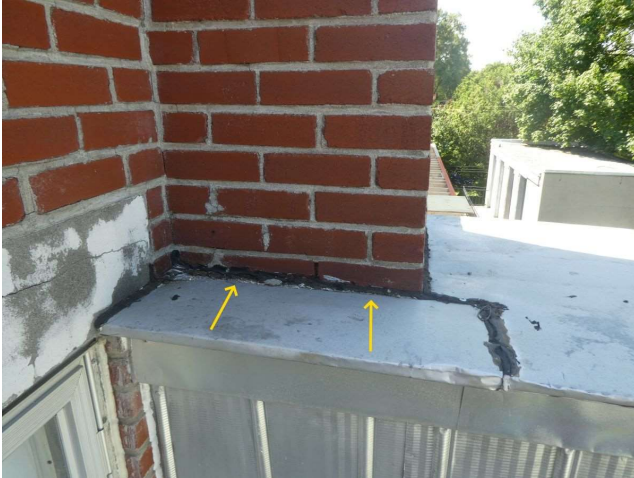
Rear balcony (second floor)

POORLY INSTALLED FLASHING

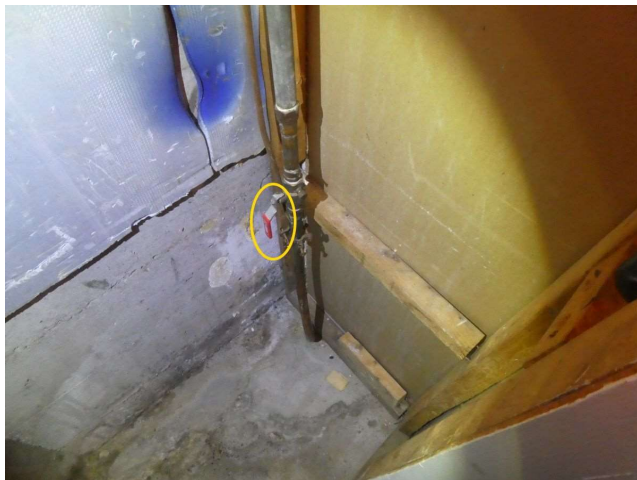
Basement (front wall)

NO DEFECT ON THE MAIN WATER VALVE

We observed no defects on the water supply piping before the main shut-off valve or at the main shut-off valve.

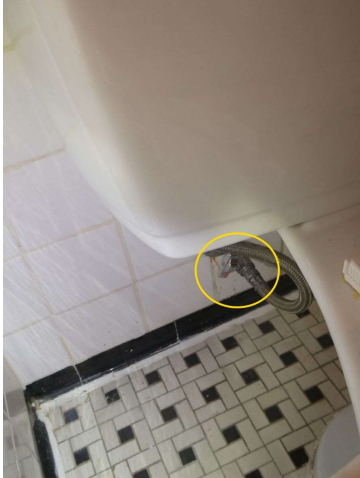
NO WATER SUPPLY

The water supply for the ground floor toilet was turned off.

We do not operate water valves at the risk of creating leaks on a faulty valve or connection.

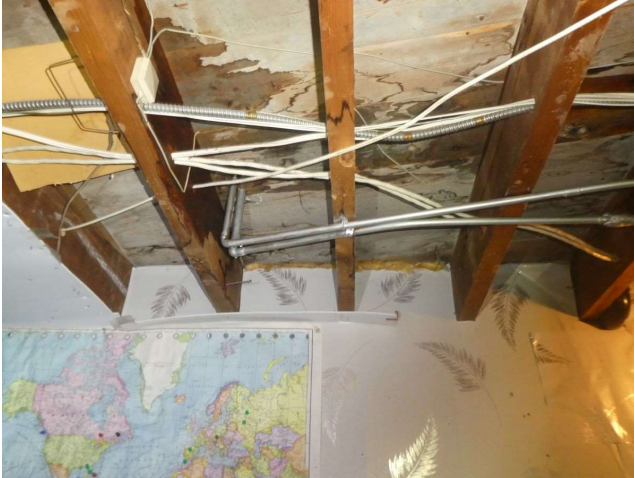
Basement (mechanical room)

LEAK

We noted several leaking appliances or faucets.

In their current state, there is currently a risk of water damage to other components, such as flooring and structural elements of the floor.

We recommend that you have the necessary corrections carried out by a licensed plumber.

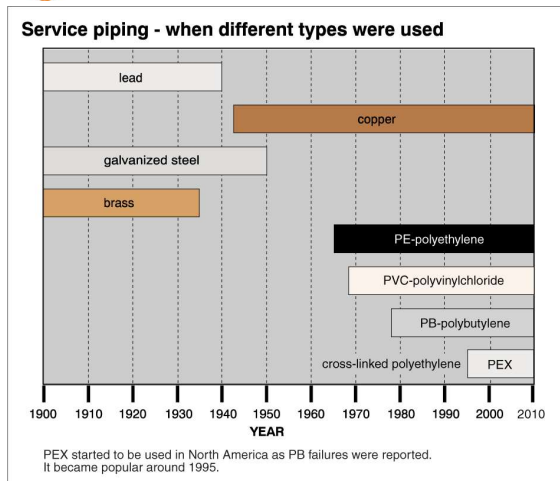
Illustration

STEEL PIPING

We note that some sections of the water supply system are made of steel piping, which will corrode and develop leaks.

We recommend that you replace all outdated plumbing. This type of material can effect the quality of the drinking water. Have the water quality tested by an expert. Be sure to replace all old steel pipes.

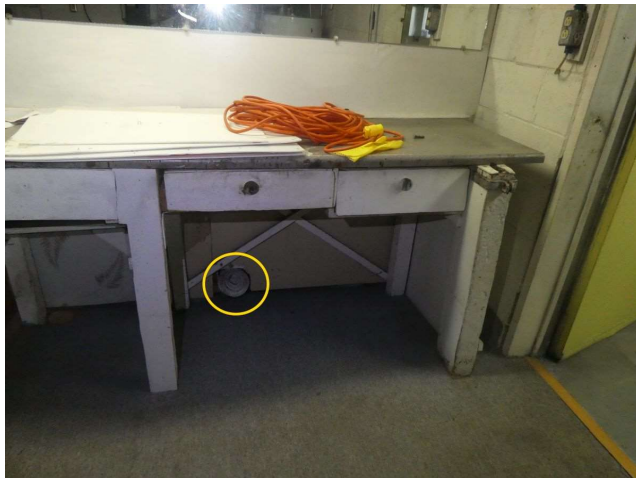
Basement (mechanical room)

CLEANOUTS

We observed one or more of the the property's cleanouts.

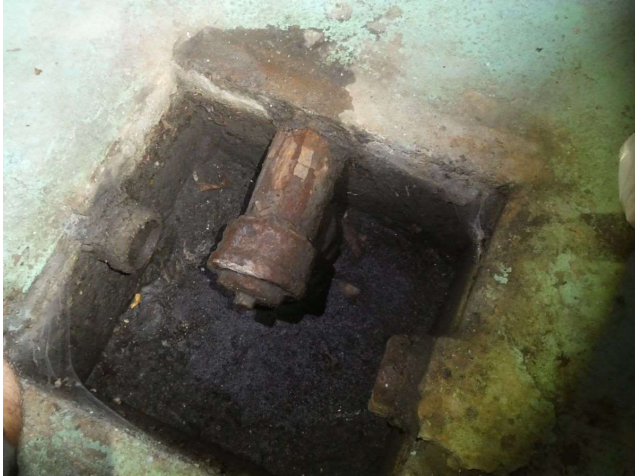
Front garage

CAST IRON WASTE PIPE

We noted that some of the drainage piping was made of cast iron.

Formerly, plumbing pipes were made of galvanized steel, cast iron or lead. Nowadays, these materials are no longer recommended for health reasons, such as lead, or durability, such as galvanized steel, or even convenience, such as cast iron.

Although the system is still operational, given its age, it is likely that some repairs will be required.

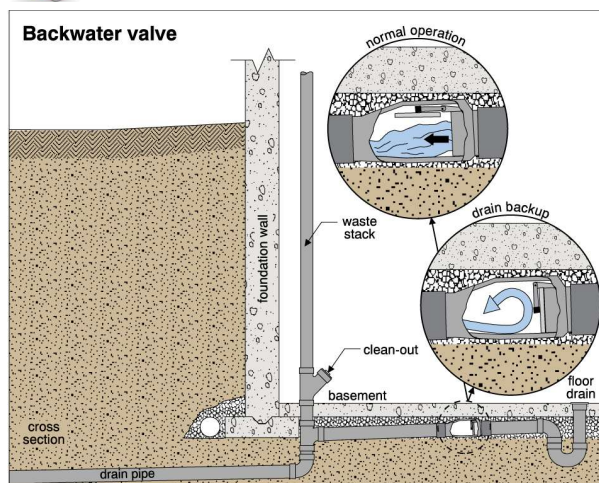
Illustration

BACKWATER VALVE FOR FLOOR DRAIN NOT LOCATED

It is appropriate to have a backwater valve on the floor drain to avoid potential sewage backup. Make sure the water level is maintained in the basement floor drain's P-trap to prevent gases/odors emanating from the sewer from entering into the house.

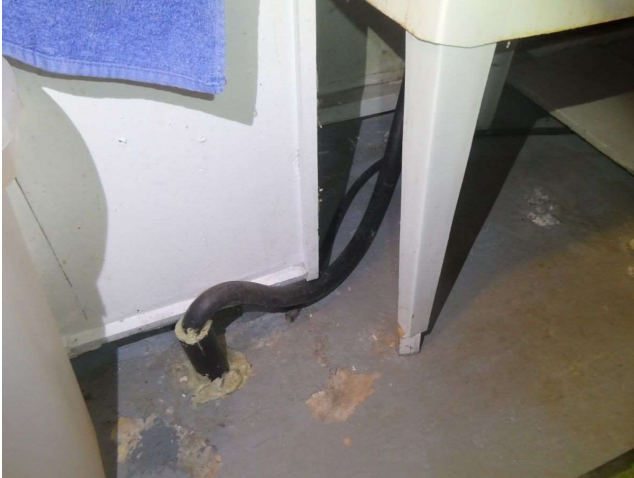
Basement (air exchanger room)

ARTISINAL FLOOR DRAIN

We noted that the floor drain in the basement was not installed properly.

We recommend contacting a licensed plumber to have the floor drain and lavatory drain corrected.

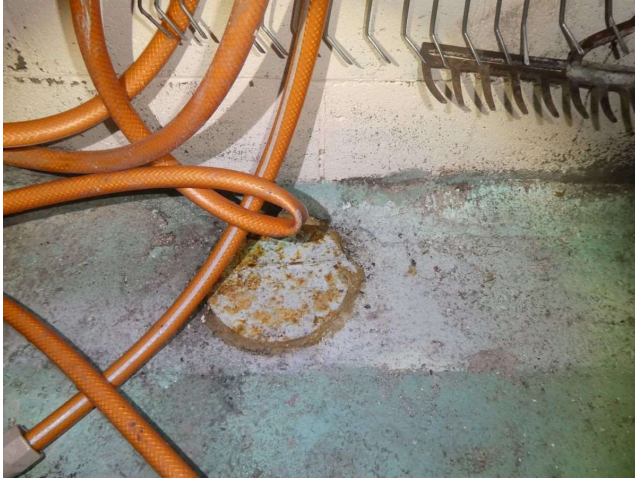
Front garage

ORIGINAL BACK WATER VALVE

We noticed what appeared to be the original backwater valve for the front garage's retention pit.

We recommend that you have this device evaluated by a licensed plumber

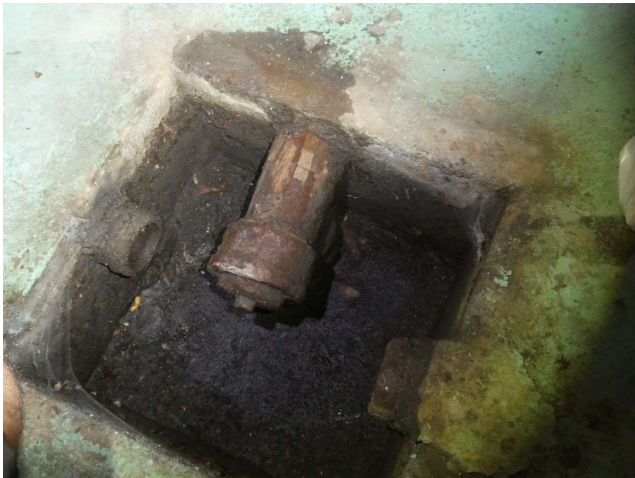
Front garage

MISSING COVER

We noted one or more catch basins that missing covers..

We recommend that you have a cover installed on the catch basin.

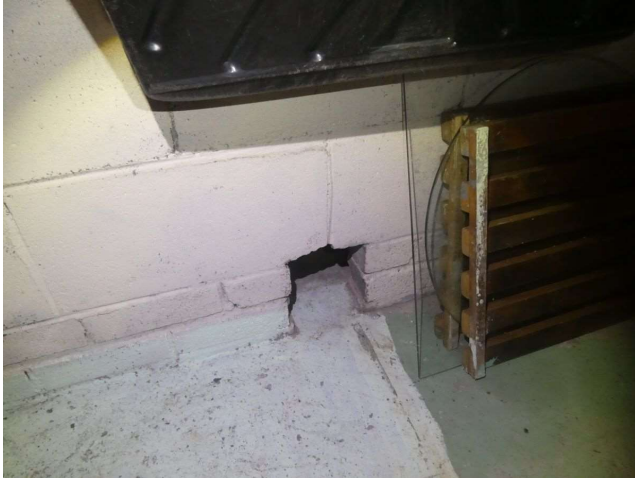
rear garage

NO GARAGE FLOOR DRAIN

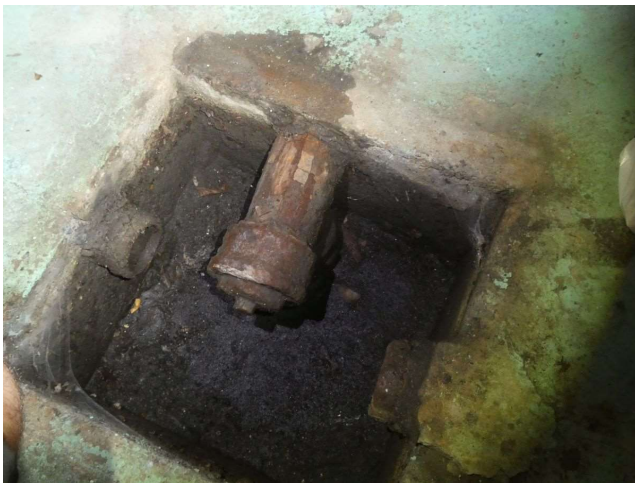
Front garage

SUMP PIT (OR CATCH BASIN) TO BE CLEANED

The property has one or more sump pits (or catch basins) with sediment accumulation.

We recommend that you have these basins cleaned regularly by a licensed plumber.

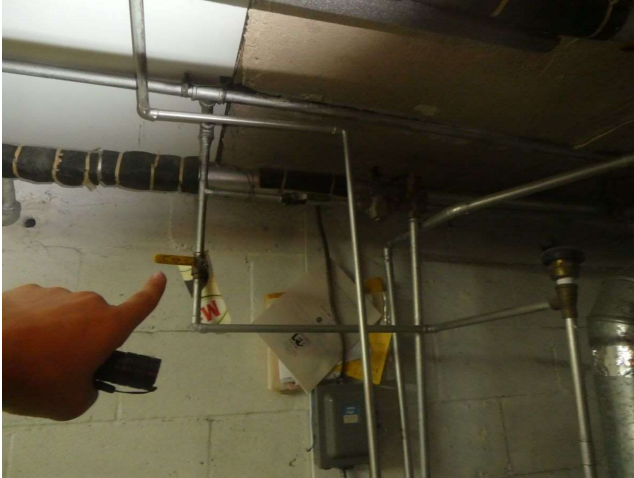
Basement (mechanical room)

CLOSED SUPPLY VALVE

The water supply valve to one or more water heaters was closed.

In order to prevent leaks or damage that may result from their operation, the water valves are not operated.

We recommend that you obtain the seller's declaration and verify of the condition of the uninspected items.

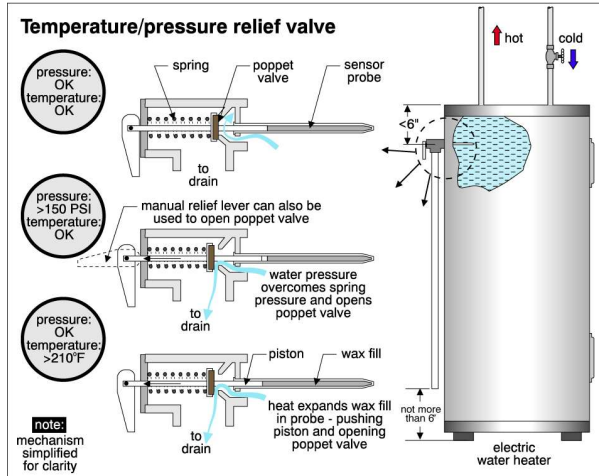
Illustration

NO DISCHARGE PIPE

We noted that one or more water heaters did not have a discharge pipe attached to their temperature/pressure relief valves.

We recommend that you contact a licensed plumber to make the necessary corrections.

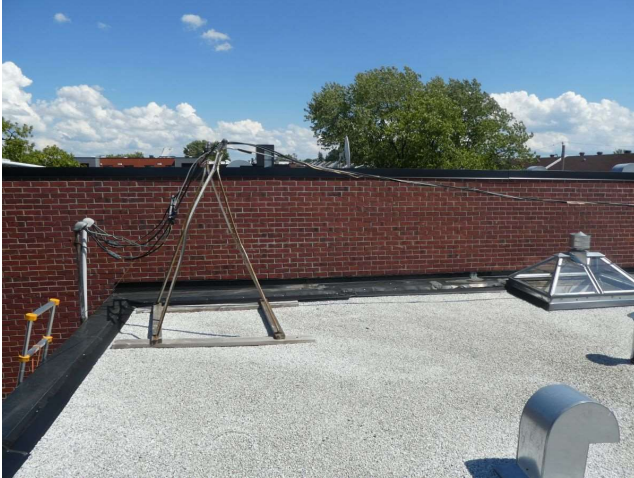
ELECTRICAL STAND

We noted two electrical stands on the roof.

This applies pressure to the roof and may eventually pierce or damage the roof, causing infiltration. The wood that it is resting on may rot, causing direct pressure of the steel support stand and the roof. The wood must be maintained, and in solid condition at all times.

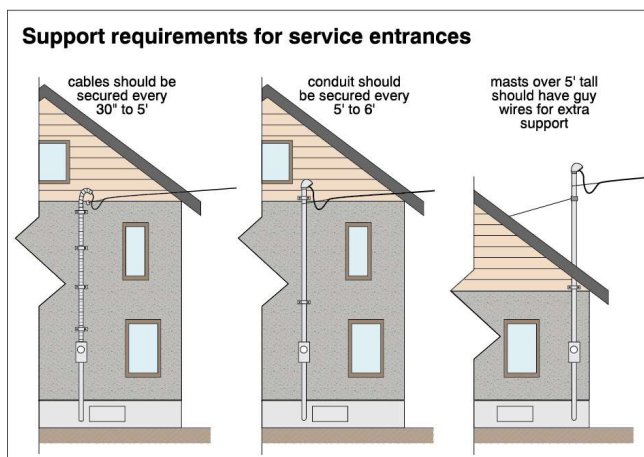
Illustration

MISSING ELECTRIC MAST BRACKETS

We noted that one or more brackets for the electric mast were missing.

We recommend that you consult an electrician to perform the necessary corrections.

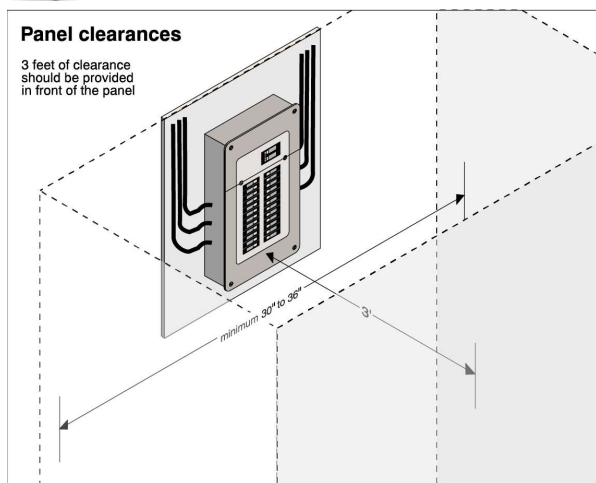
Illustration

NO ACCESS TO ELECTRICAL PANEL

We noted one or more electrical panels that were not safely and easily accessible.

We recommend that you contact an electrician to perform the necessary corrections.

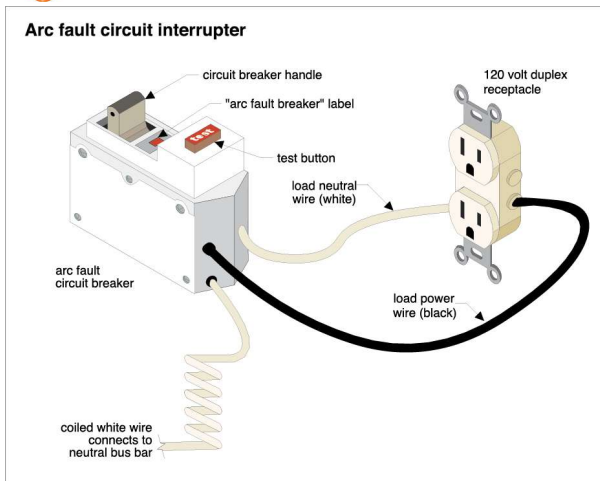
Illustration

NO ARC FAULT CIRCUIT INTERRUPTER (AFCI)

We noted the absence of an Arc-Fault Circuit Breaker (AFCI) inside one or more electrical panels. AFCIs began being installed in the mid-2000s.

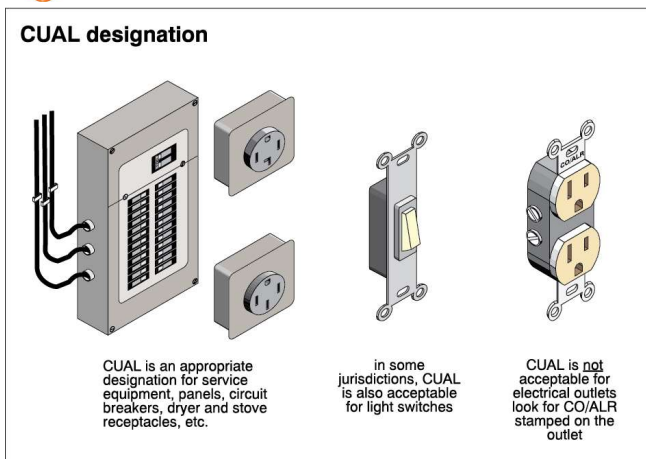
Illustration

ALUMINUM WIRING

We noted the presence of aluminum wiring.

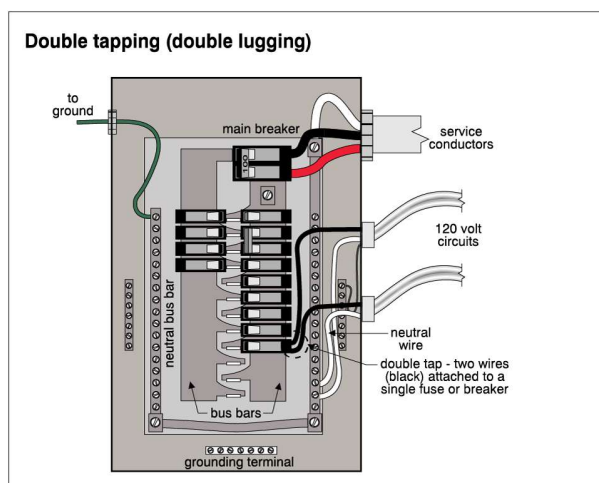
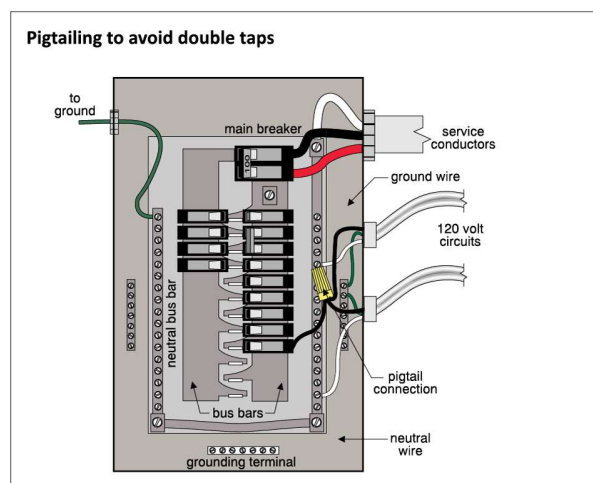
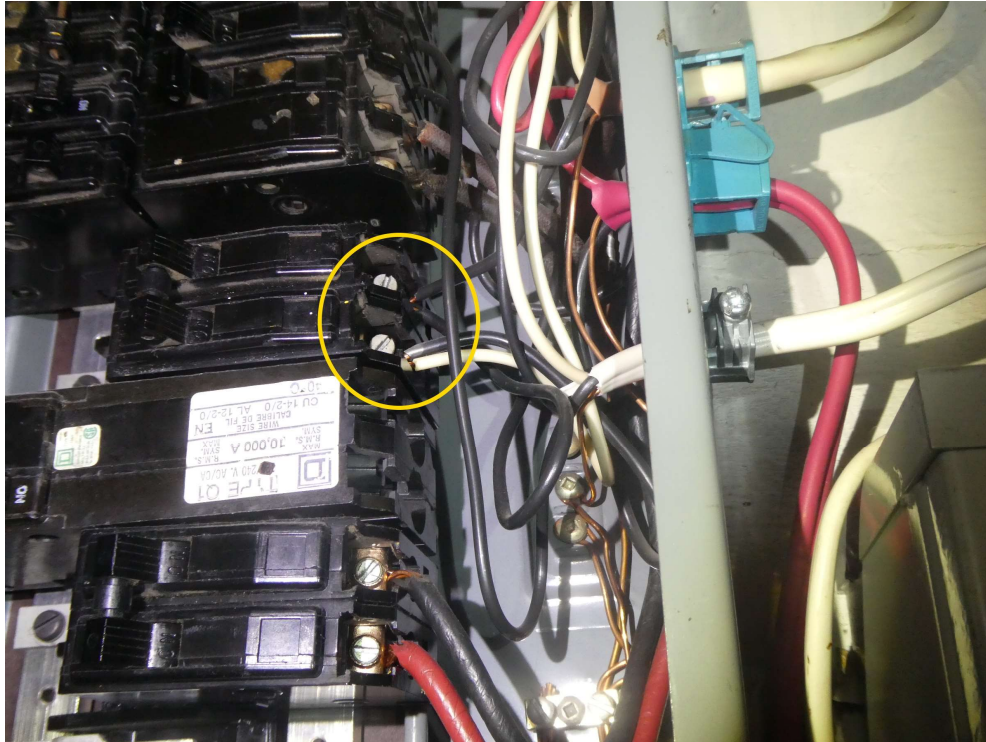
Base electrical panel

DOUBLE-TAPPED CIRCUIT BREAKER

We noted one or more double-tapped circuit breakers.

There are circuit breakers that can hold two wires, but these are not allowed everywhere.

We recommend contacting an electrician to carry out the necessary corrections.

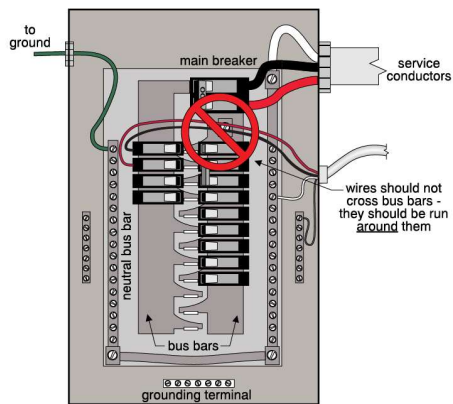
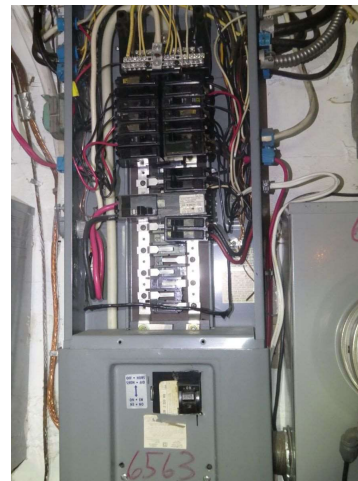
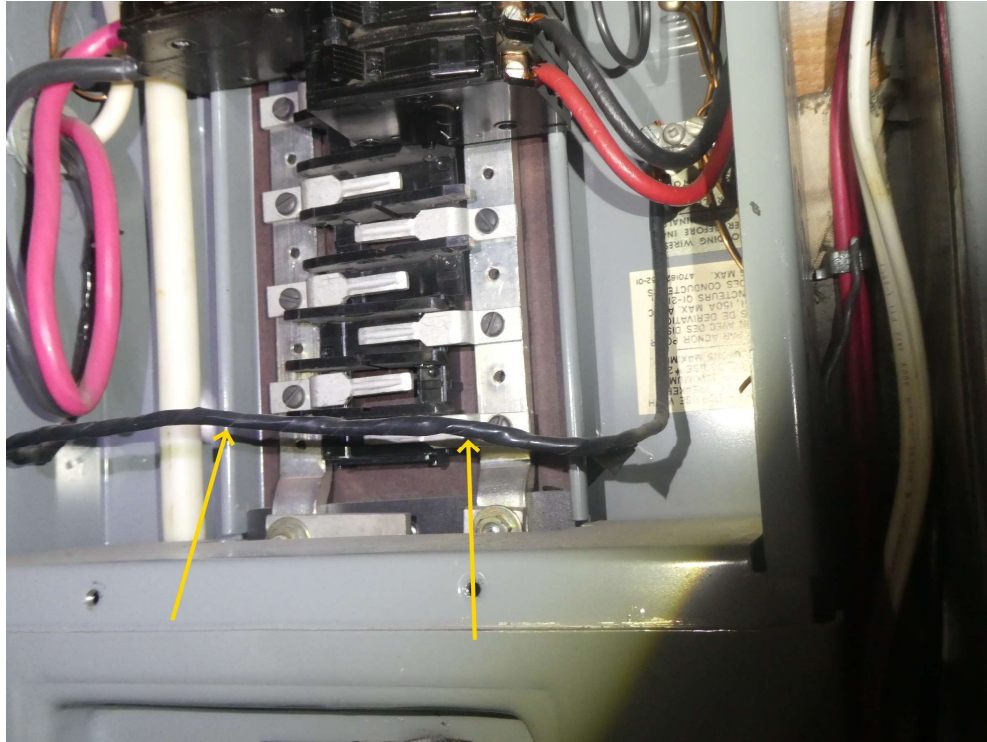
Electrical panel

WIRE CROSSING THE BUS BAR

Wires shouldn't cross bus bars

We observed wires crossing the bus bar in one or more electrical panels.

We recommend performing the necessary corrections to make the distribution panel safe.

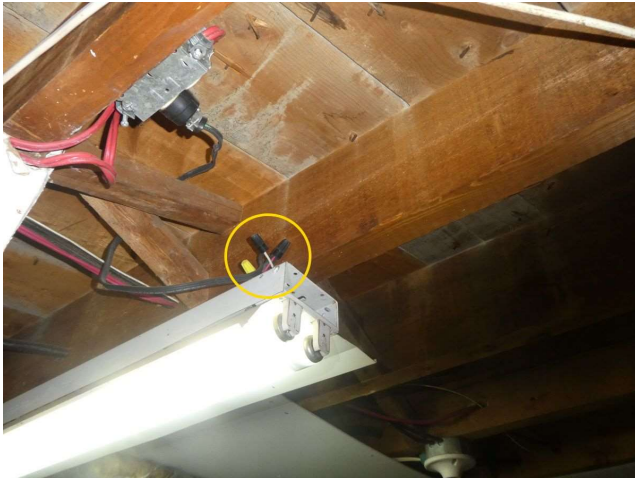
Basement (mechanical room)

EXPOSED WIRING (LIVE)

We found one or more live exposed electrical cables.

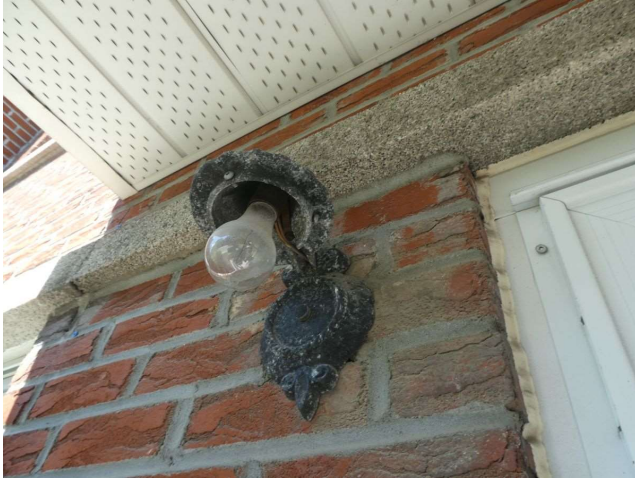
Front facade

DAMAGED LIGHT FIXTURE

We noted one or more damaged light fixtures.

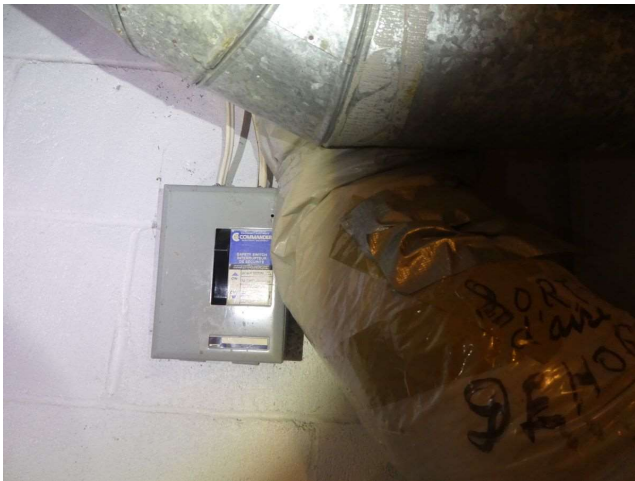
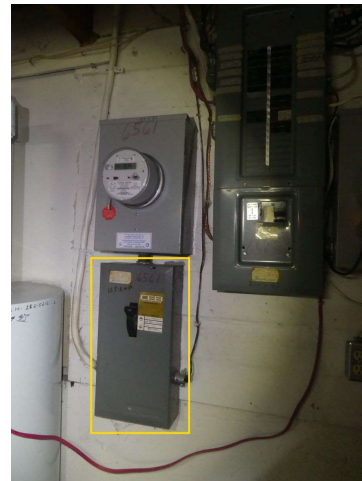
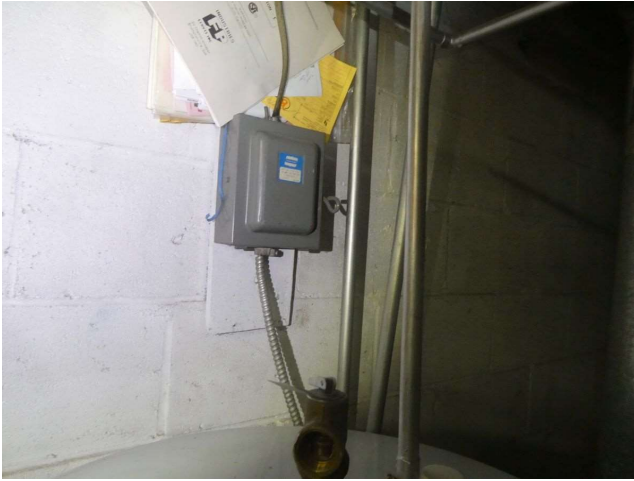
FUSE BOX

Disconnect for air exchanger

Main disconnect for second floor

We noted one or more electrical fuse boxes.

Ceramic fuse holders, whether or not in a metal housing, are considered obsolete and dangerous and should be replaced. The end terminals of these panels, which are found on walls or ceilings, are exposed, and there is a risk of accidentally touching a live wire by changing a fuse.

We recommend that you contact an electrician to carry out the necessary corrections.

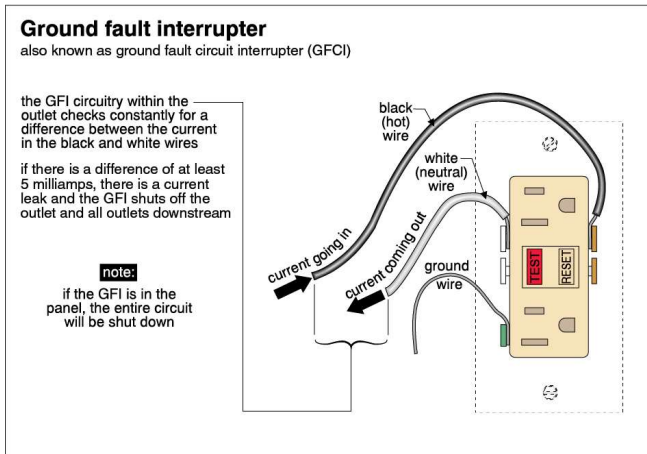
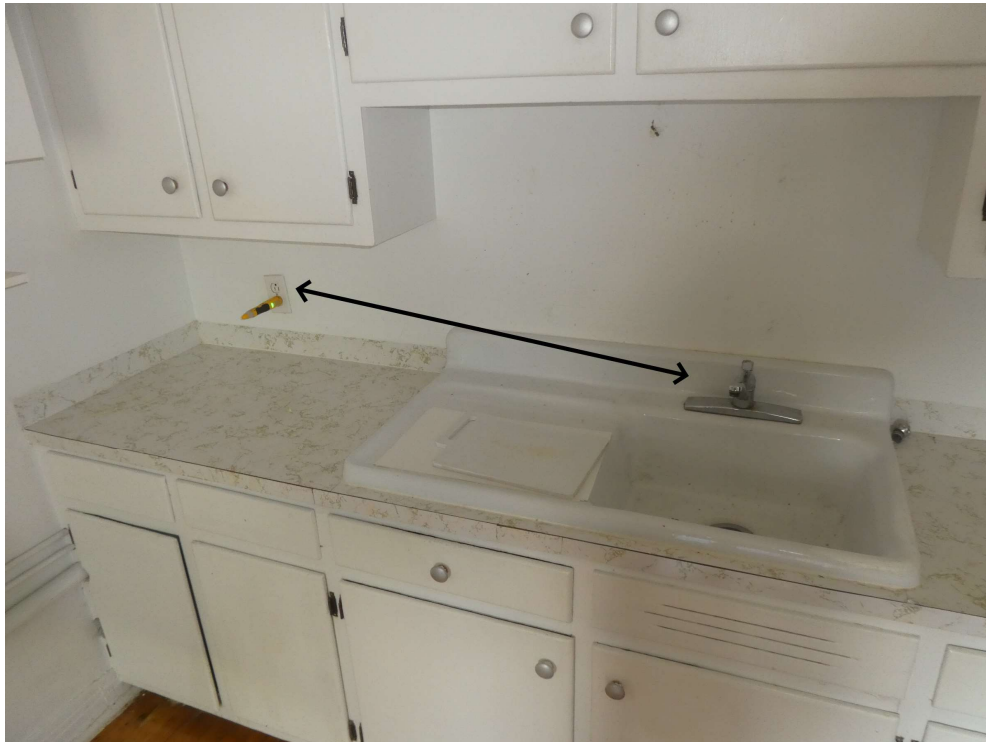
Second floor kitchen

OUTLET (OR BREAKER) WITHOUT GFCI PROTECTION

GFCI outlets have a safety measure in which, in the event of a short circuit or current differential, the outlet will trip to cut off the power supply. The absence of this component near a water source poses a safety hazard to anyone that occupies the property.

We recommend contacting an electrician to perform the necessary corrections to make the use of these outlets safe.

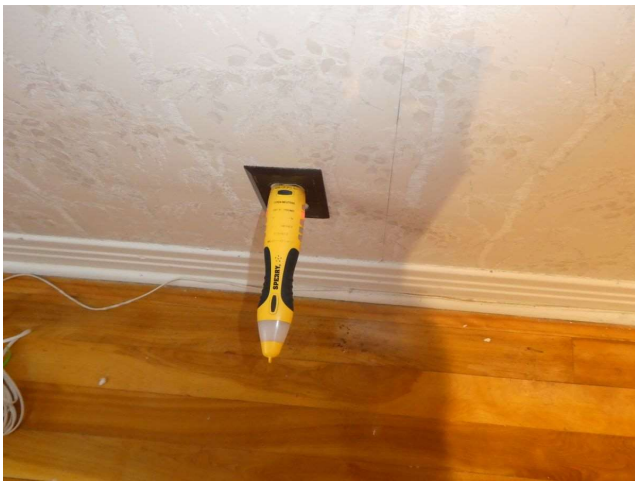
Ground floor (front bedroom)

OUTLET WITH NO GROUND

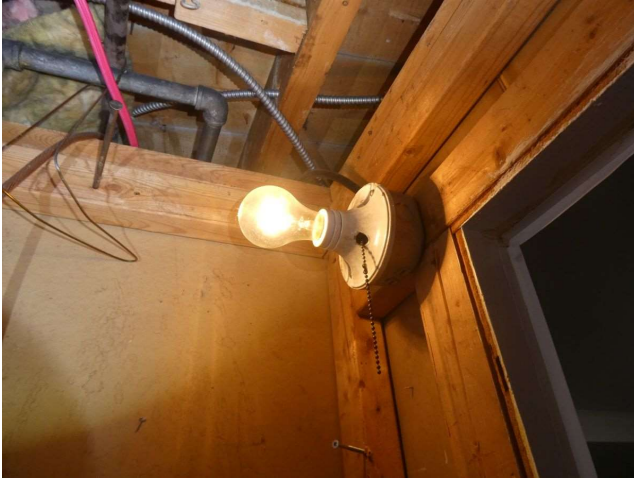
Basement (main valve closet)

UNPROTECTED LIGHT BULB

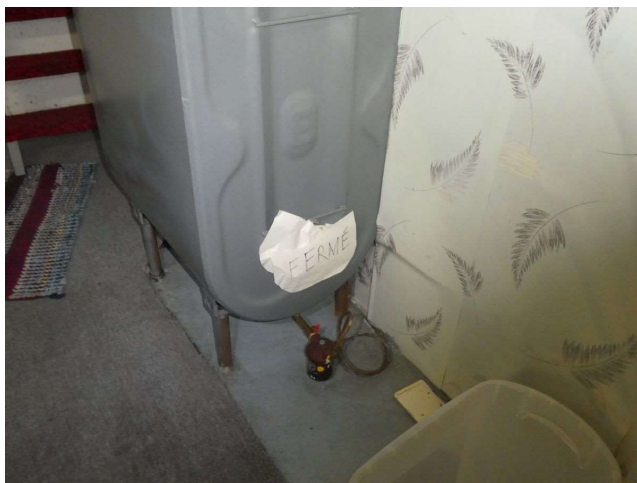
CANNOT INSPECT CENTRAL HEATING

The fuel valve for the oil reservoir was turned off during the inspection.

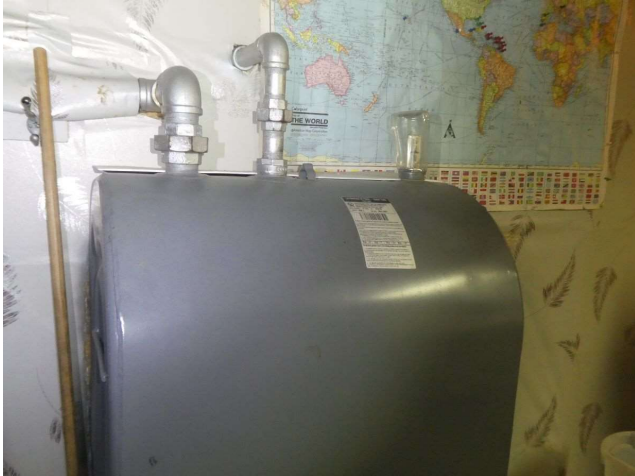
Basement (mechanical room)

EXPERTISE RECOMMENDED FOR FUEL OIL RESERVOIR

We were unable to carry out a verification of the walls of the tanks and check its nameplate. The tank is inaccessible and hidden by objects.

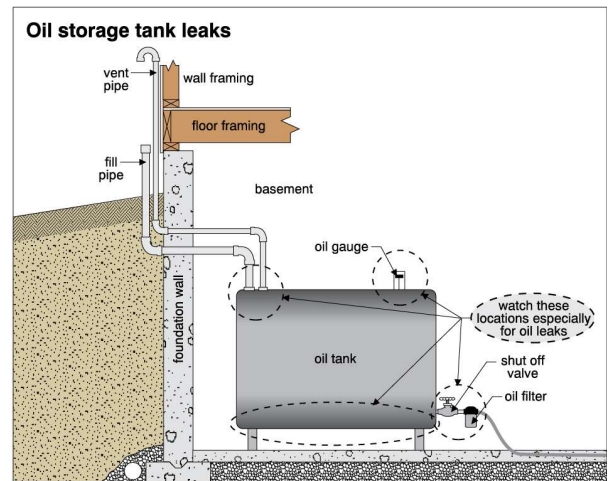
Example

We noted that the fuel gauge cover on the oil reservoir was missing or damaged.

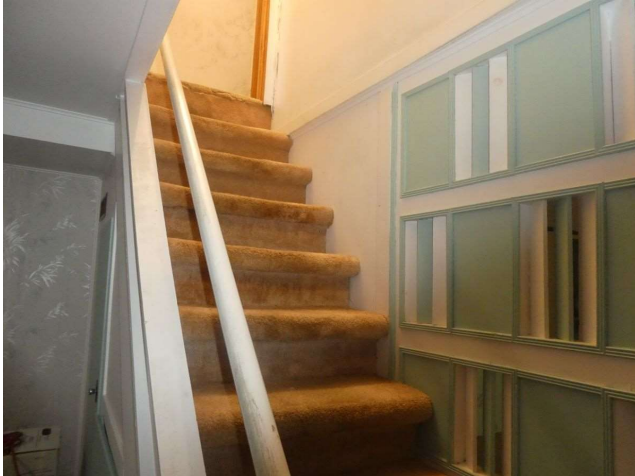
basement staircase

NARROW STAIRCASE

We noted that the width of one or more staircases was too narrow to be used safely

We recommend consulting a licensed contractor for correction and further evaluation.

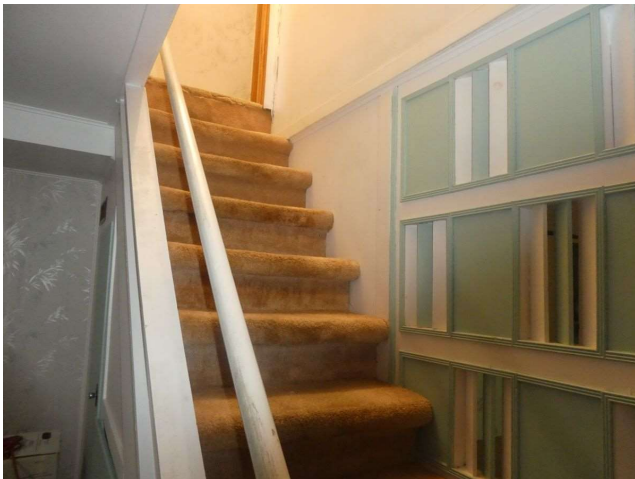
basement staircase

STEEP STAIRCASE

We noted one or more steep staircases.

We recommend consulting a licensed contractor for correction and further evaluation.

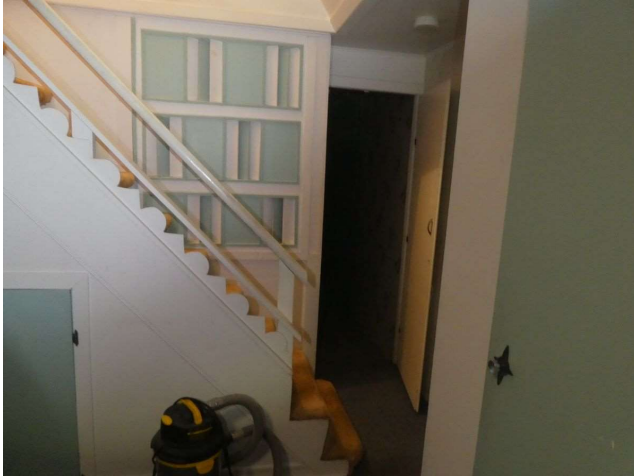
basement staircase

HORIZONTAL BALUSTERS

We noted one or more guardrails with horizontal balusters.

Horizontal guardrail enclosures are a child hazard since the child can easily climb these materials.

We recommend modifying or replacing the guardrail.

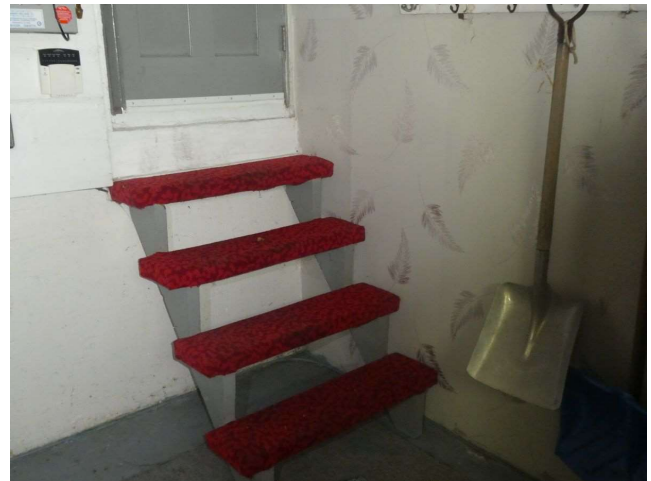
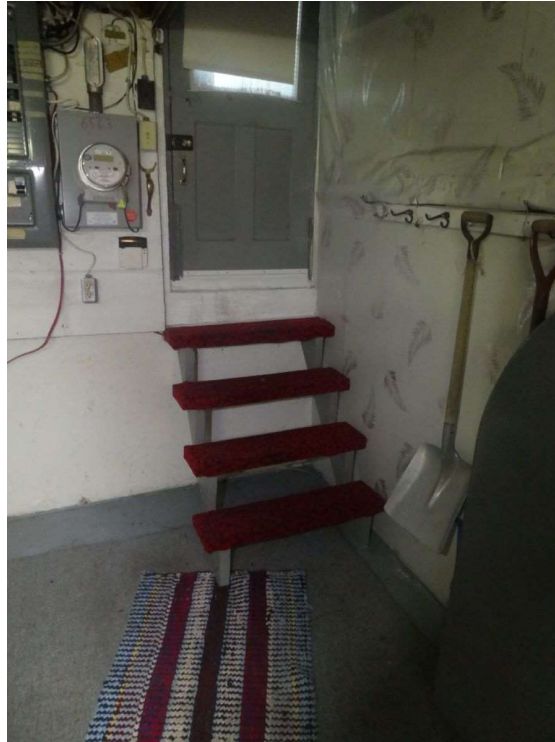
Rear base exit

NO LANDING

We noticed that one or more staircases opened towards the steps without a permanent landing.

This poses a fall hazard to anyone who uses the stairs.

We recommend using a licensed contractor to have the necessary corrective measures taken to secure the stairwell as soon as possible.

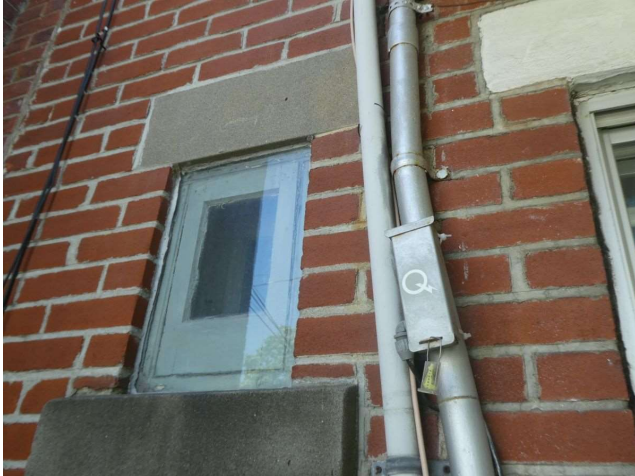
Ground floor (pantry window)

OLD WINDOW

We noted one or more windows that have exceeded their life cycle.

To improve energy efficiency, we recommend replacing these windows with more efficient models.

We recommend that you begin budgeting for their replacement and to contact a licensed contractor to carry out the necessary replacements.

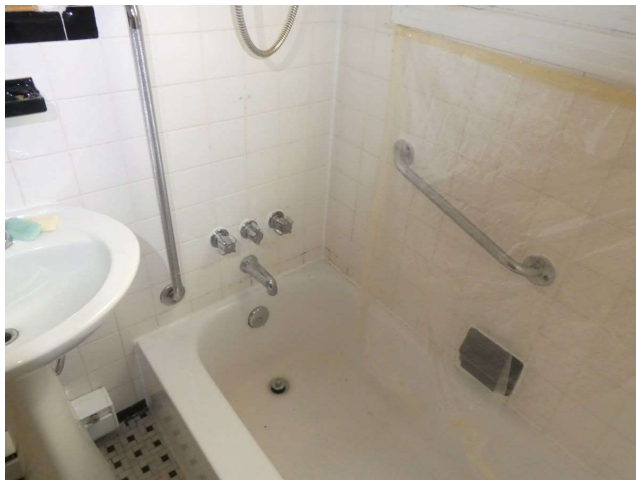
Second floor washroom

WINDOW IN SHOWER (OR BATH)

We noted one or more windows in a shower or bathtub.

This situation can cause water damage and rotting of the window components (as well as those found behind the wall).

We recommend contacting a licensed contractor to further evaluation and correction.

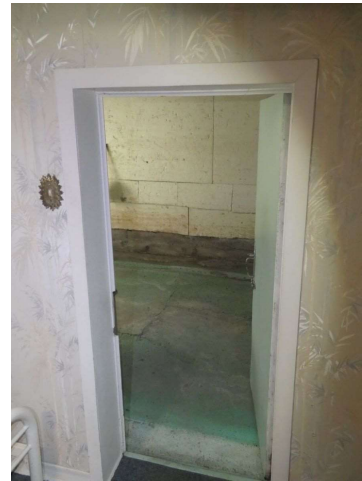
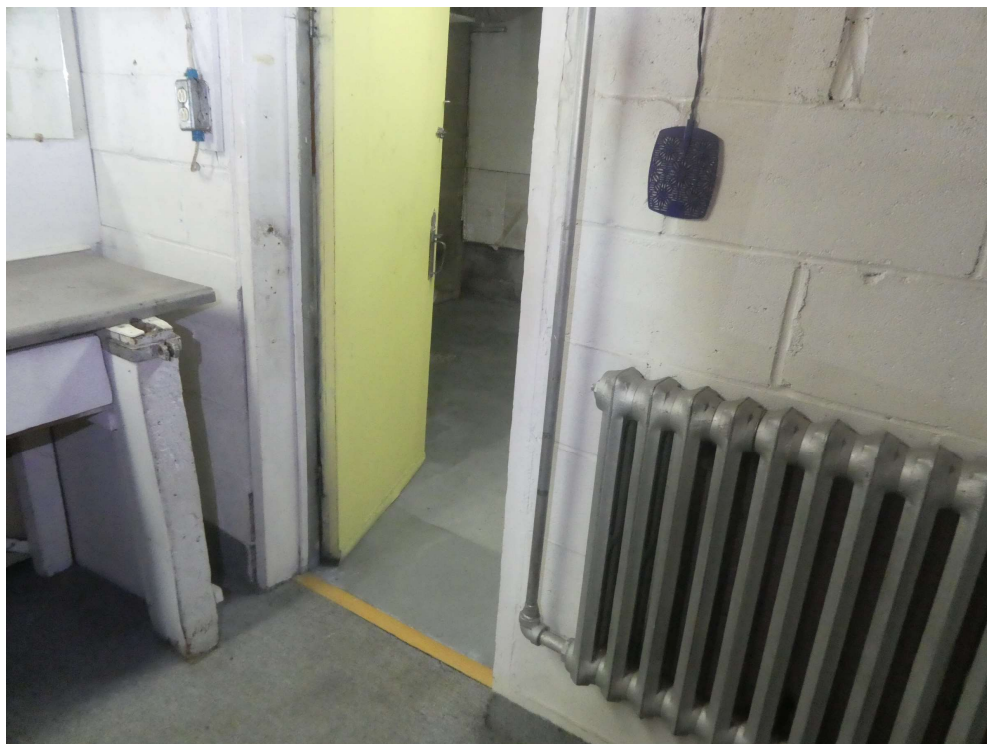
Front garage

GARAGE DOOR (MAN'S DOOR) DOESN'T CLOSE AUTOMATICALLY

We noted that the interior door providing access to the living area from the garage did not close itself automatically.

The air-tightness between the garage and the living spaces must be optimal to prevent exhaust fumes from being transported into the home.

We recommend having the necessary corrective measures taken so that any door connecting the home to the garage closes automatically, is airtight and fire resistant.

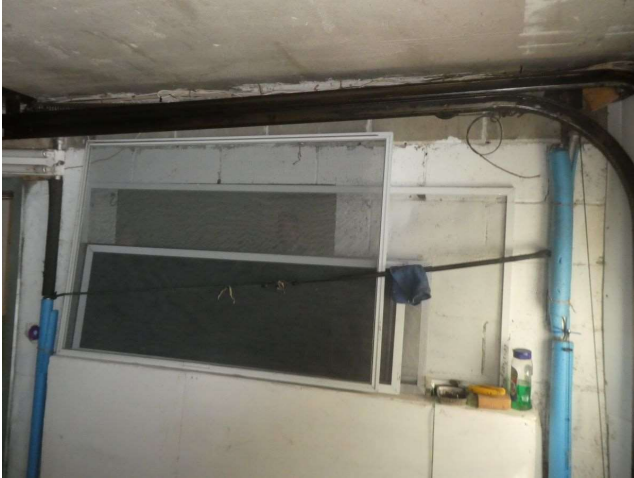
Front garage

OPENINGS IN THE GARAGE

We noted one or more openings in the walls and/or ceiling of the garage that may allow exhaust fumes into the home's living quarters, which can be harmful to the health of anyone who occupies the property.

We recommend that you have the problem corrected.
