File number: [REDACTED]
Inspection date: August 1, 2022

PRE-PURCHASE INSPECTION REPORT

Kevin Mercurio
Les Inspections Mercurio Inc.
1066 rue du Souvenir
Saint-Eustache, Québec
J7R 0M5
August 2, 2022

The property is a 1957 construction duplex. The foundation walls are made poured concrete and the siding is made of brick, stucco and wood. The windows are made of aluminum and the property has a multilayer asphalt and gravel roof covering. This building also has:

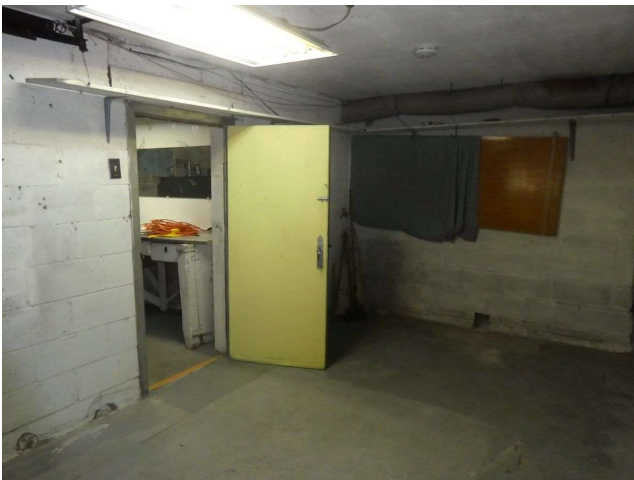
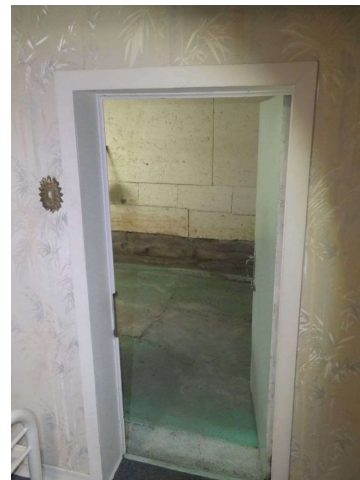
Front garage

HOLLOW CORE INTERIOR GARAGE DOOR (MAN'S DOOR)

We noted that the door providing access to the garage from the residence was a hollow core wood door.

We recommend having the necessary corrective measures taken so that any door connecting the home to the garage closes automatically, is airtight and fire resistant.

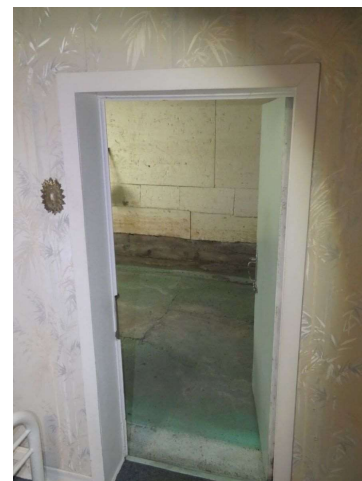
Front garage

MISSING (OR DAMAGED) MAN'S DOOR WEATHERSTRIPPING

We noted that the weatherstripping at the man's door was either missing or damaged.

We recommend contacting a licensed contractor to have this resolved..

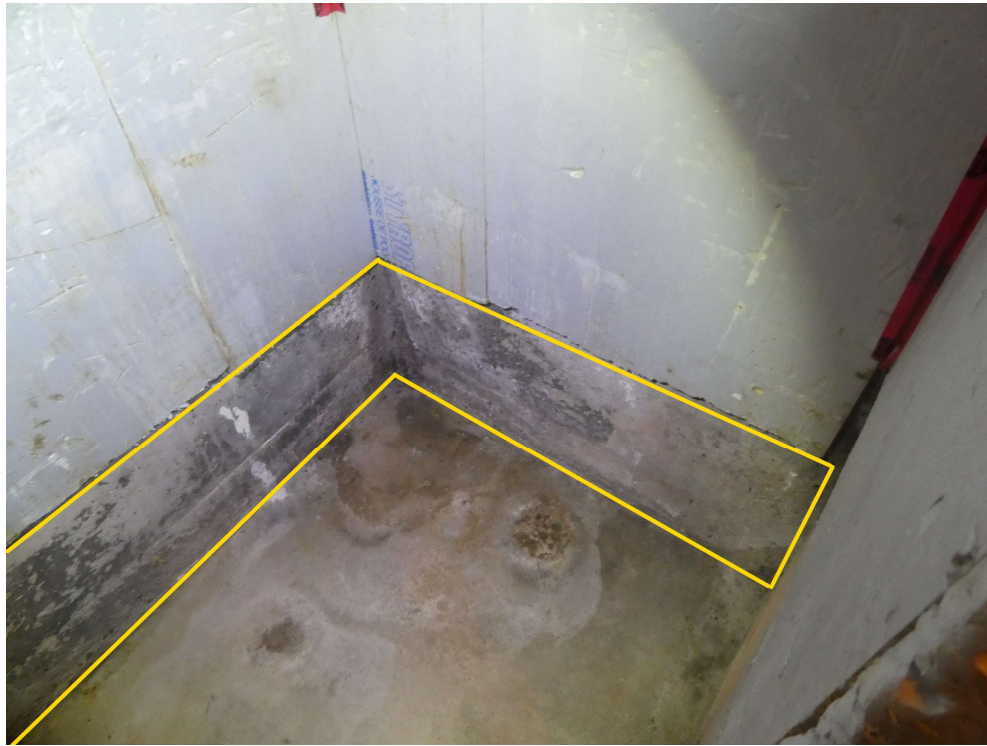
Basement (main water valve closet)

NOT INSULATED

We noted that one or more foundation walls were not insulated.

For energy saving and comfort purposes, the foundation walls should be insulated.

However, before undertaking such work, the foundation walls should be waterproofed from the exterior and the drainage system should be operational. If the foundation is not waterproofed, **DO NOT INSULATE THE WALL BELOW GROUND LEVEL**. The frozen ground could exert adverse pressure on the foundation wall. Furthermore, a wall unprotected from humidity may deteriorate faster during freezing/thawing cycles.

We recommend consulting a licensed contractor for further evaluation.

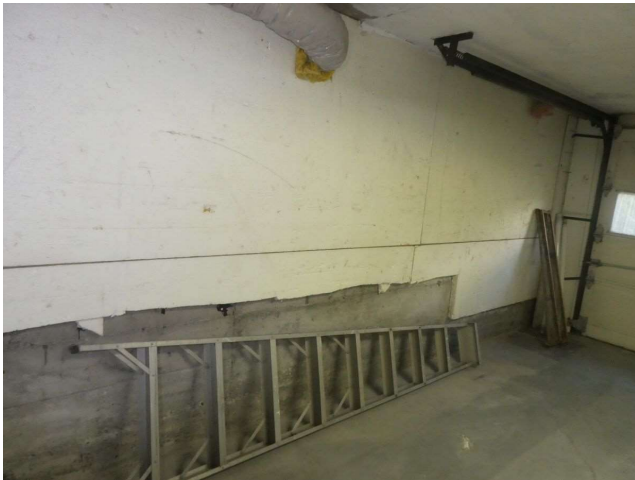
rear garage

EXPOSED COMBUSTIBLE INSULATION

We noted one or more areas in which there was exposed combustible insulation.

We recommend contacting a licensed contractor to have the situation evaluated further.

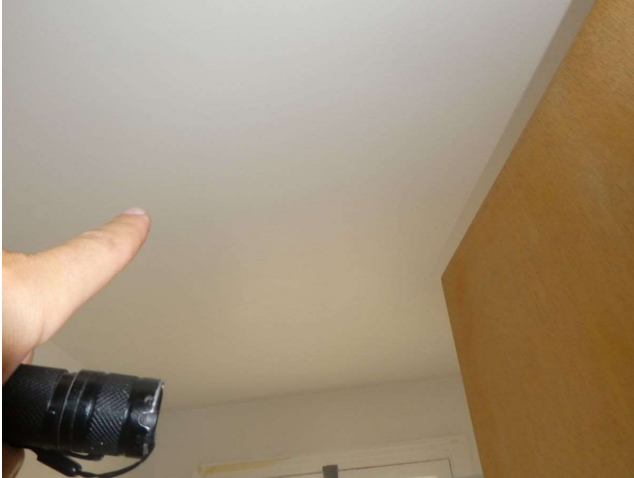
Second floor washroom

MISSING

We noticed one or more washrooms without ceiling fans.

The concentration of moisture in a bathroom where showers are used can lead to premature failure of interior finishes such as paint and wallpaper, and result in mildew and rot in concealed areas.

We recommend that you consult a licensed contractor to correct the situation.

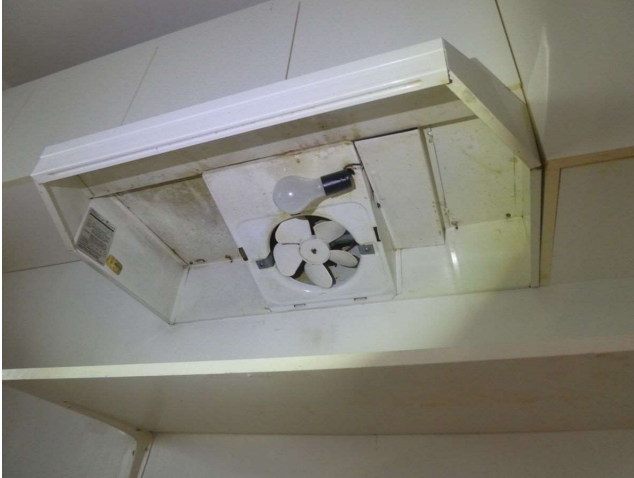
Second floor kitchen

MISSING FILTER

We noted one or more missing rangehood filters.

We recommend installing a rangehood filter.

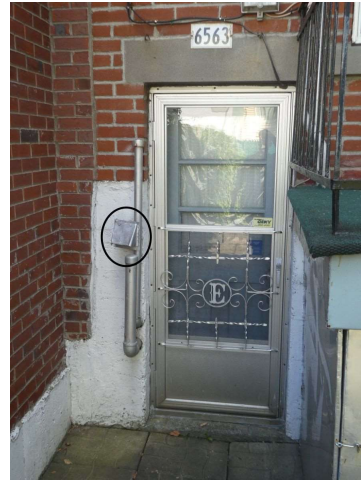
Rear facade

DAMAGED REGISTER

We noted that one or more dryer exhaust registers were damaged or improperly installed.

We recommend that this situation be corrected by a qualified contractor and that the register be kept clear at all times.

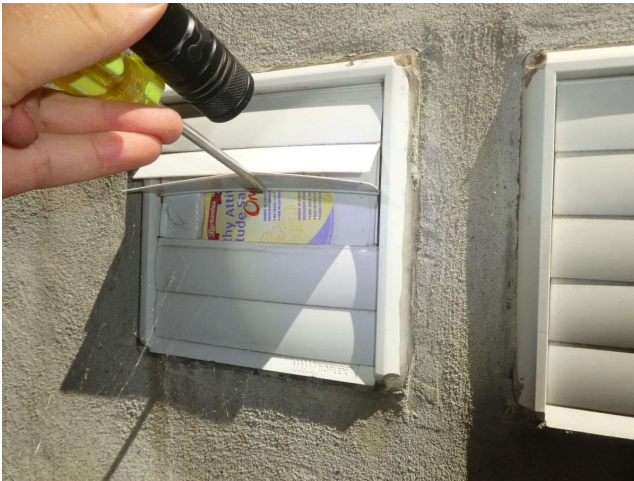
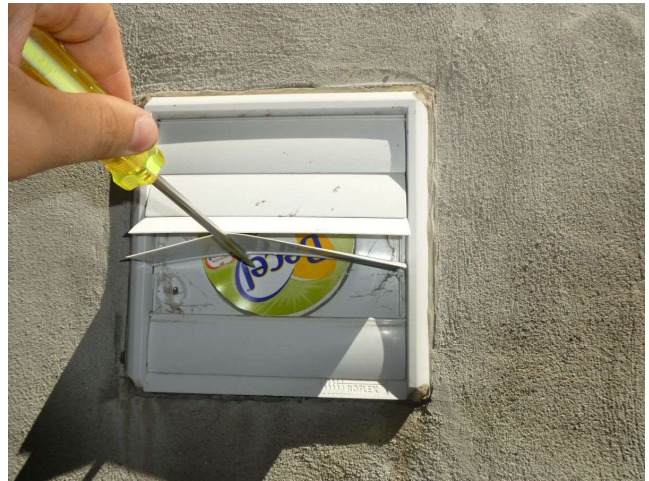
left facade

SEALED DUCTWORK

The property's air exchanger's ductwork was blocked. As a result, we were unable to operate it to confirm it's proper functioning..

Our inspection was therefore limited.

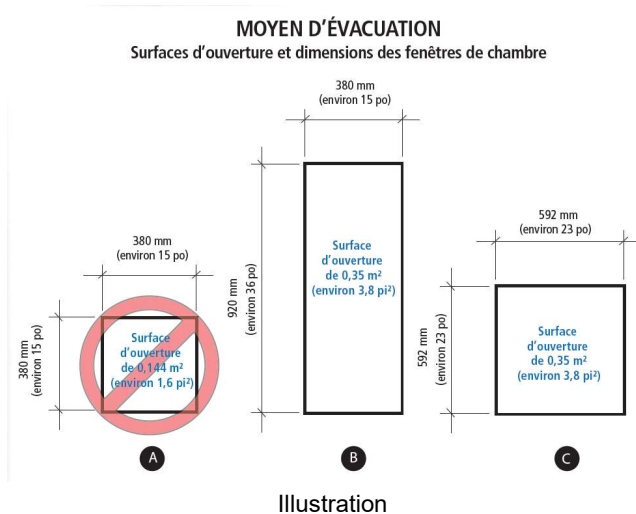
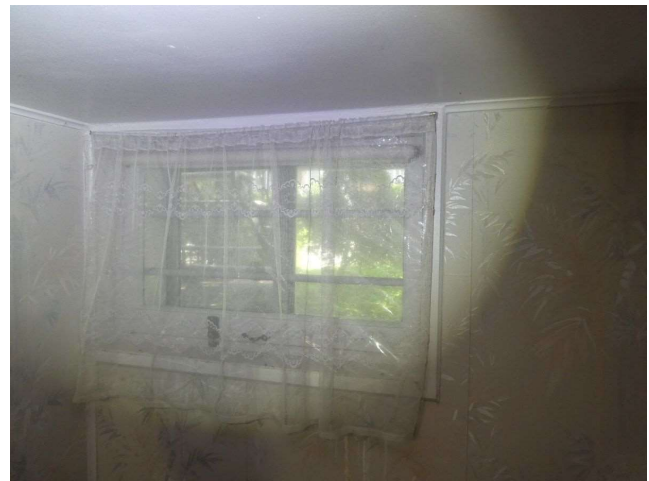
Basement (front room)

UNDERSIZED BASEMENT WINDOW

We noticed one or more basement windows that were undersized to constitute an emergency exit for a bedroom.
