PRE-PURCHASE INSPECTION REPORT

Kevin Mercurio

Les Inspections Mercurio Inc.

July 24, 2022

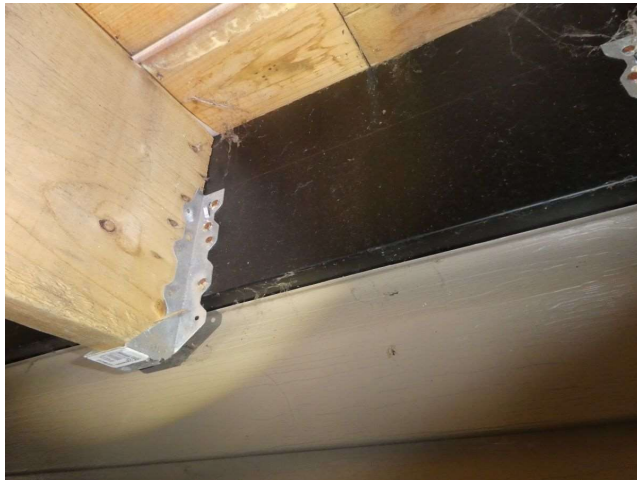
Below rear balcony

IMPROPERLY FASTENED DECK JOISTS

We noted that deck's floor joists were attached to the ledger board without joist hangers.

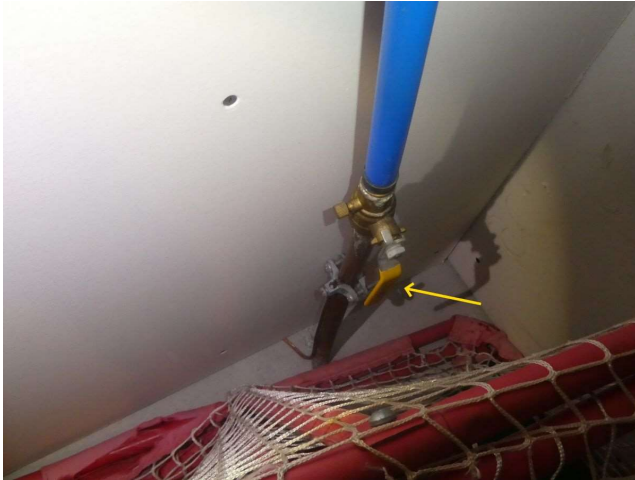
Basement (sump pit room)

NO DEFECT ON THE MAIN WATER VALVE

We observed no defects on the water supply piping before the main shut-off valve or at the main shut-off valve.

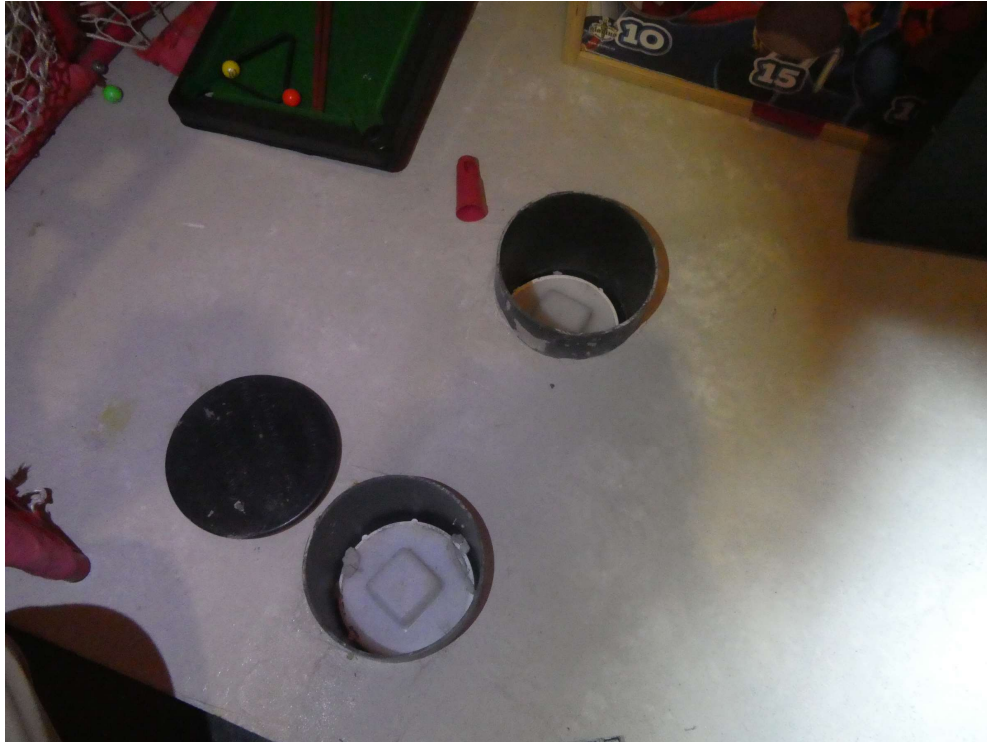
sump pit room

We noted that the cleanouts providing access to the property's foundation drain were covered with a geotextile membrane.

Over time, the geotextile membrane may wear or be torn, creating an opening that risks blocking the drain.

It is recommended that rigid cap be installed to cover the access points.
