PRE-PURCHASE INSPECTION REPORT

Kevin Mercurio

Les Inspections Mercurio Inc.

July 24, 2022

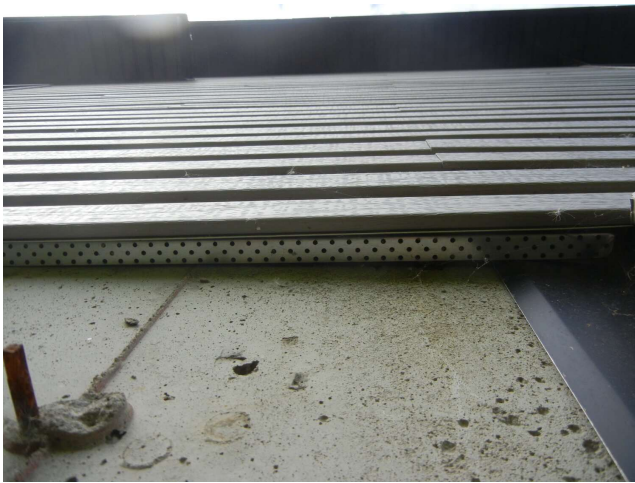
NO SCREEN BEHIND SIDING

We recommend contacting a licensed contractor to have this corrected.

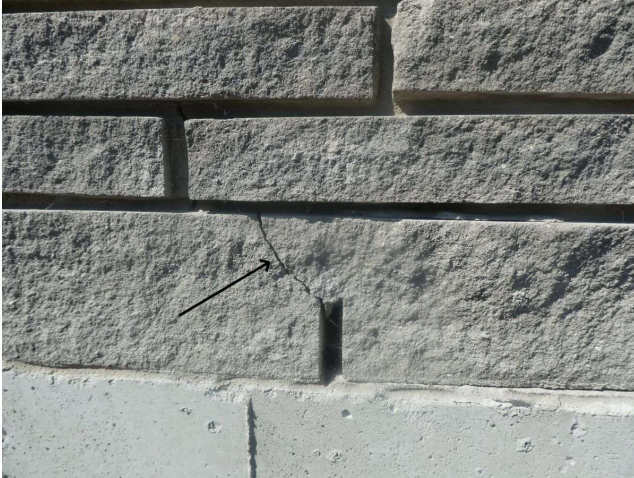
Front facade

MASONRY WORK REQUIRED

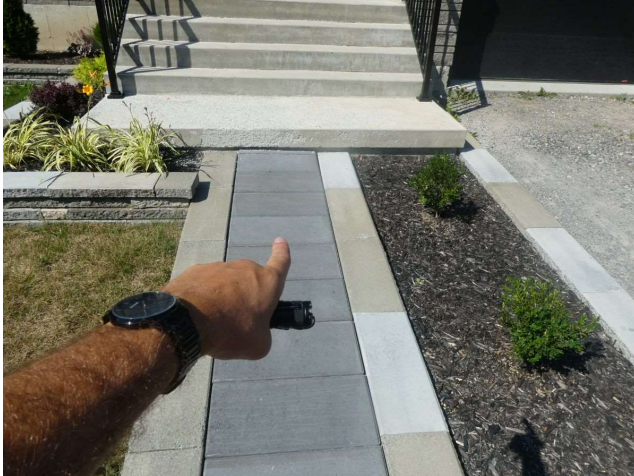
front walkway

SHIFTING OF PAVING STONES

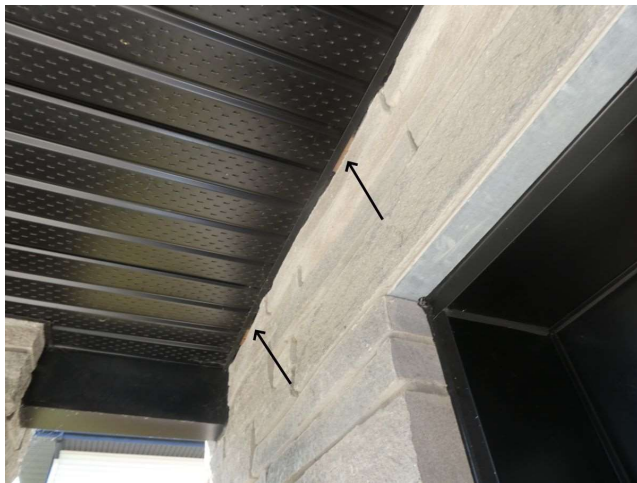
Front balcony

OPENING IN THE SOFFIT

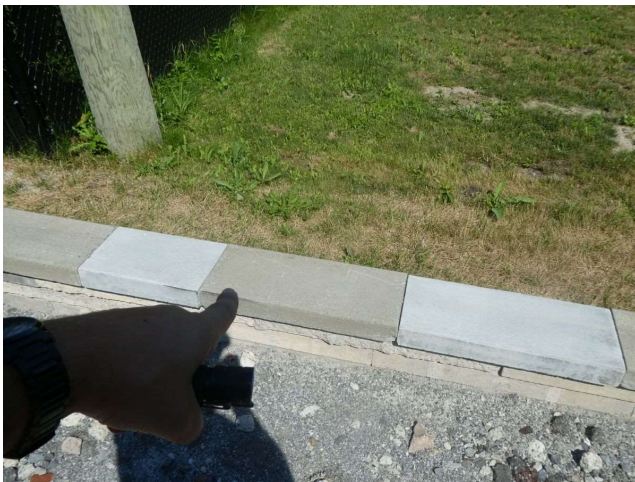
Driveway

UNSECURED RETAINING WALL

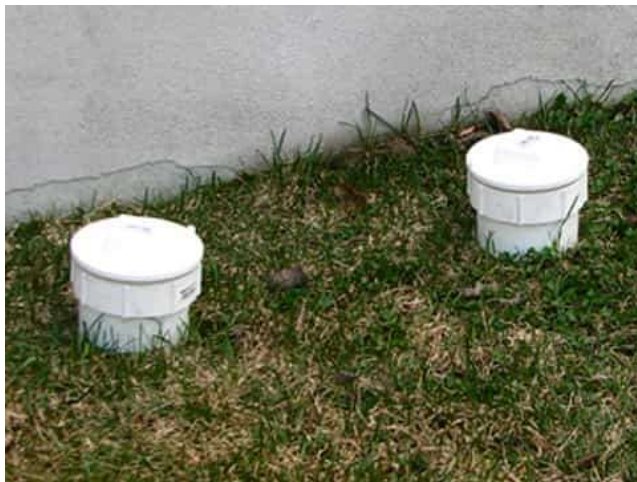
Floor drain

We noted that one or more floor drains were not equipped with a strainer.

We recommend a strainer be installed to prevent objects from falling into the drain and causing hard to unclog obstructions.

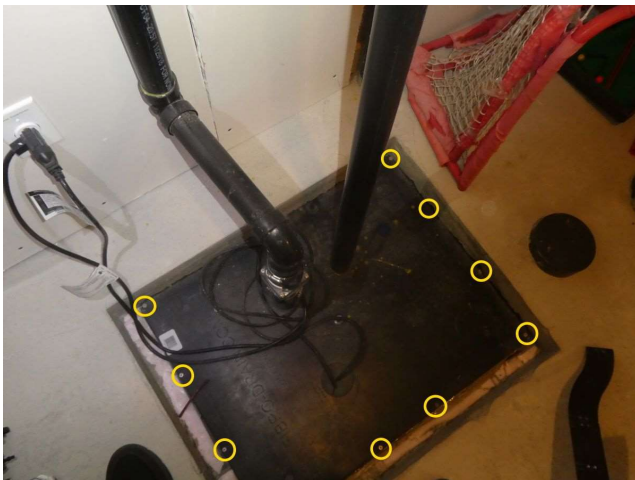
SCREWED CATCH BASIN LID

We were unable to open the catch basin because its cover was fastened using screws.

We recommend that you obtain a completed copy of the vendor's declaration form in order to be aware of the statements that relate to these non-inspected items. We recommend that you obtain any documents deemed relevant that pertain to these plumbing elements.

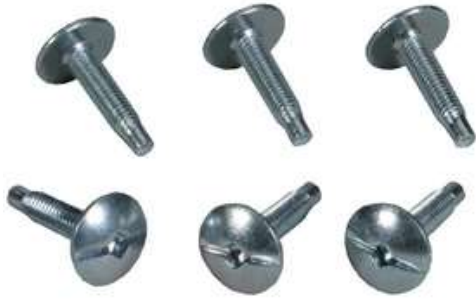
COVER FASTENED USING WRONG SCREWS

We noted that the cover of the electrical panel was fastened with pointy screws.

We recommend contacting a master electrician to replace the screws.

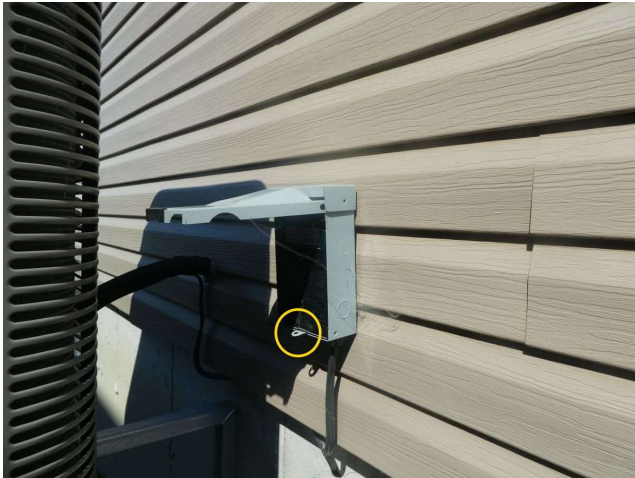
left facade

SAFETY DISCONNECT WITHOUT LOCK

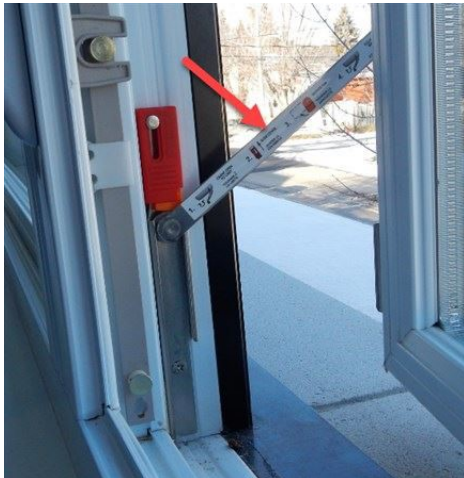
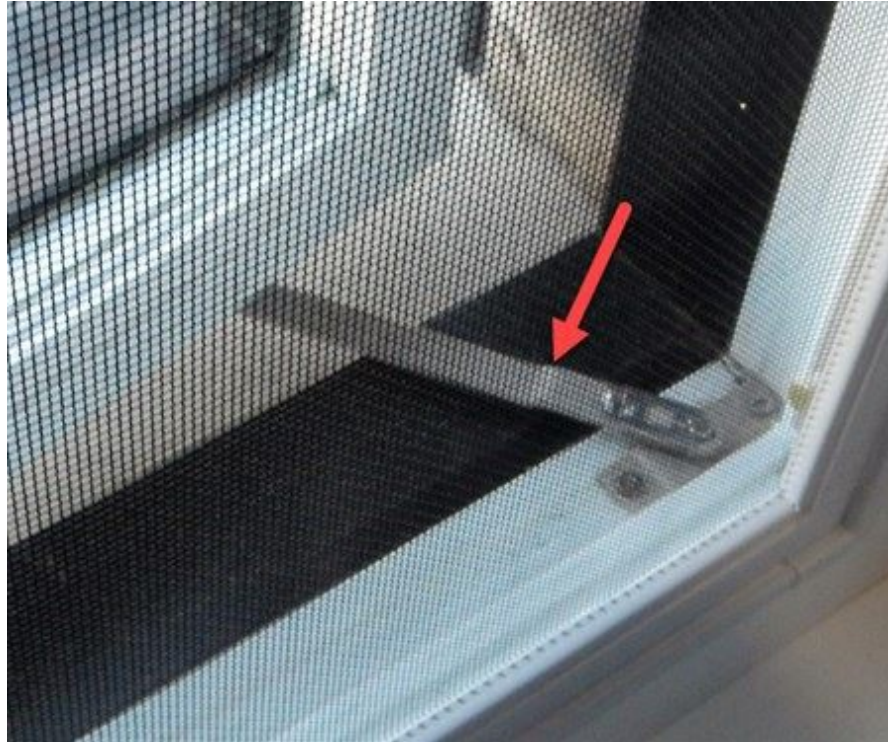
UNSAFE WINDOW OPENING

We noted certain unsafe window openings.

To prevent an accident, we recommend that the windows in question be protected by a guardrail or by a limiting device.

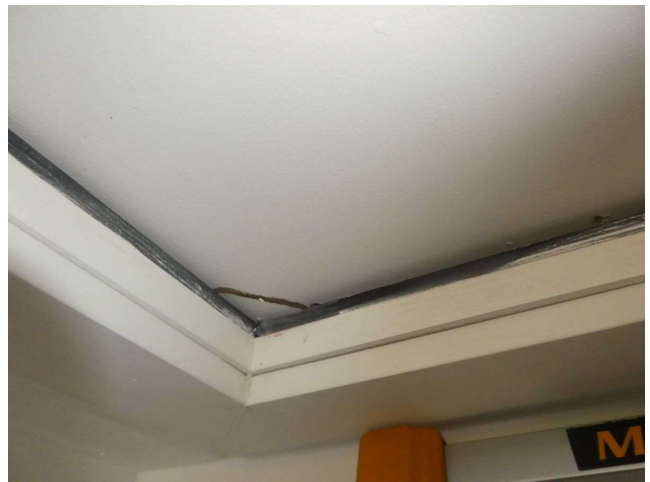
INADEQUATELY SEALED ATTIC ACCESS HATCH

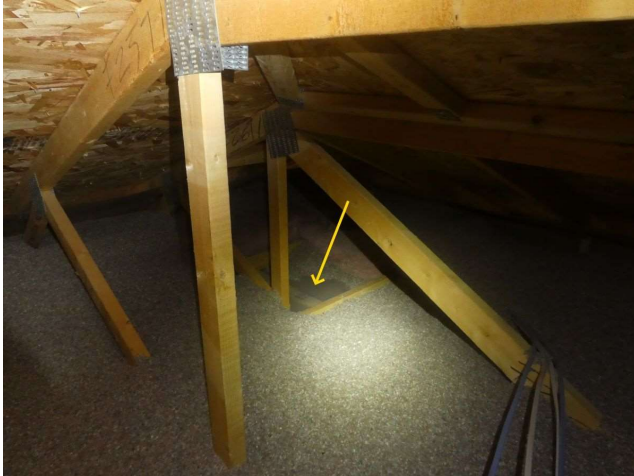
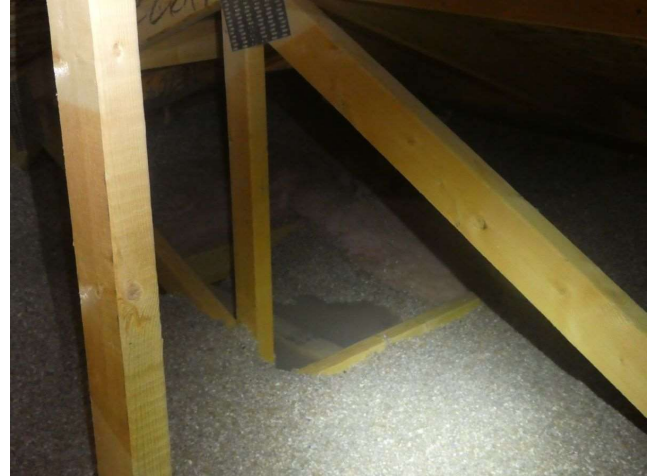
attic

DISPLACED INSULATION

We noticed some displaced insulation in the attic, which can allow for heat loss.

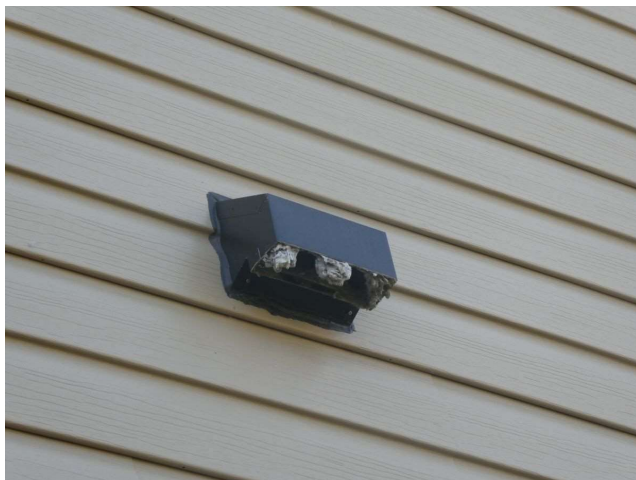
Right facade

CLOGGED

One or more dryer registers appeared to be clogged.
